# Insights from Steady overflow and Wave overtopping tests

Adaptation  
to climate  
change

WL2024R20\_047\_4\_P2C\_Overflow-Overtopping\_Insights

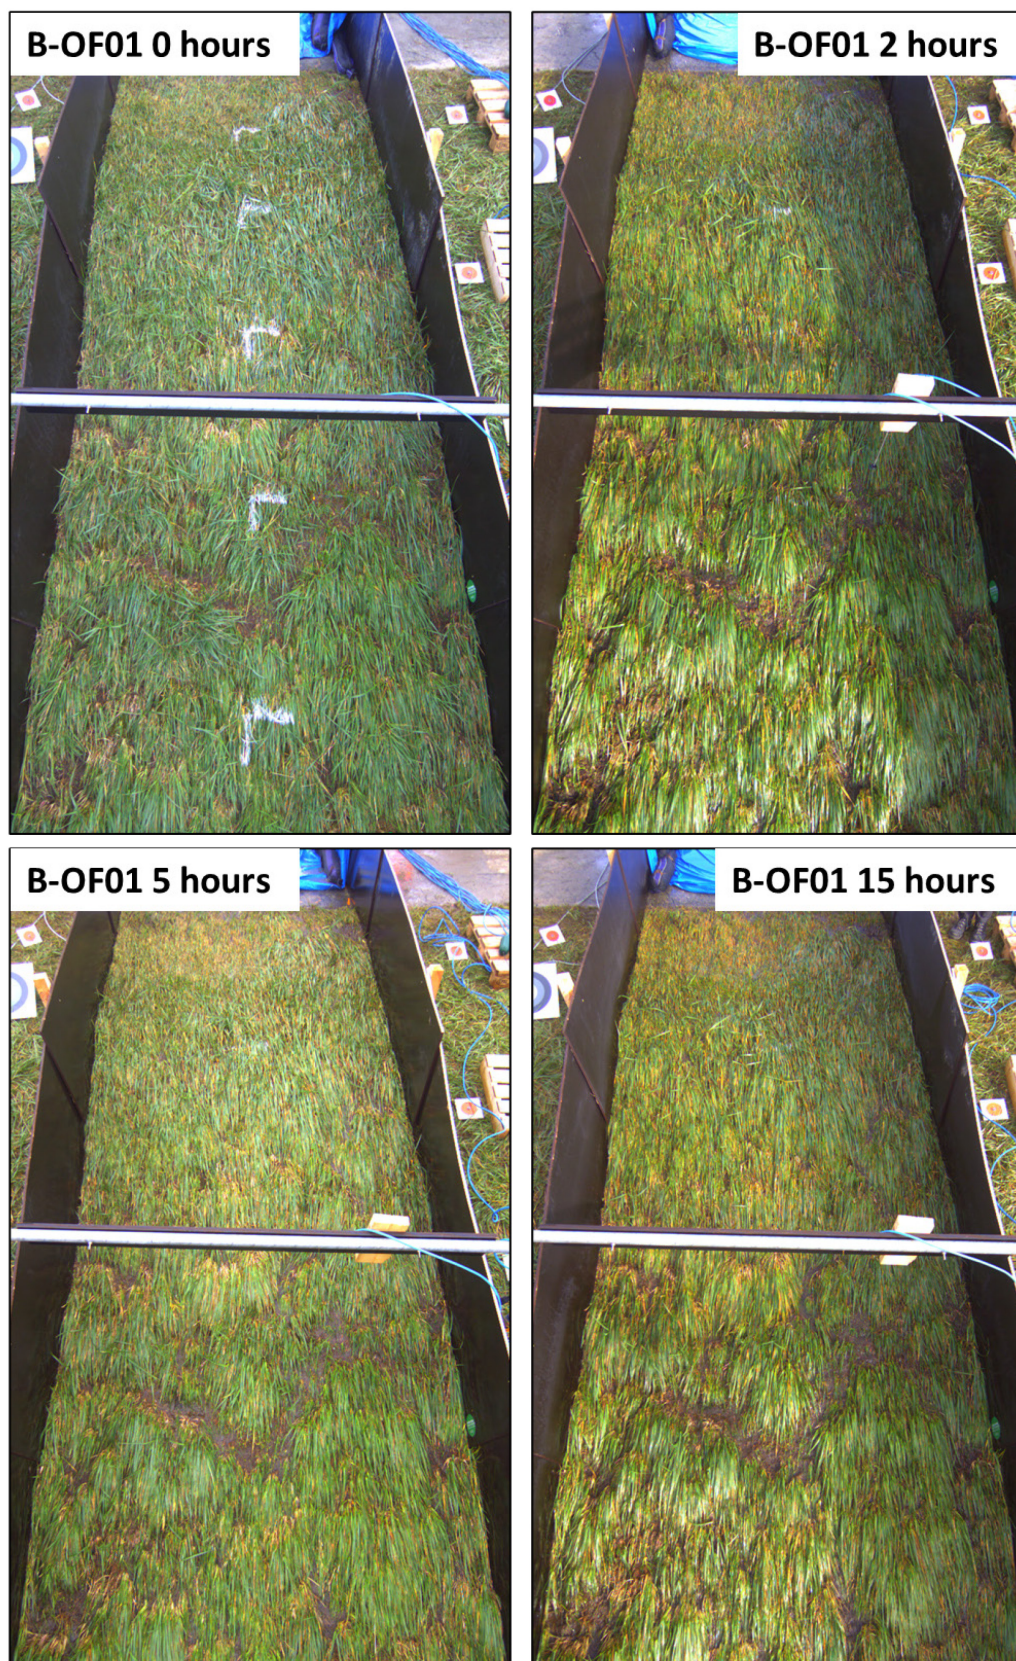
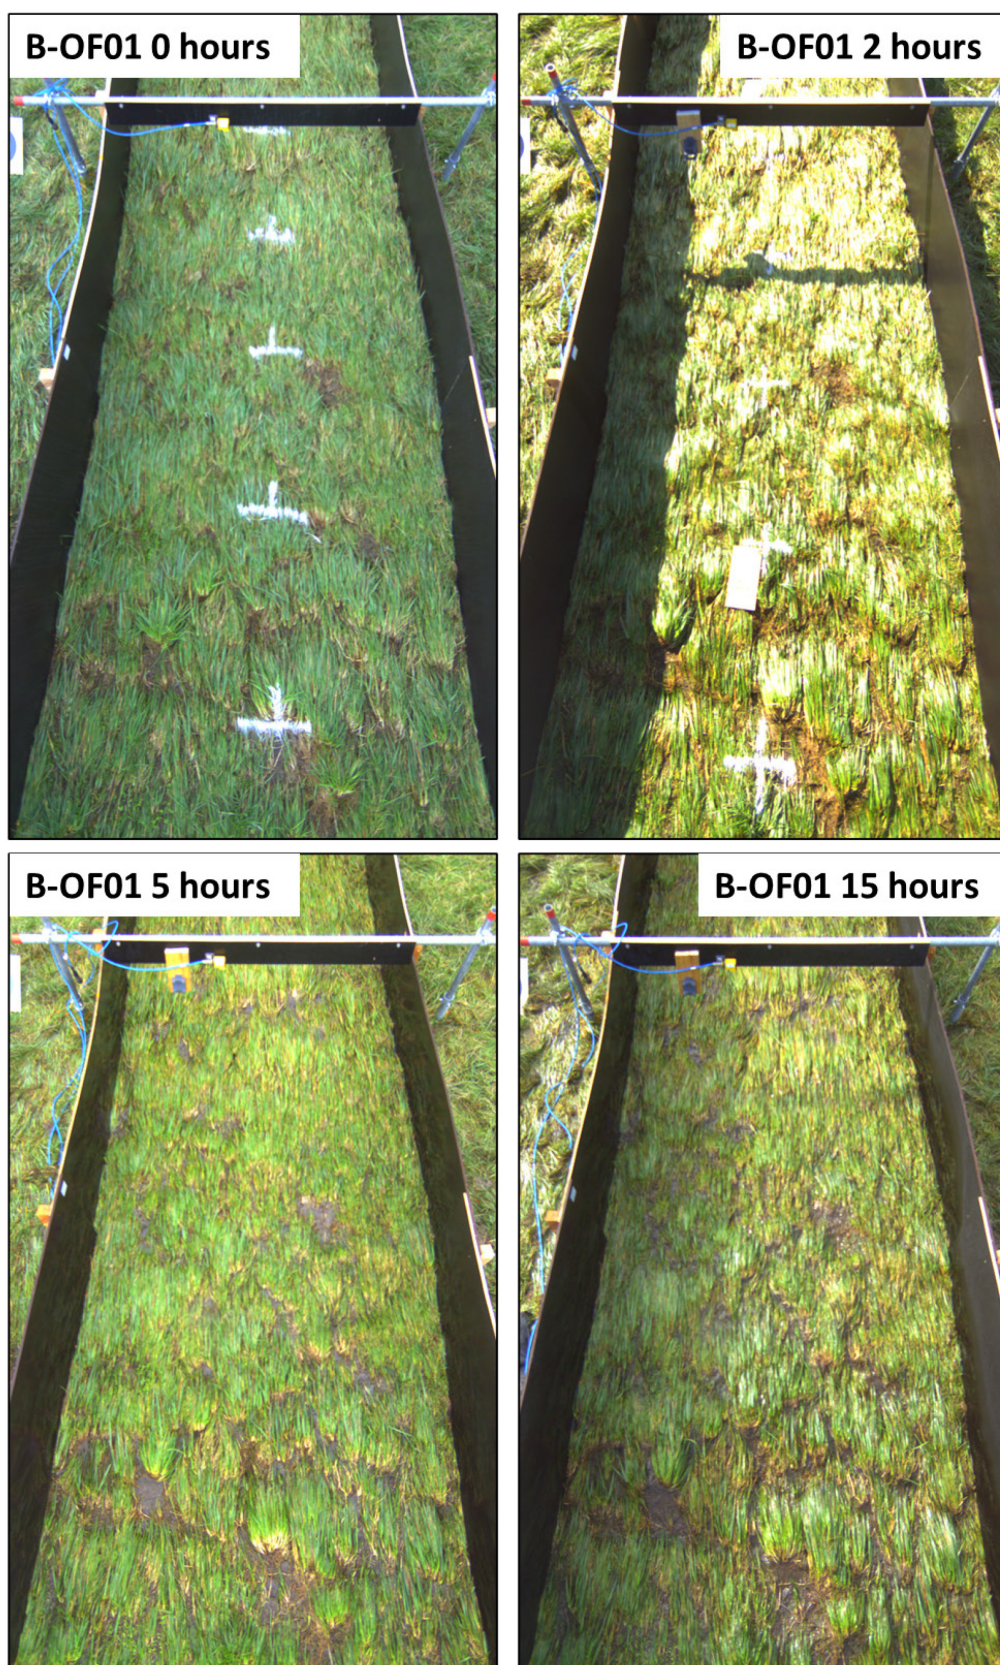
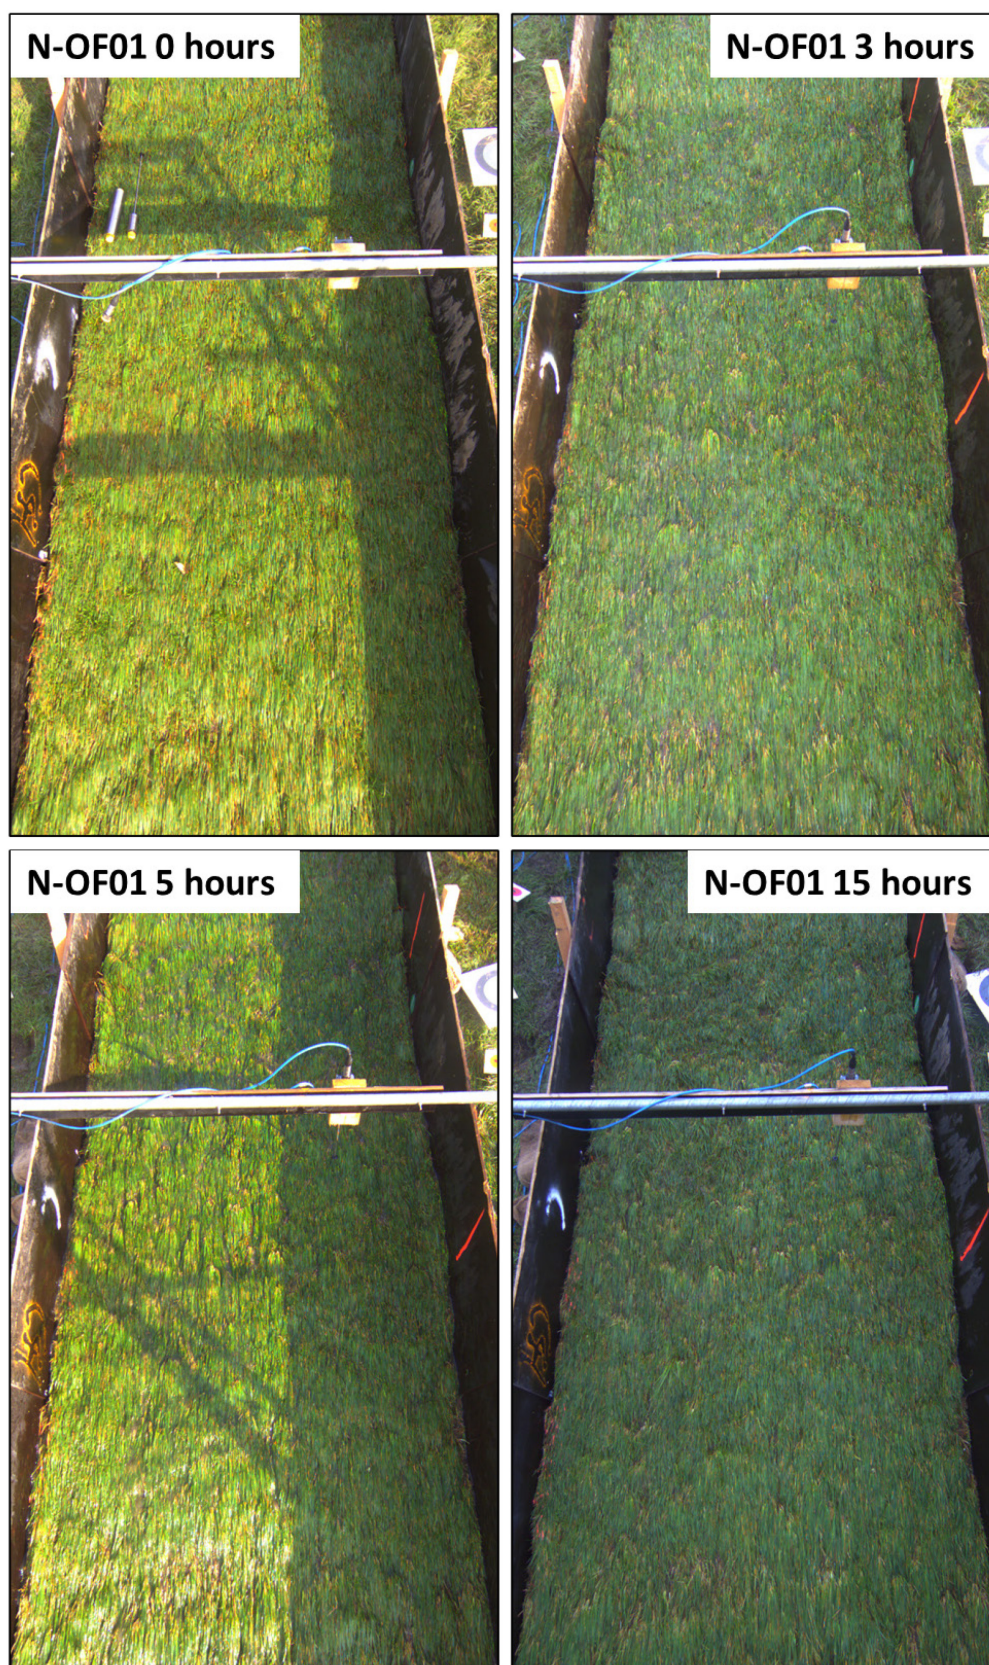
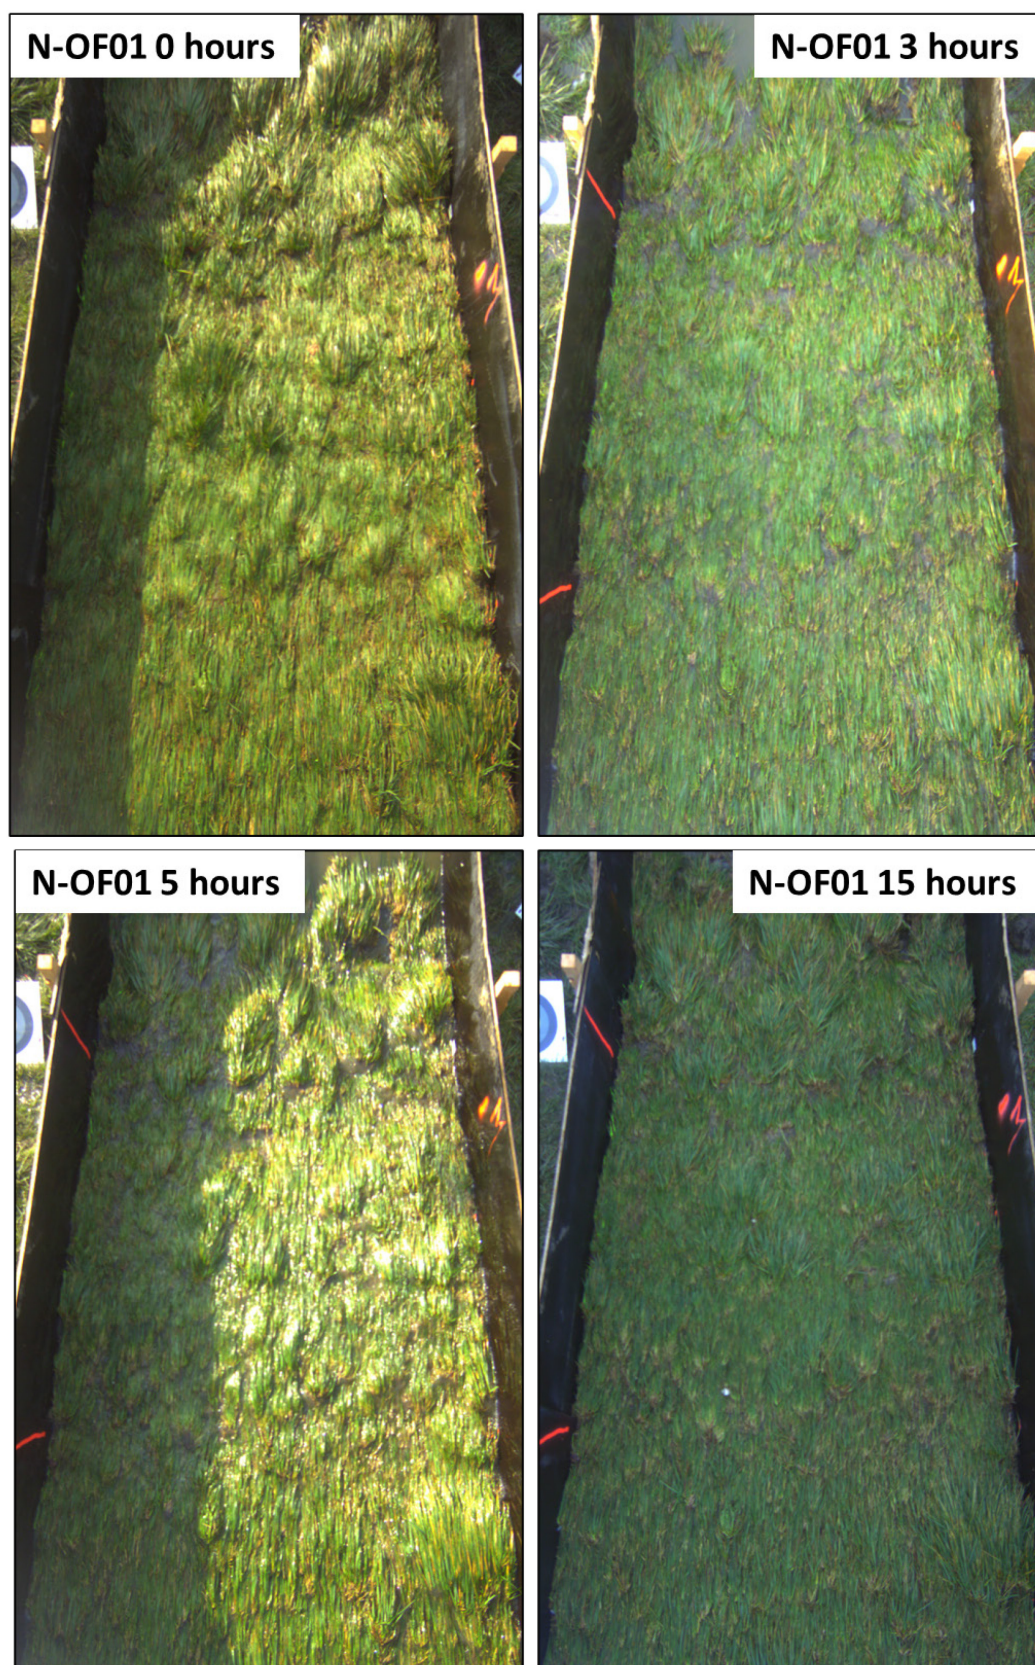
For the reference grass cover layer, a strong contrast is noticed in onset and evolution of the cover layer state for the Dutch and the Belgian levee. The grass cover layer of the Dutch levee is continuous and effectively forming a cover, while the cover layer for the Belgian levee is patchy, discontinuous and shows barren spaces from the onset. This indicates that the surface of the landward slope of the Belgian levee is more uneven, probably caused by the intermittent presence of grazing sheep on the levee slopes. The practice of grazing on levees also occurs in the Netherlands, but not on this specific part of the levee. **The patchiness clearly show that the sheep cause small-scale damage to the surface and its vegetation cover, making it more prone to evolution of barren patches and erosion.** However, as the continuous overflow tests also indicate, **the irregularities do not compromise the integrity and erosion resistance as a whole (in contrast to larger anomalies described further in this report).** Higher discharges appear to have negative impact as well.

Figure 22 - Evolution of grass cover layer quality at B-OF01 site, upper slope, at different times during the experiment.

Figure 23 - Evolution of grass cover layer quality at B-OF01 site, lower slope, at different times during the experiment.

Figure 24 - Evolution of grass cover layer quality at N-OF01 site, upper slope, at different times during the experiment.

Figure 25 - Evolution of grass cover layer quality at N-OF01 site, lower slope, at different times during the experiment. Toe is towards the upper part of the image.

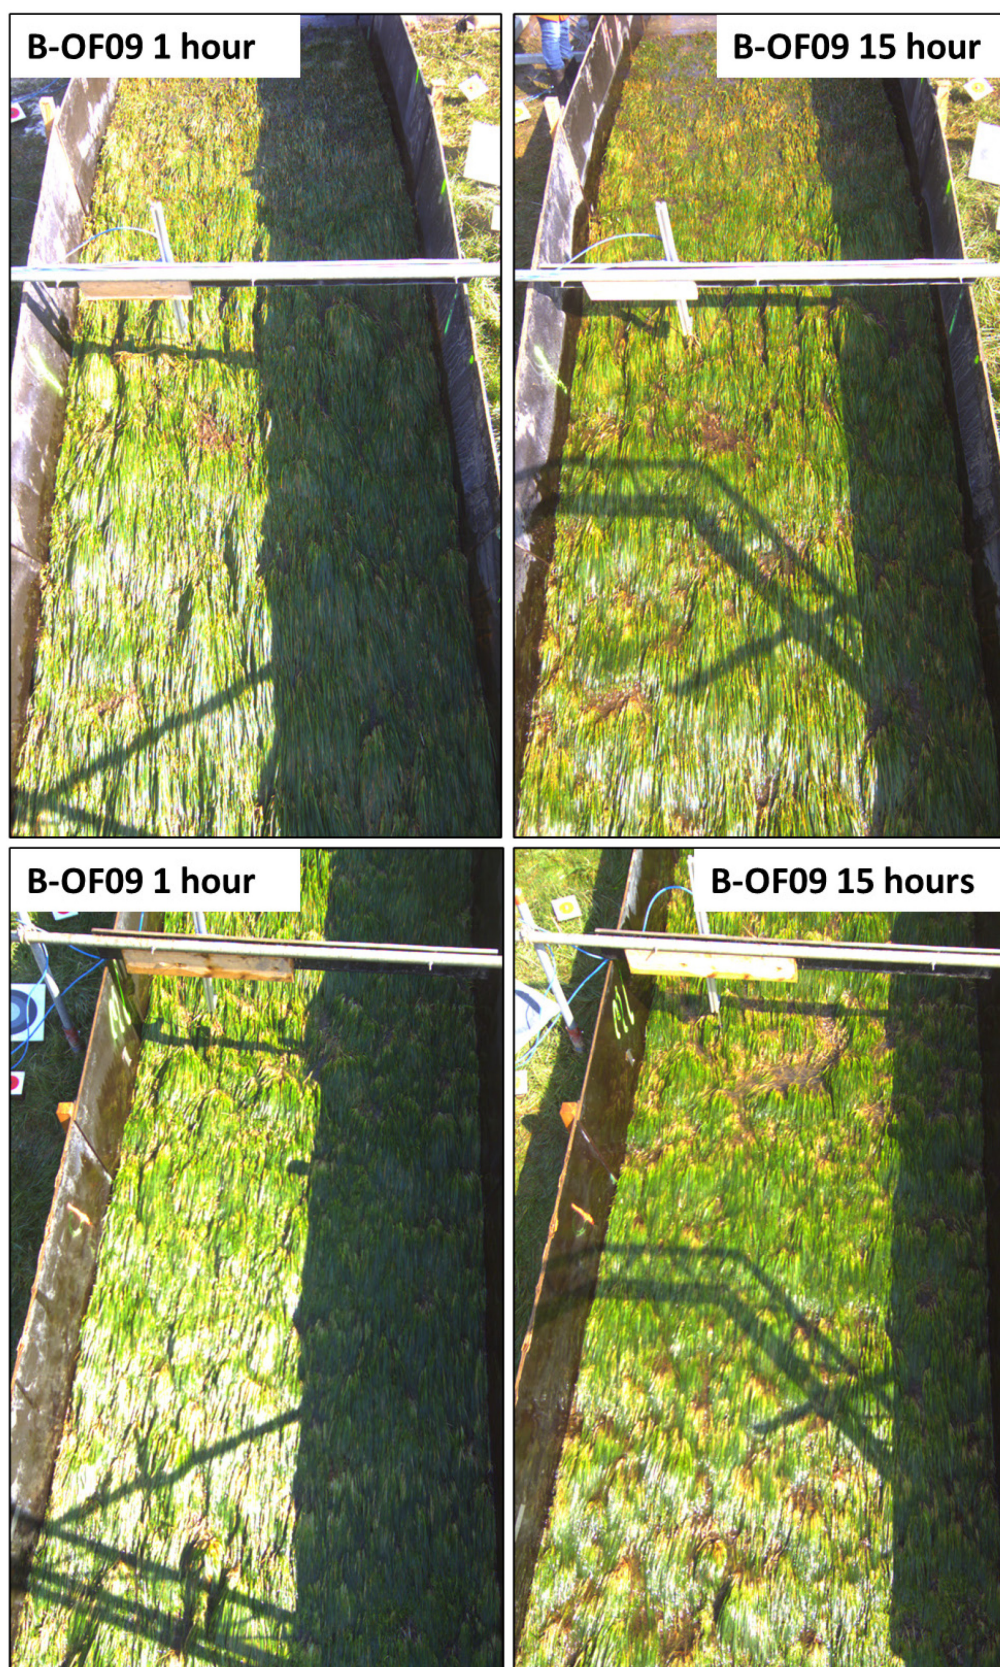
Figure 26 - Evolution of grass cover quality at B-OF09 site, upper (top row) and lower slope, at different times during the experiment.

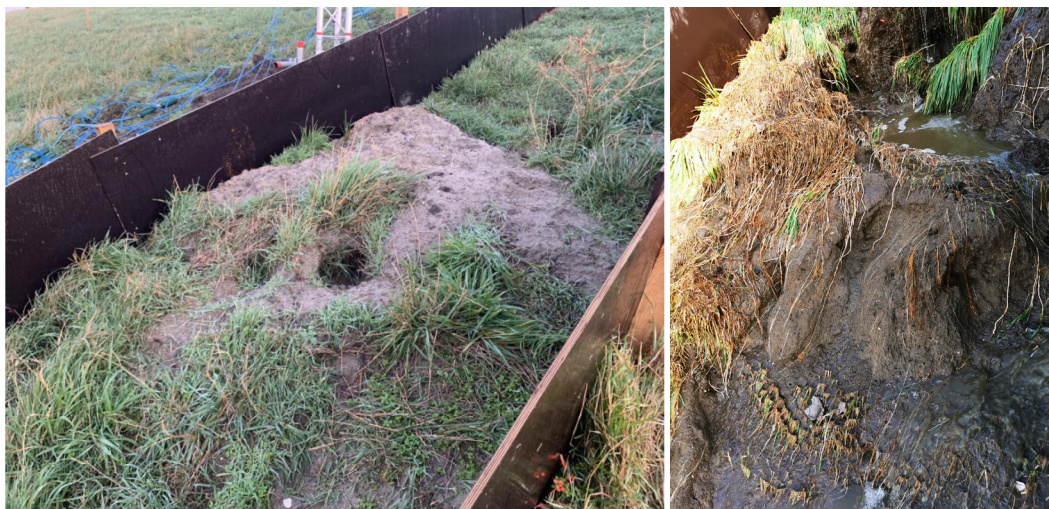
Figure 27 – N-OF05: (left) initial burrow state and (right) exposure of wire fence (lower part of the image) and erosion depression (upper part of the image) during the experiment.

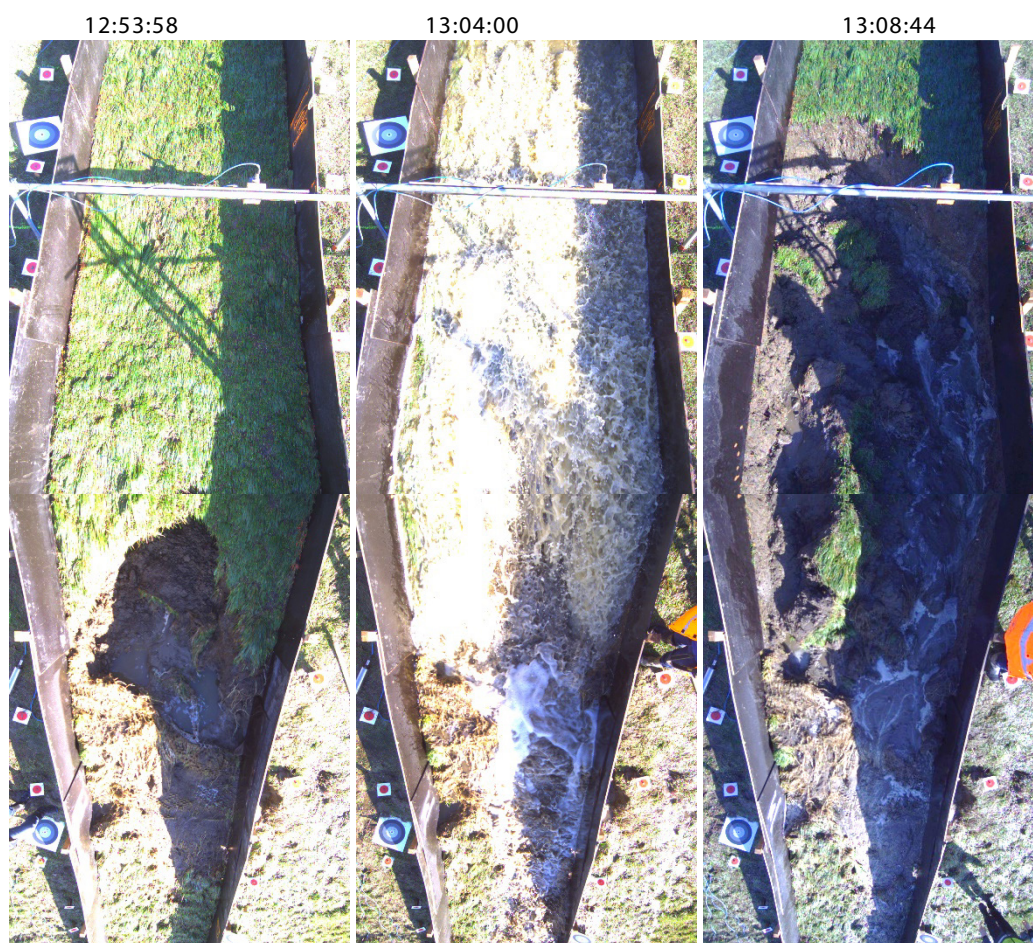
Figure 28 - N-OF05: Evolution of the damage during the last 15 minutes of the test; upper camera portal (= upper slope view).

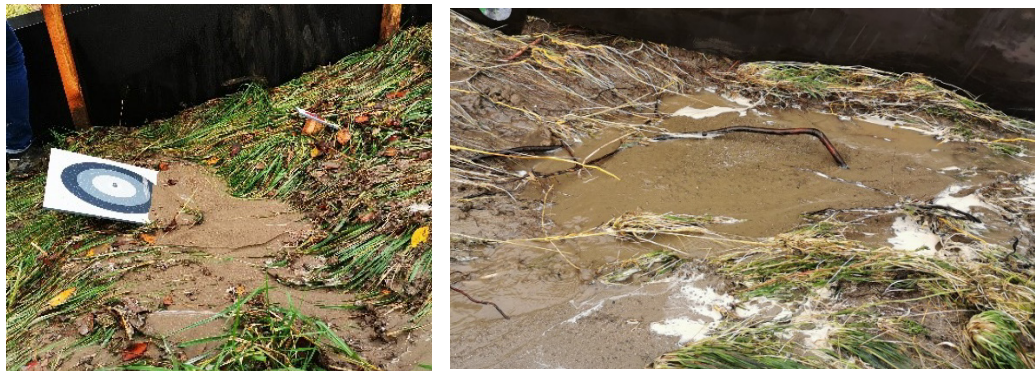
Figure 29 - Sand outflow and boils outside the test section (left: B-OF04 outside the section; right: B-OF11 inside the section).

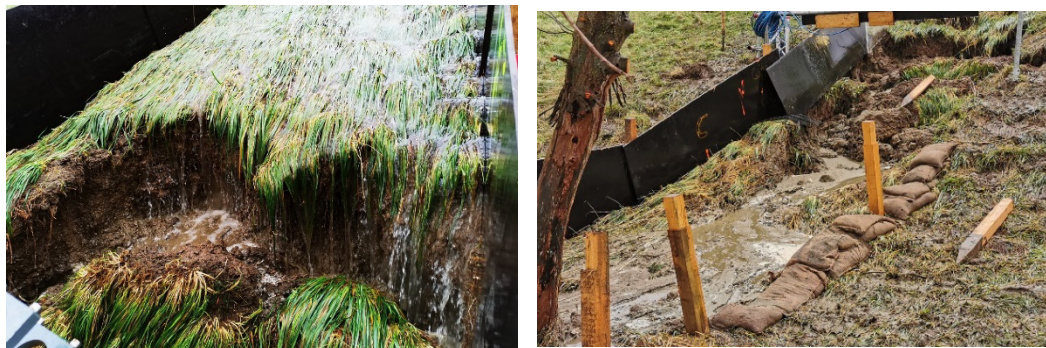
Figure 30 - Outcome of the B-OF04 (left) and B-OF11 test.

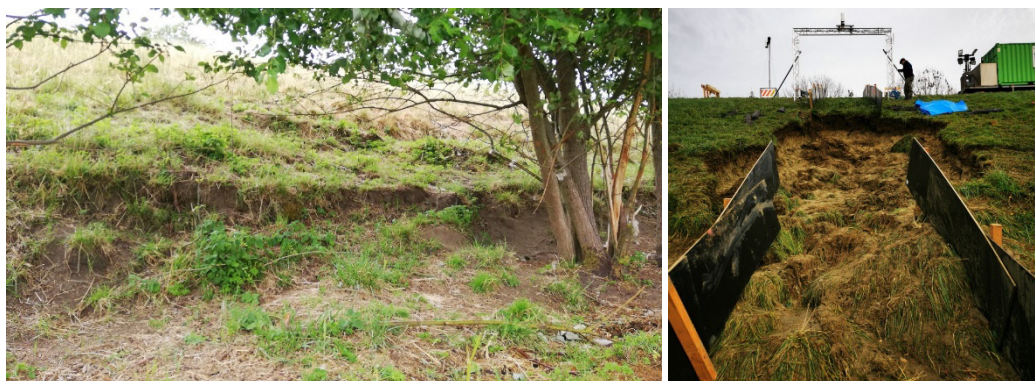
Figure 31 - B-OF05 site prior and after the overflow experiment.

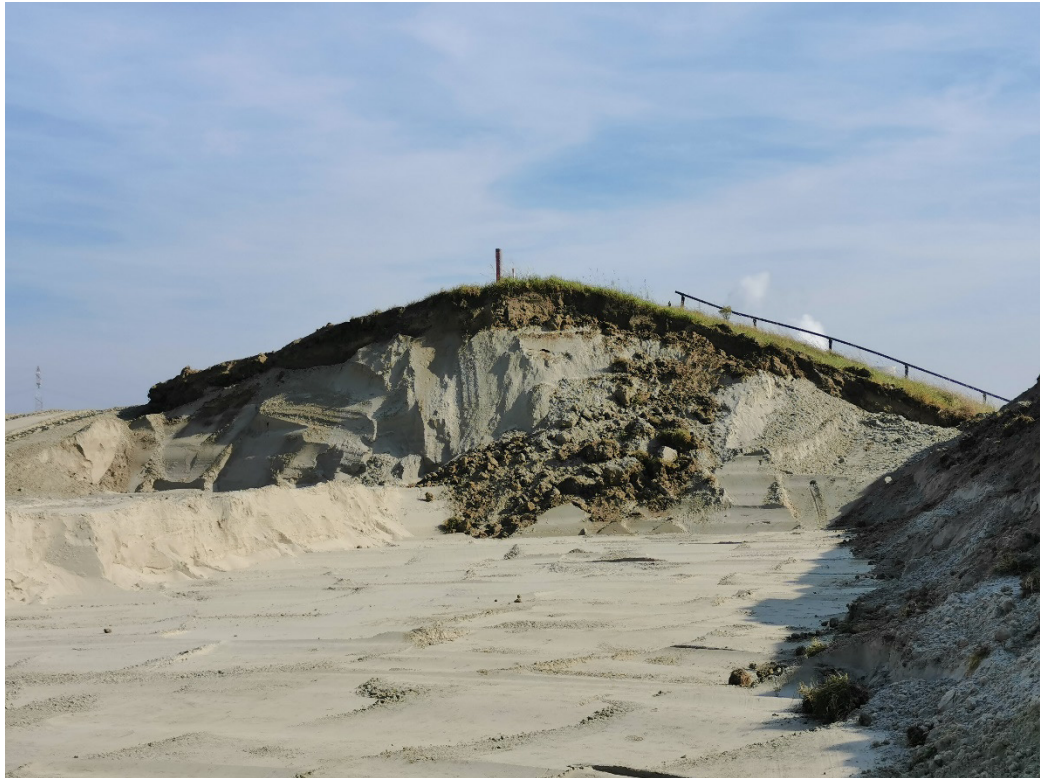
Figure 33 - Internal structure of the levee near N-OF05 during excavation. The clay cover layer is less approx. 80 to 100 cm thick.

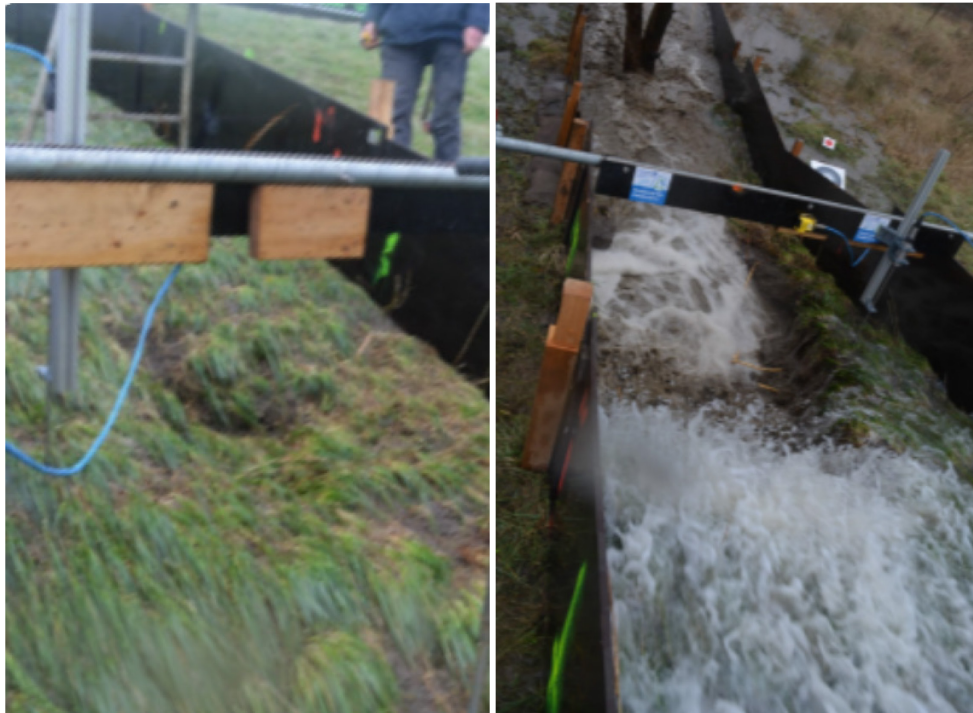
Figure 34 - Depression of the cover layer before the last run (left) and the collapse and erosion afterwards (right) during test B-OF11 (Photos: A. Koelewijn).

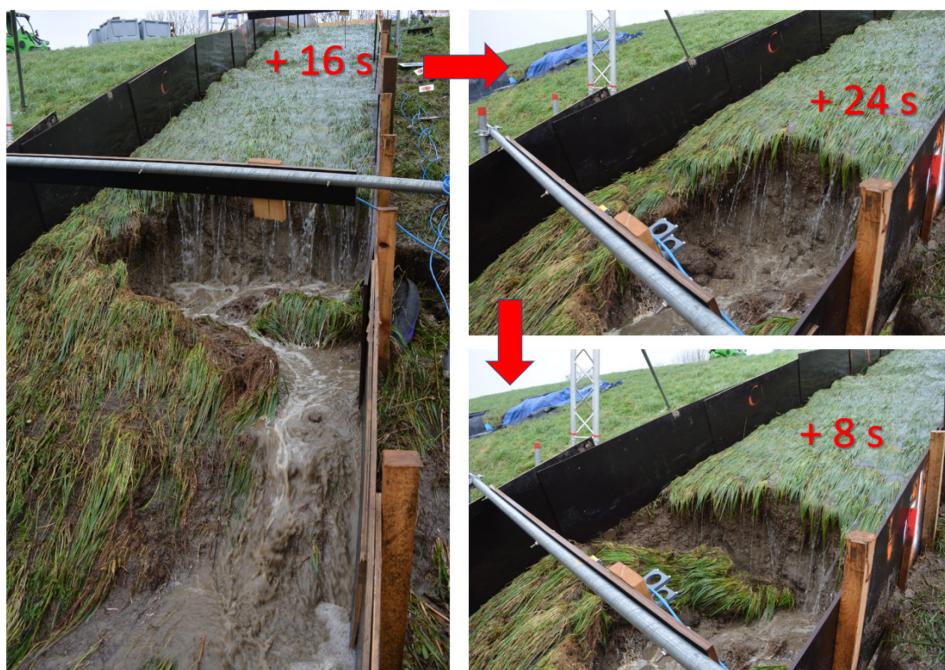
Figure 35 - Collapse and head scarp regression during test B-OF04. (Photos: A. Koelewijn)

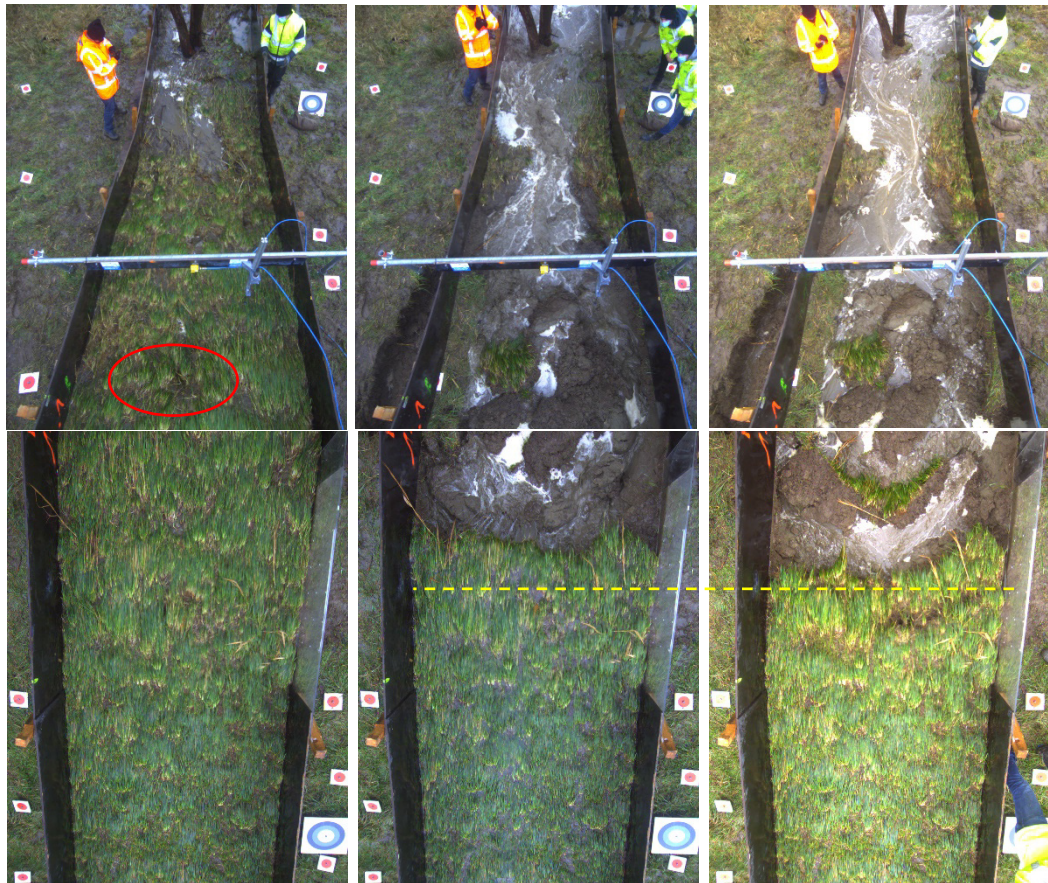
Figure 36 - Sequence of photos during the failure at test B-OF11. Left: 14:54 before the last overtopping activity. The initial depression is indicated by a red circle; Middle: 14:59, flow already stopped, and collapse has occurred; Right: 15:04, further collapse of the head scarp is ongoing. Yellow striped line indicates progression. Note that further tearing of the top layer is occurring beyond this line.

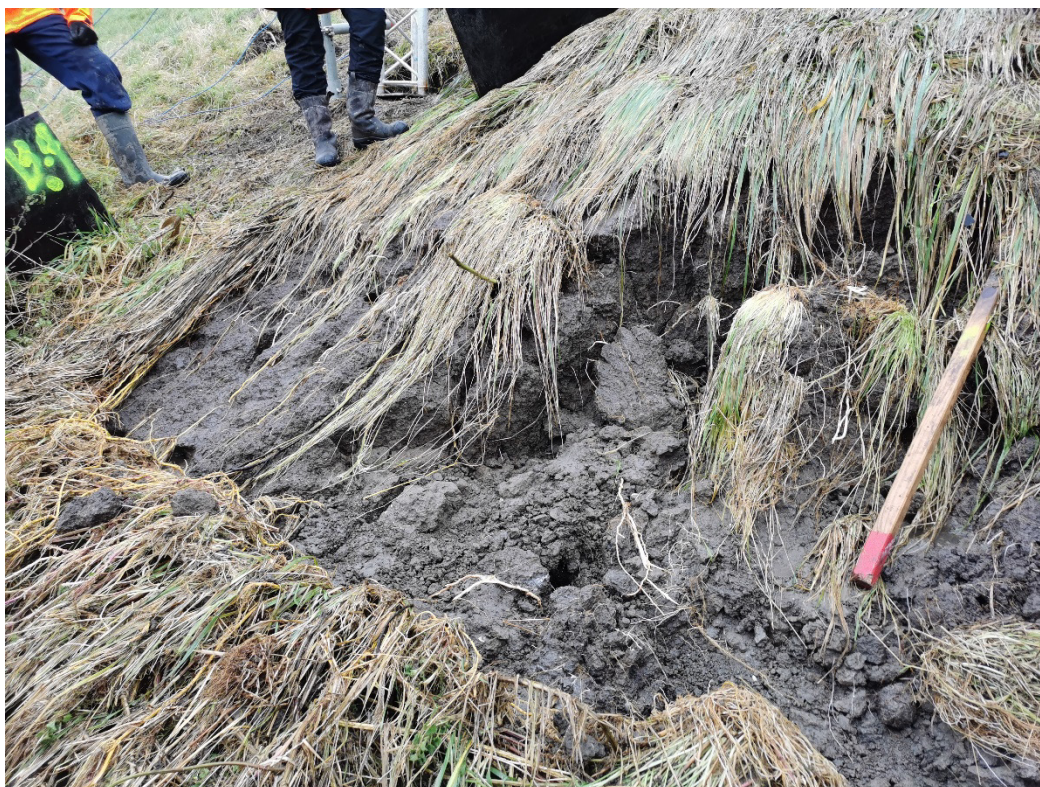
Figure 40 - Detail of the damage on the upper side of the reed field after 30 minutes of overflow.

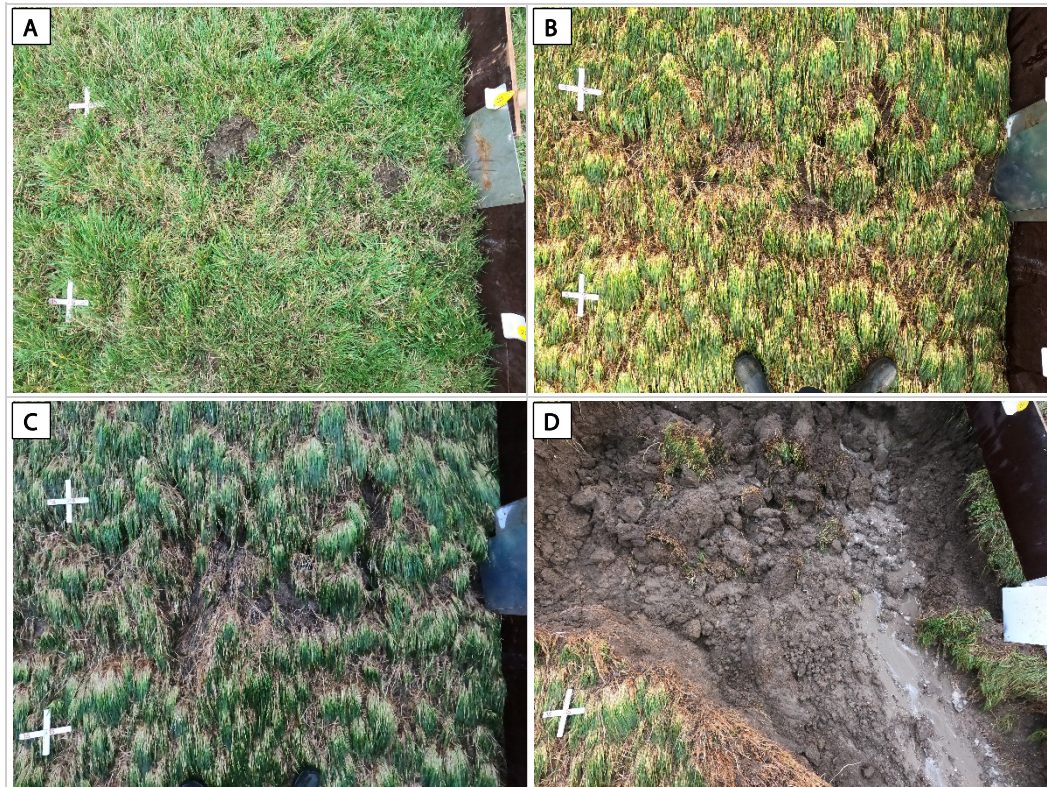
Figure 42 – Detail of levee slope of N-OT01 (box 13-14CD): A) at the start, B) after wave sets I, II, III and IV, C) after wave sets I, II, III, IV and V and D) continuing with wave set V for an extra 3 hours and 45 minutes of storm.

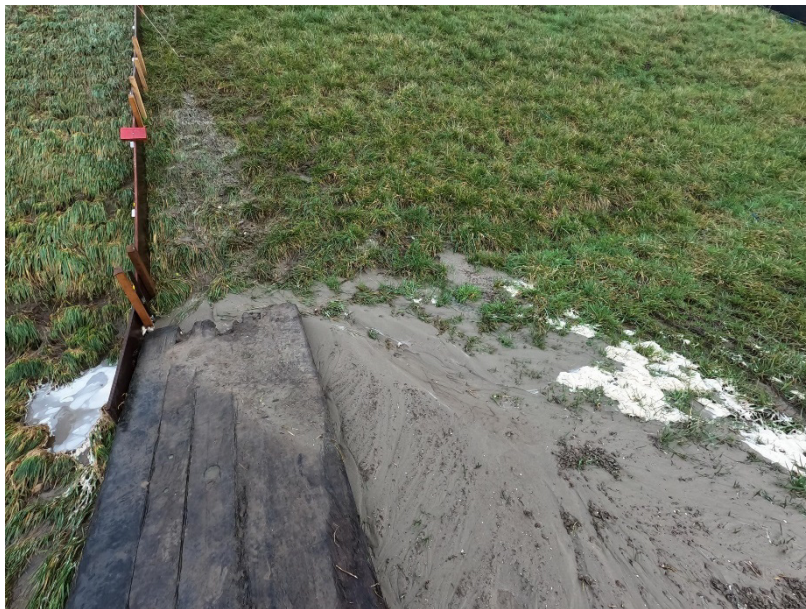
Figure 43 - Sand released through a mole hole outside the test section after 4 sets of waves.

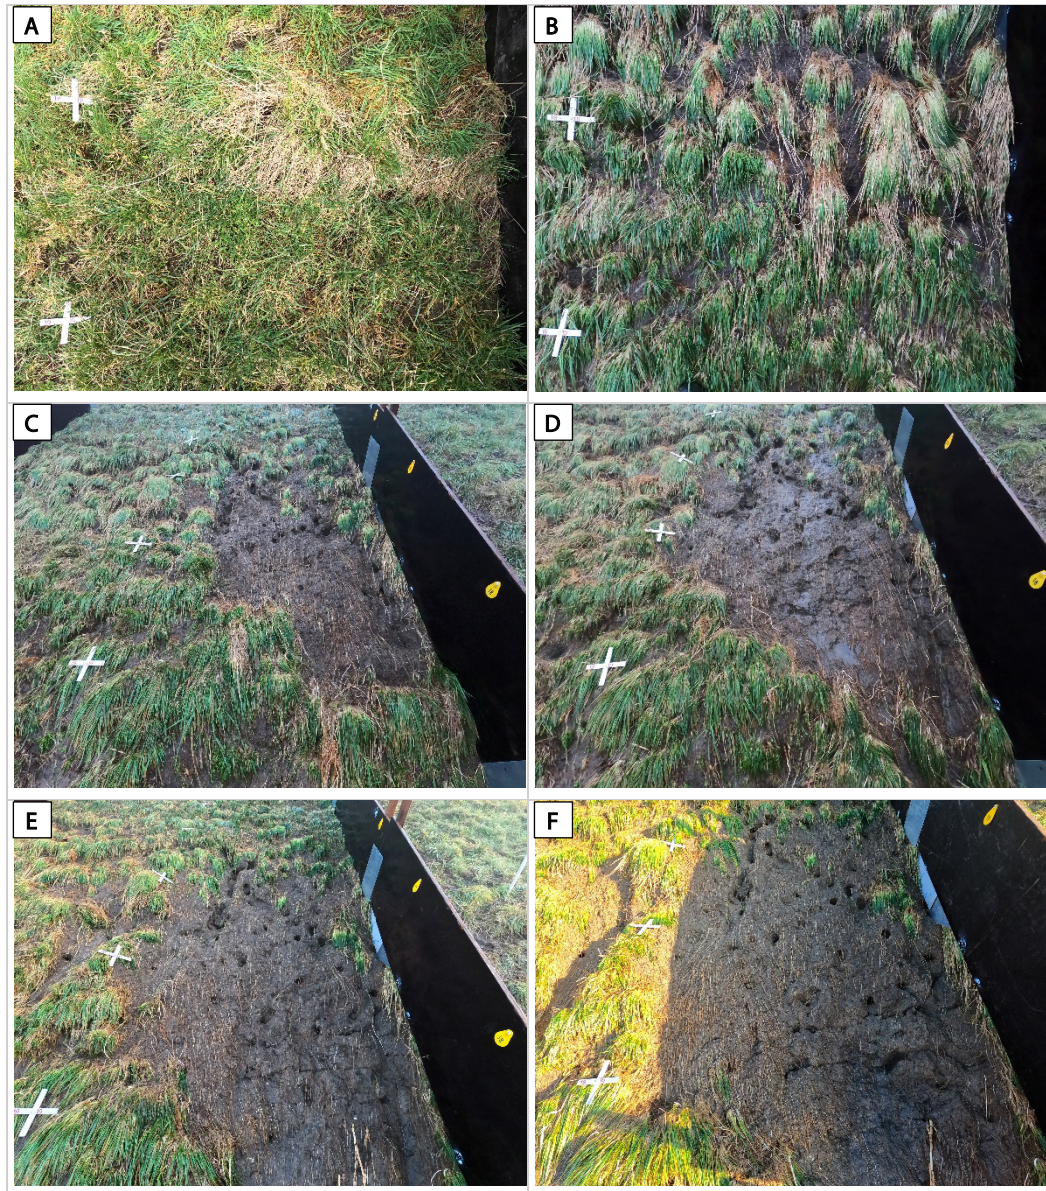
Figure 44 – Detail of levee slope of N-OT02 (box 18-19CD): – A) at the start, B) after wave set I, C) after wave sets I & II, D) after wave sets I, II & III, E) after wave sets I, II, III & IV and F) continuing with 1 storm hour of wave set V.

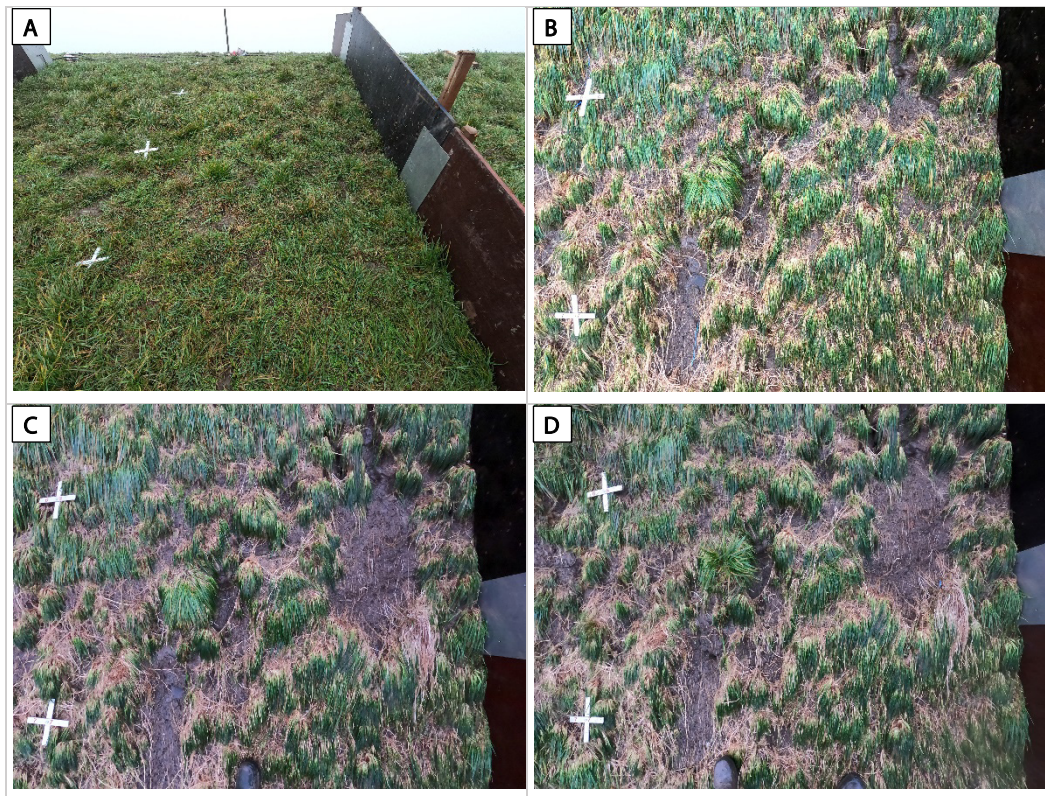
Figure 45 – Detail of levee slope of N-OT03 (box 6-7CD): A) at the start, B) after waves set I, II & III, C) after repeating III for 1 storm hour and D) after repeating III for 2 storm hours.

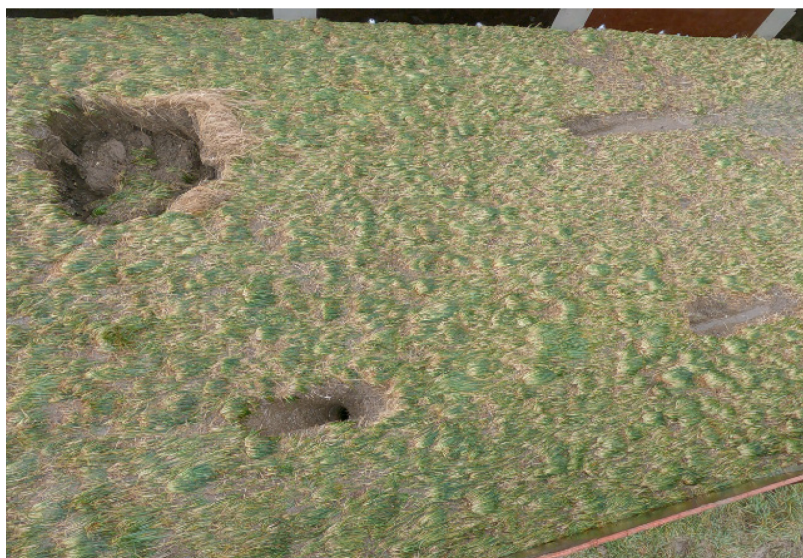
Figure 49 – Erosion pit around pipe inlet in box 7-8CD during the N-OT04 test (15' after start of wave set III)

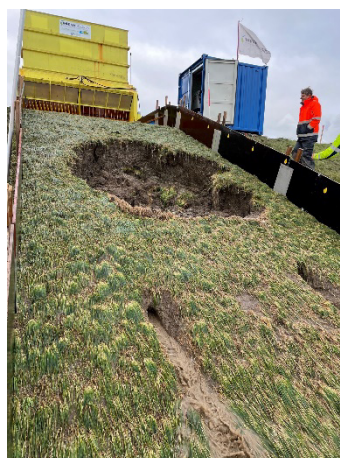
Figure 50 – Large erosion pit around both pipe inlets in box 7-8AB/CD as outcome of the N-OT04 test (30' after start of wave set III)
