16_089_2
FHR reports

Monitoring the morphodynamics of the Zwin inlet

Interim report
2 years after the extension works

Montreuil, A-L.; Dan, S.; Houthuys, R.; Verwaest, T.

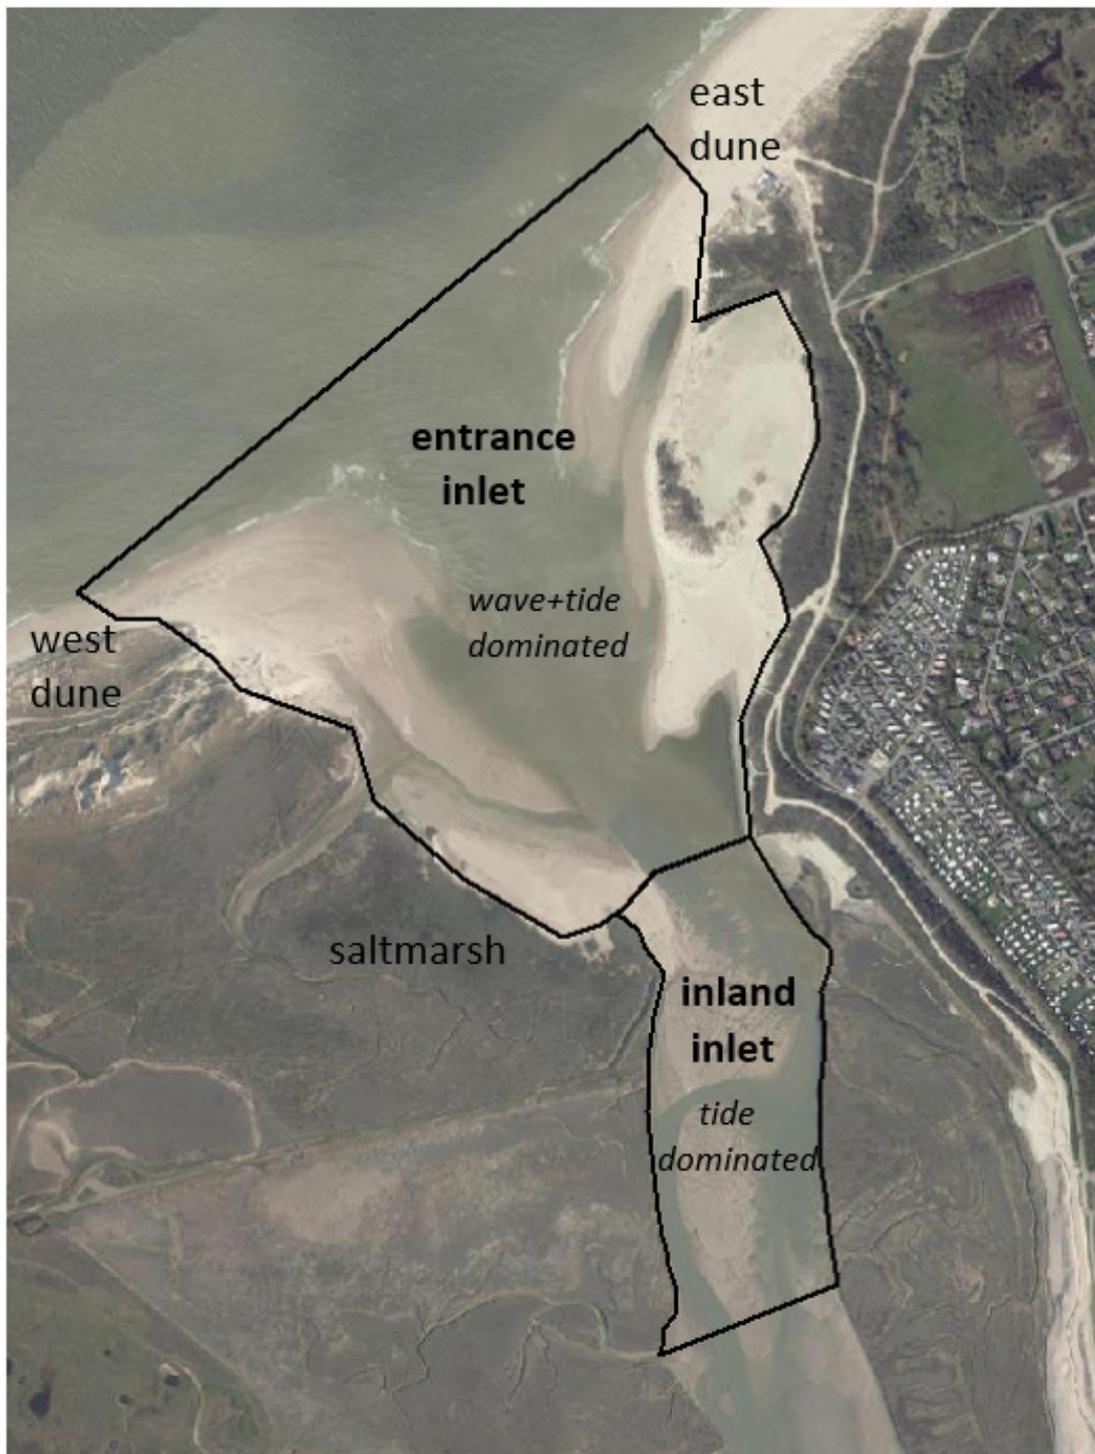
Figure 1 – Morphological units of the tidal inlet. Unit delineated based on the 5 m contour line.

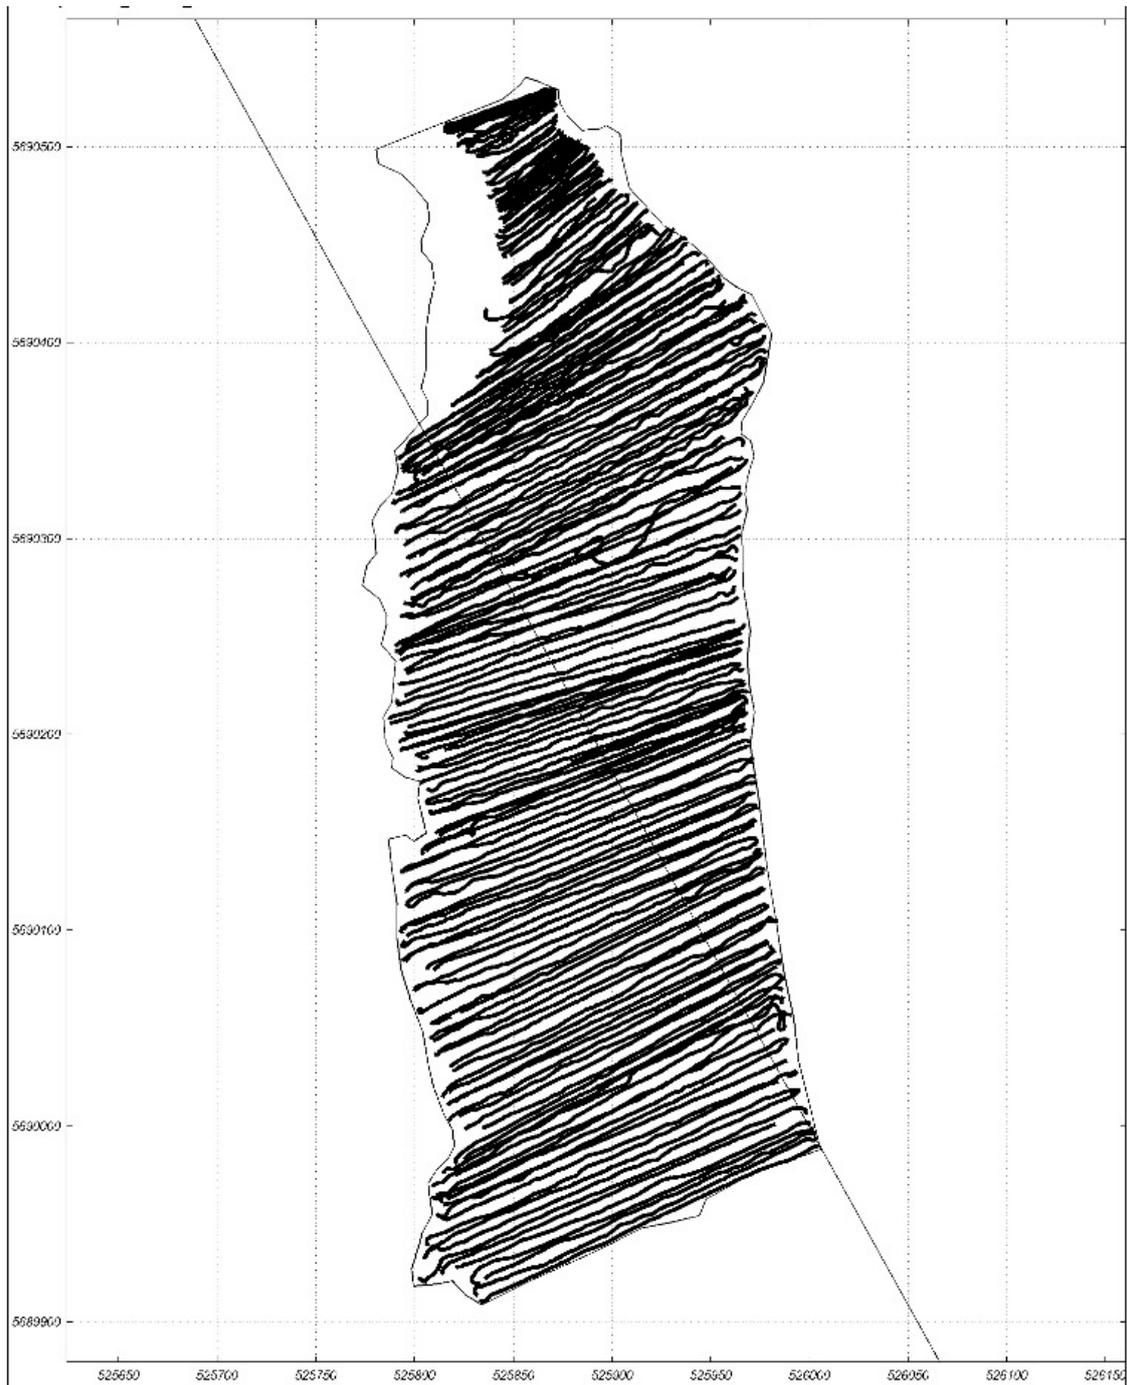
Figure 2 – Example of typical tracks of a Qboat survey.

Bathymetry of the inland inlet area was surveyed by Aqua Vision using a remotely-controlled Q-Boat 1800RP system equipped with an ADCP and GPS devices. The advantage of such system is to be capable to sound the bed surface in shallow zones. Bathymetric measurements were done in January 2019 and October 2020 (Table 1 and Table 2). The reported error ranges from 2 cm in horizontal and 3 cm in vertical direction. A typical track survey is displayed in Figure 2. Regarding the post-processing, the point clouds (x, y, z) were first converted to Lambert72 from ETRS89. Then, they were used to generate a TIN and then converted to a Qboat DEM with 0.1 m cell size (i.e. appropriate with the spacing between the surveys points). Finally, consecutive Qboat DoDs were calculated from the Qboat DEMs, by subtracting the elevations in each grid, on a cell-by-cell basis.

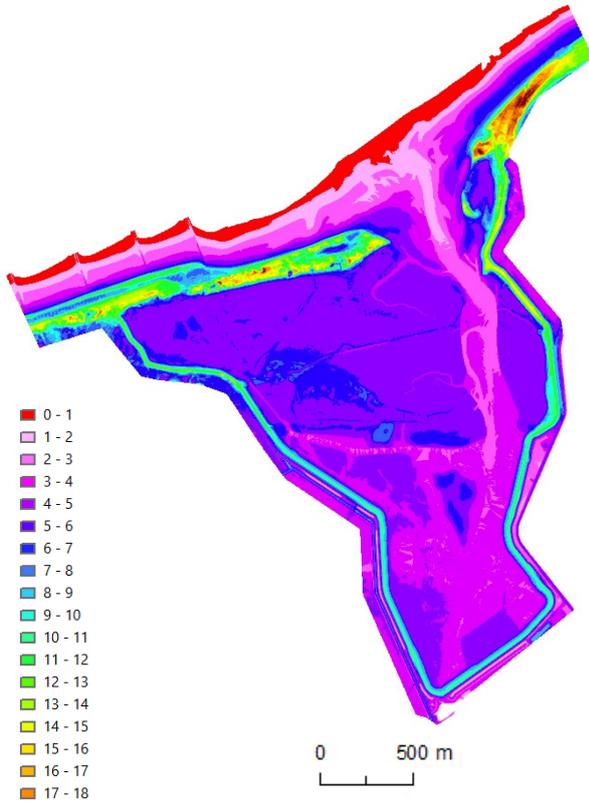
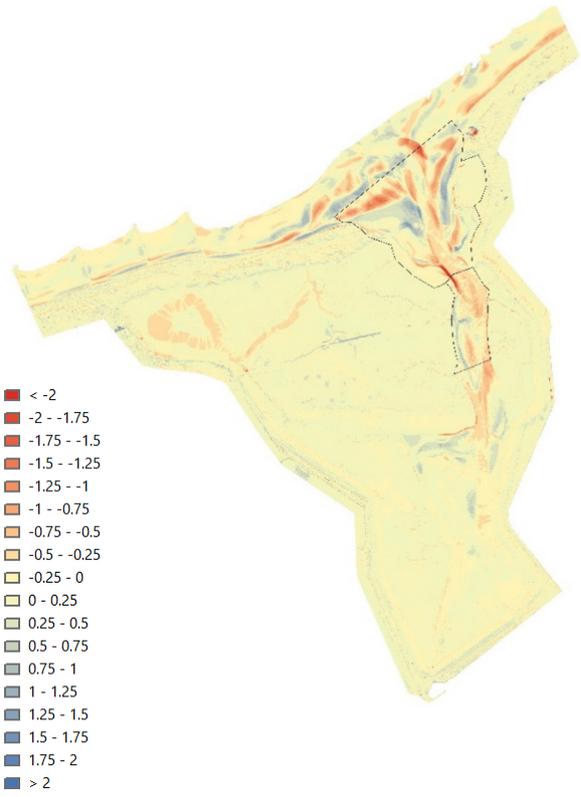
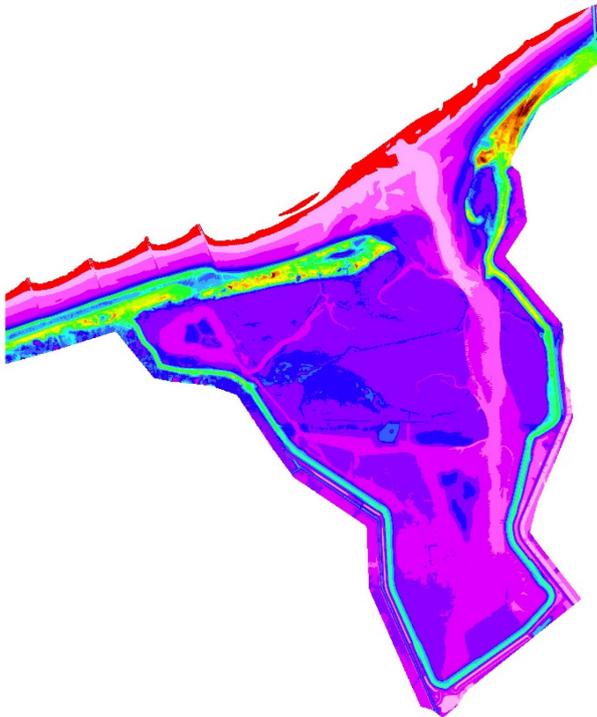
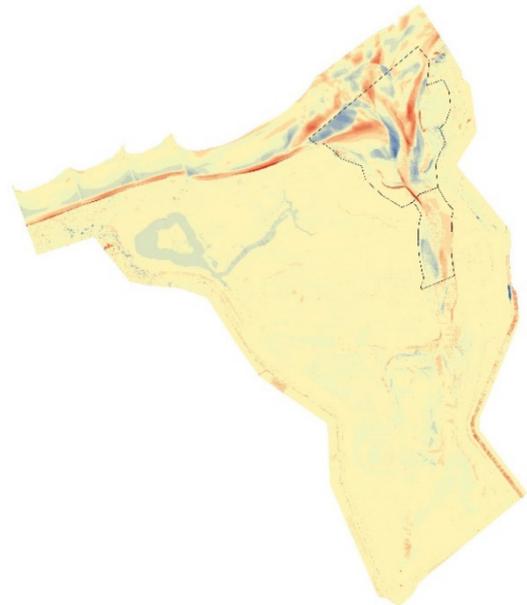
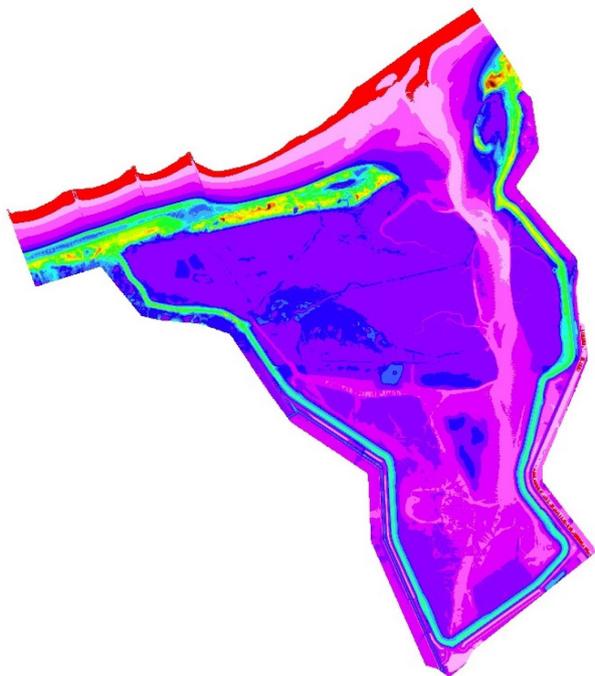
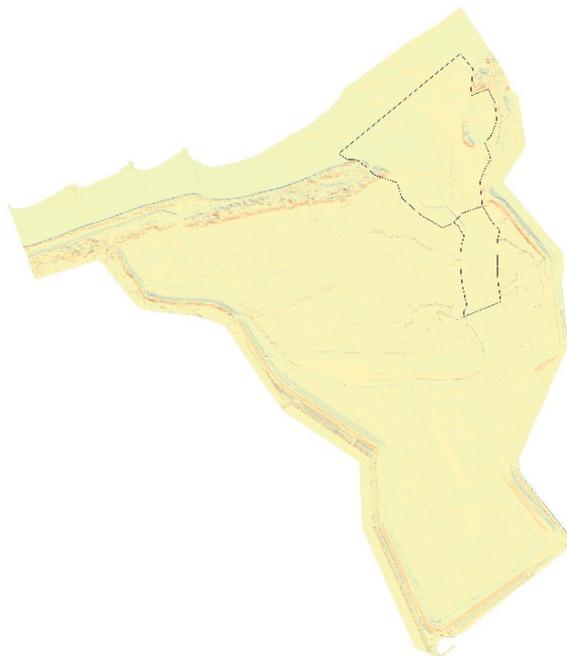
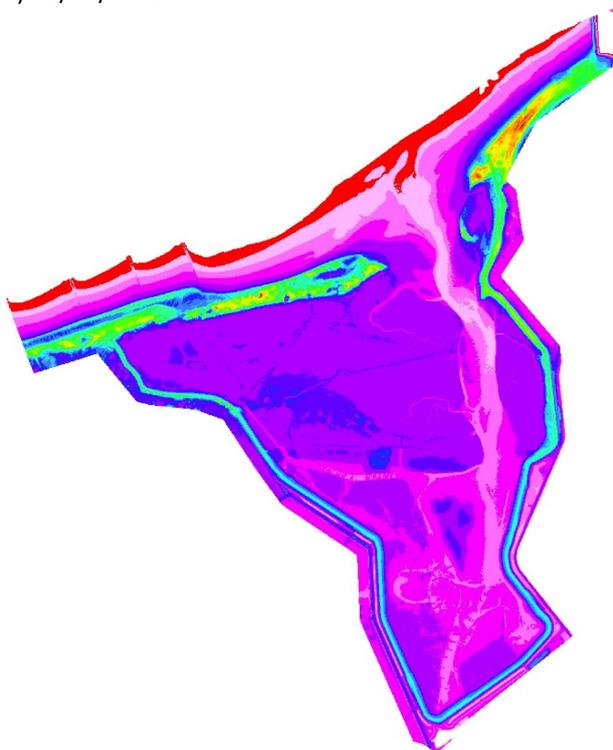
Figure 3 – LiDAR DEMs on A) 20/04/2019, B) 29/10/2019, C) 28/02/2020 and D) 10/04/2020 (i.e. from 2.5 month to 14.2 month after opening of the dyke and the consecutives DoDs (E, F, G)
Note: the grey polygons correspond to the entrance and inland inlet units.

Significant morphological changes exceeding 2 m in height occurred at seasonal scale in the year after the opening of the dyke (20/04/2019-29/10/2019, 29/10/2019-28/02/2020), while a relative stability was observed over the two months period between 28/02/2020-10/04/2020 in the first year after the opening. After 1.4 years (06/11/2018-10/04/2020), the inland inlet unit was subject to a decrease of sediment volume of -45 296 m³ which was equivalent to an average reduction in elevation of about 0.42 m (Table 3). At the same time, the sediment volume in the entrance inlet unit did not change so significantly. Significant morphological changes occurred in the main channel which became deeper and wider, and migrated eastward (Figure 4). Channel erosion reached its maximum exceeding 3 m depth, located on the westward edge between the entrance inlet and the inland inlet (around 600 m from the seaward entrance). Also, a spatial variability is observed in the entrance inlet with alternating accretion and erosion zones parallel to the coast as well as on the edge of the salt marsh and dune line. This footprint is typical of migration of a three dimensional pattern of sandy bedforms. In the inland inlet, erosion dominantly along the east side of the channel suggesting deepening associated with eastward migration. In contrast, the west side of the inlet is subject to a slight accretion along the edge of the salt marsh. Thus, the channel here migrates to the east.

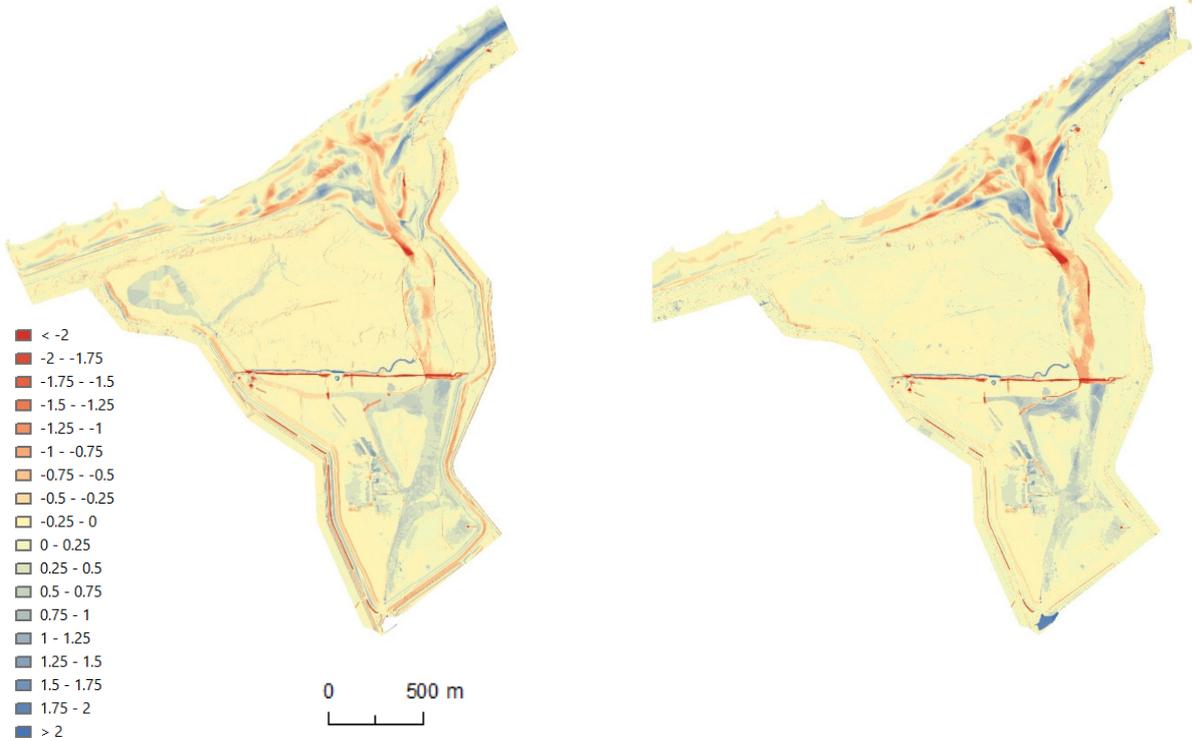
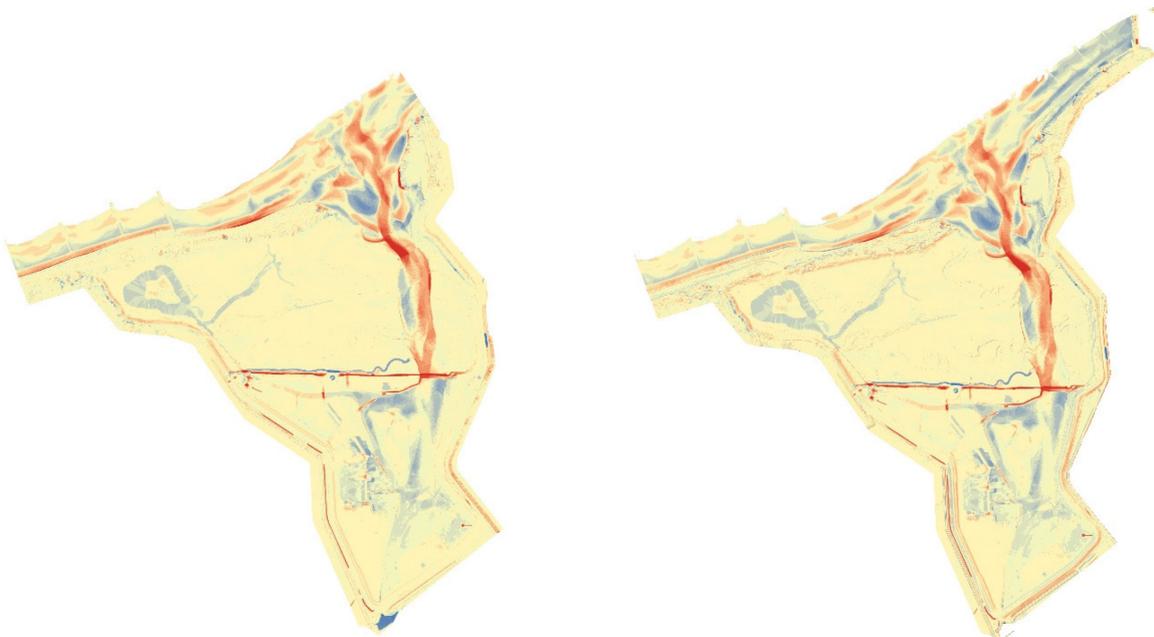
Figure 4 – LiDAR DoDs between the T0 survey before the opening of the dyke (06/11/2018) and the recent surveys.

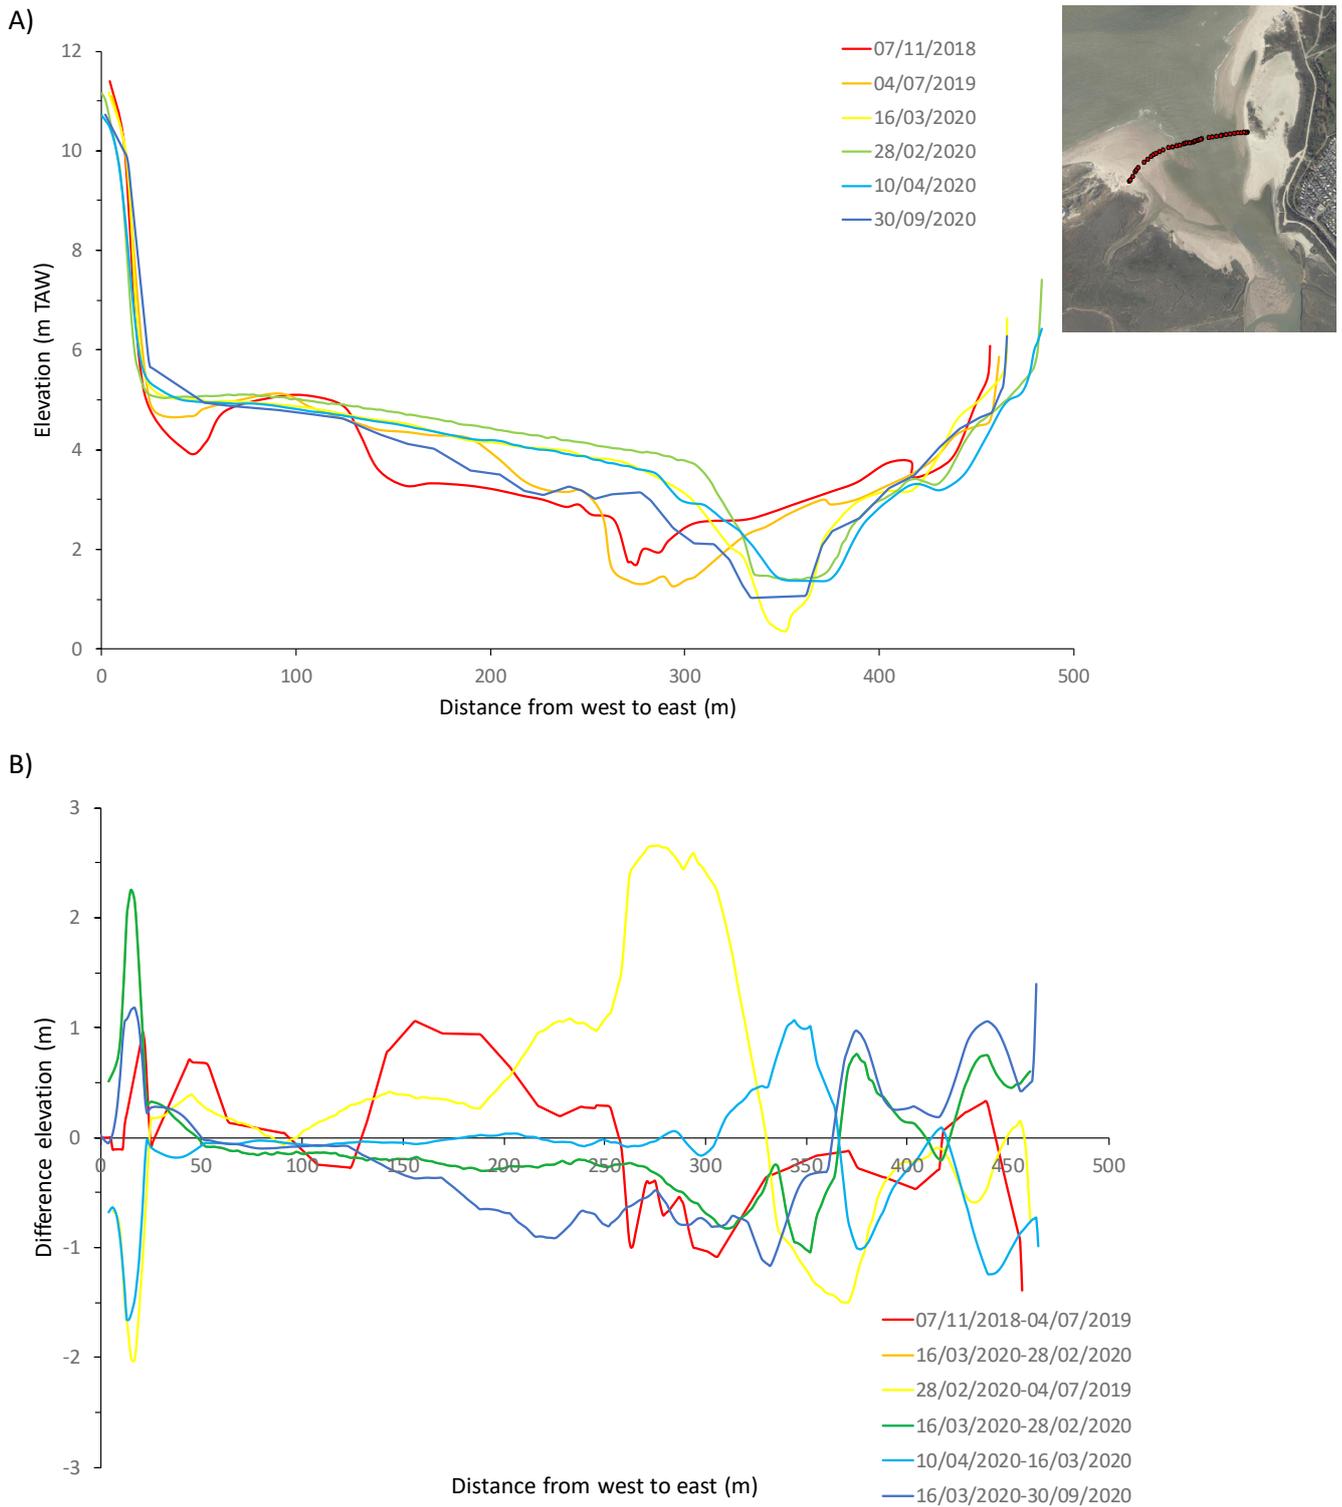
Note: profiles on 28/02/2020 and 10/04/2020 were extracted from LiDAR surveys.

Figure 5 – A) Cross-channel profiles from 11/2018 (pre-opening) to 09/2020; B) difference of consecutive surveys. Insert: location of the profile measurement. Benchmark is located in the west dune.

Cross-channel morphology of the entrance inlet was investigated based on the RTK-GPS profiles carried out from 11/2018 (pre-opening) to 09/2020. Previous cross-shore topographic profiles are presented in the progress report after the first year (Montreuil et al., 2020). Figure 5A shows the bed elevation as a function of distance from the origin of the profile. A clear morphological change is observed in the main channel located at a distance between 260 and 350 m from the benchmark located in the west dune becoming progressively wider over time. On 30/09/2020 survey, the lowest elevation of the channel was at 1.02 m TAW, while it was at 1.71 m TAW before the opening of the dyke (07/11/2018). The channel became thus 0.69 m deeper in its centre. A large difference of elevation of 2.66 m occurred between 28/02/2020 and 04/07/2019 due to an eastward migration of the channel (Figure 5B). In addition, a sand bank exceeding 1 m high and located in the profile between 45 and 160 m present before the opening of the dyke was eroded after 04/07/2019 (Figure 5A). This is probably due to the excavation works of the tidal area carried out until the opening of the dyke.

Morphological indicators were defined and extracted from the cross-shore channel profiles (Table 5). The channel basin channel based on the spring high water reference has changed over time ranging from 994.9 m³ on 07/11/2018 to 1143.05 m³ on 10/04/2020. A comparable pattern of changes has occurred for the basin of the channel based on the neap high water reference level. Also, the width of the channel has followed a similar pattern and trend, and it was highly correlated to the basin channel.

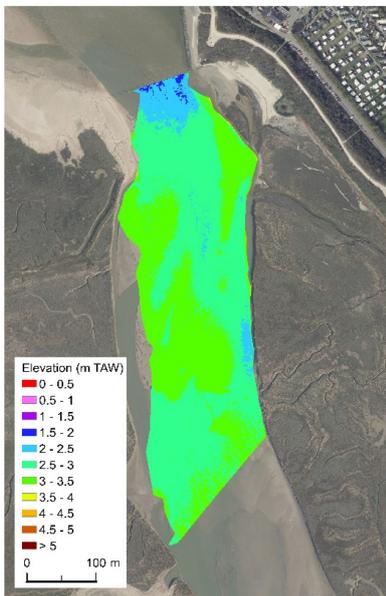
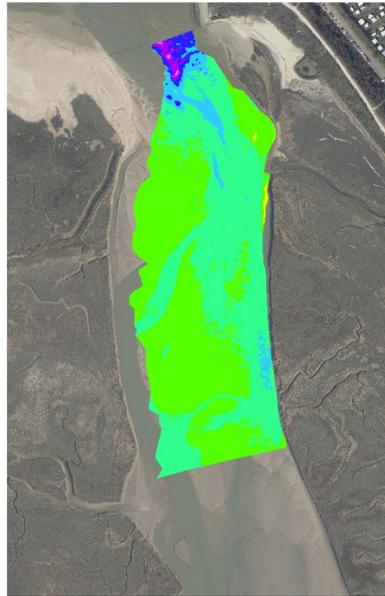
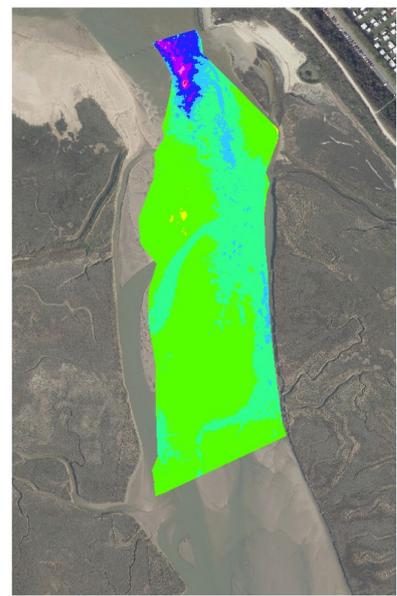
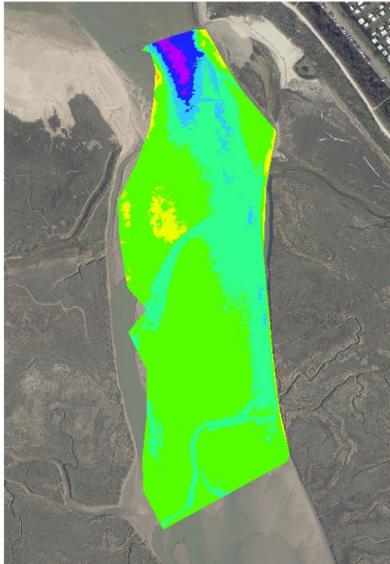
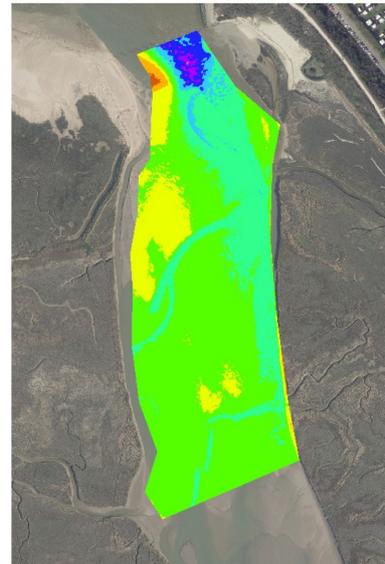
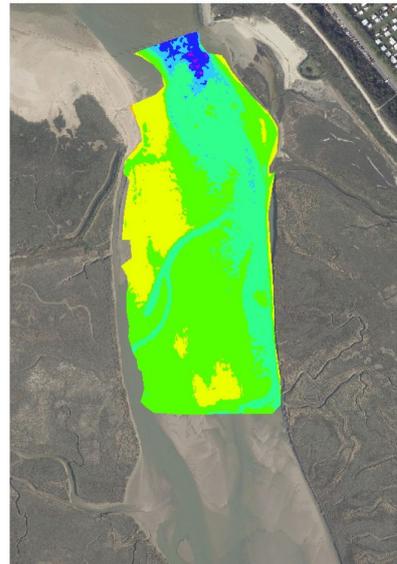
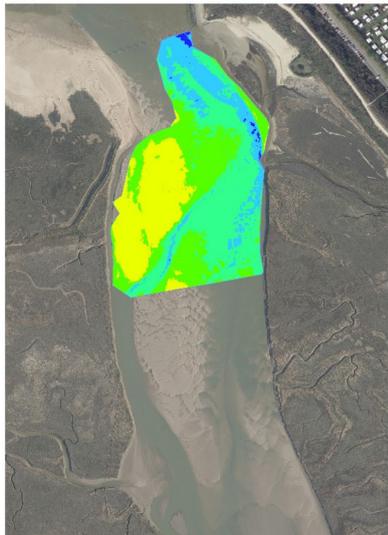
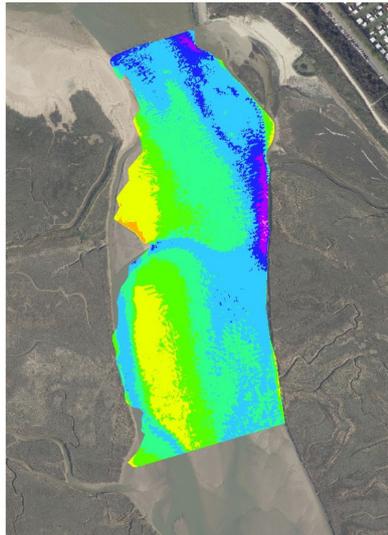
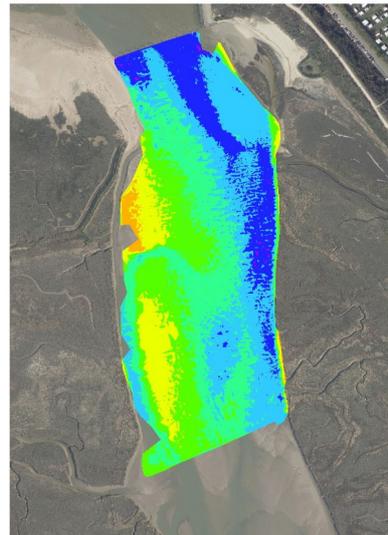
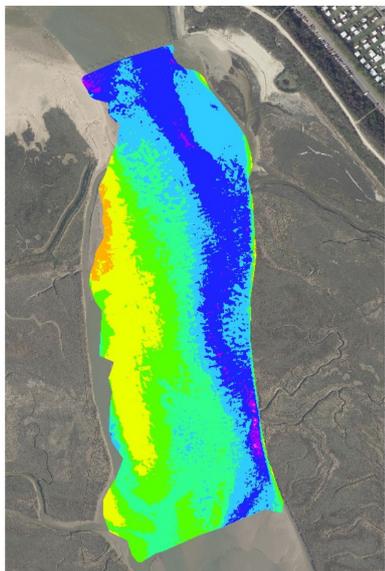
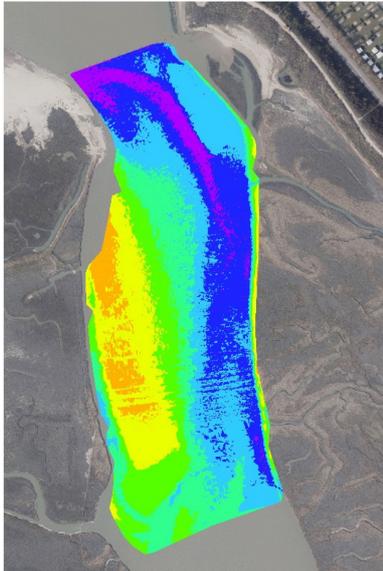
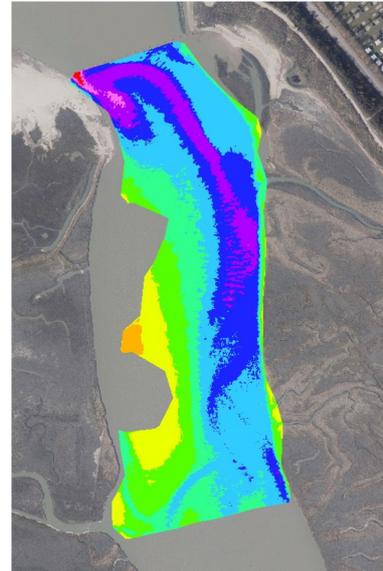
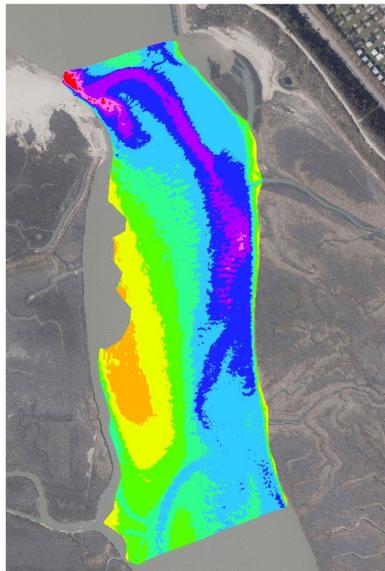
Figure 6 – Qboat DEMs of the inland inlet of the Zwin.

Figure 6 presents the bathymetric DEMs from the Qboat surveys in the inland inlet part from 07/2017 to 10/2020. A clear development of a main channel is visible in the inland inlet from 03/2019 (1 month after the opening) and it has gradually become deeper over the following 1.9 year period. In 10/2020, the north of the survey area is characterized by a wider and deeper channel compared to the pre-opening surveys, with the bed now below 0 m TAW. The channel is clearly asymmetric: the east side of the channel is significantly deeper than the west side. Also, a progressive eastward migration of the channel is observed associated with its deepening (in 10/2020 the deepest part is around 1 m TAW). In addition, the inland inlet is characterized by a large tidal bank with its crest up to 4 m TAW on the west side as well as smaller features such as bars and megaripples along the channel. A large sand bar is enclosed by the main channel and its small meander.

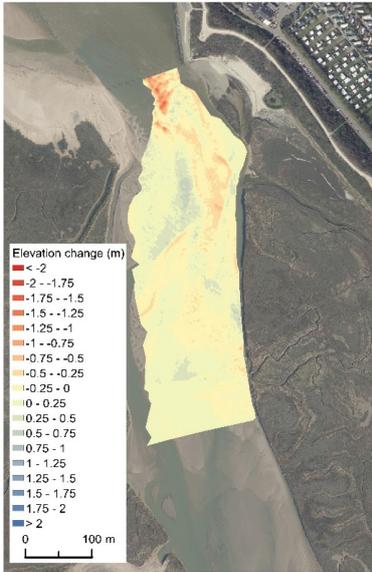
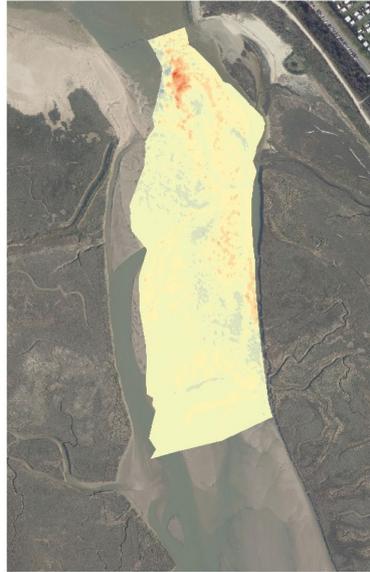
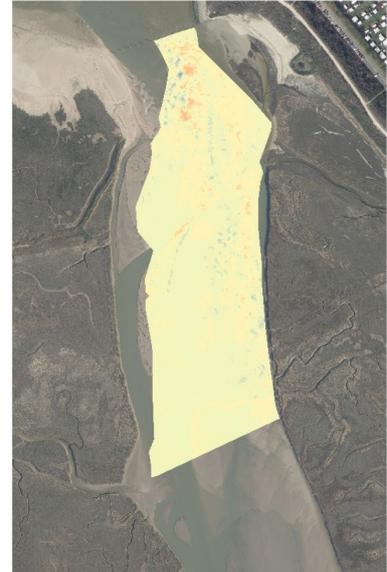
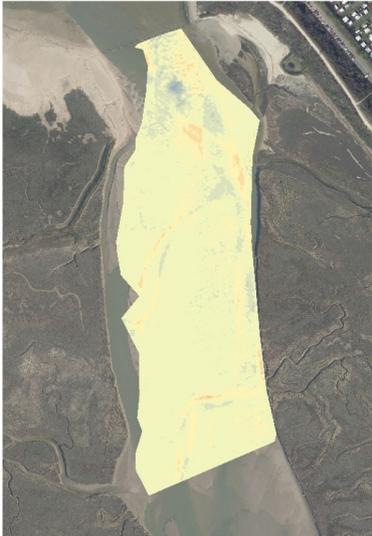
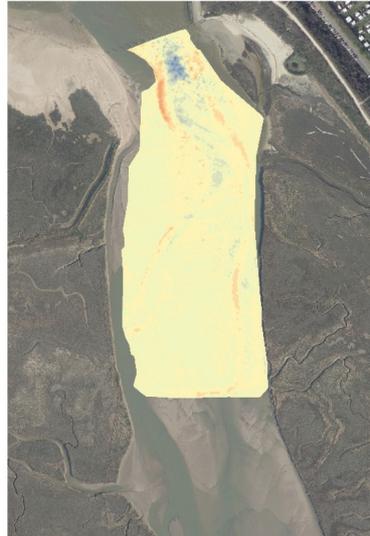
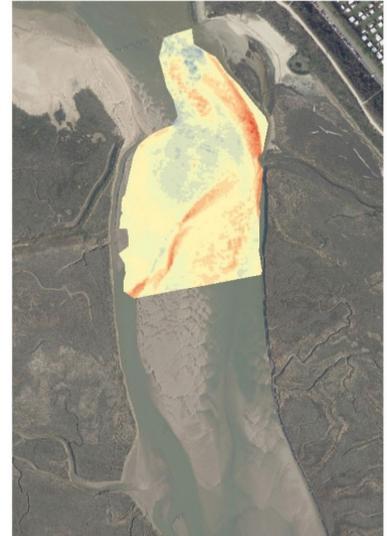
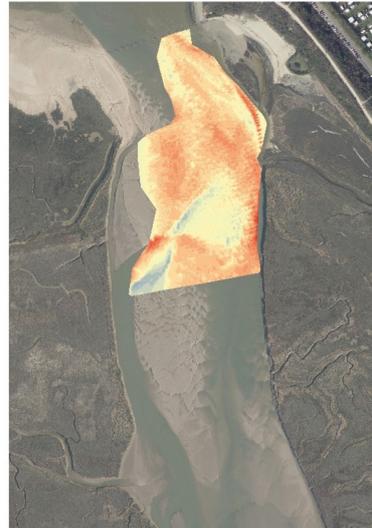
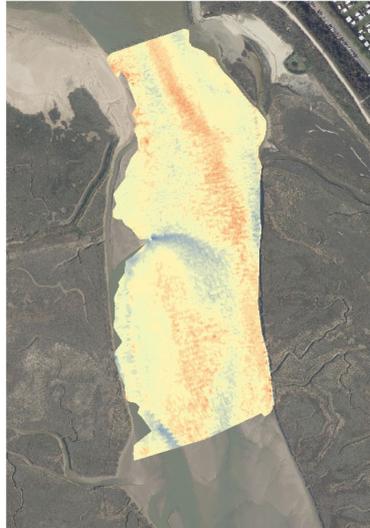
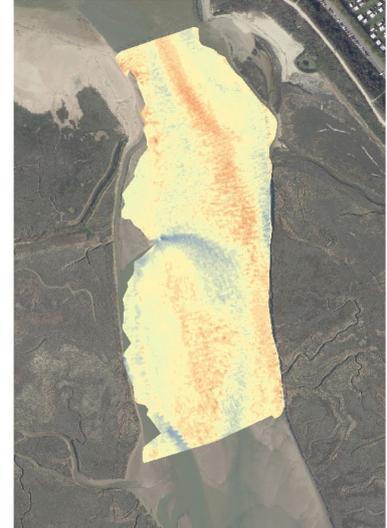
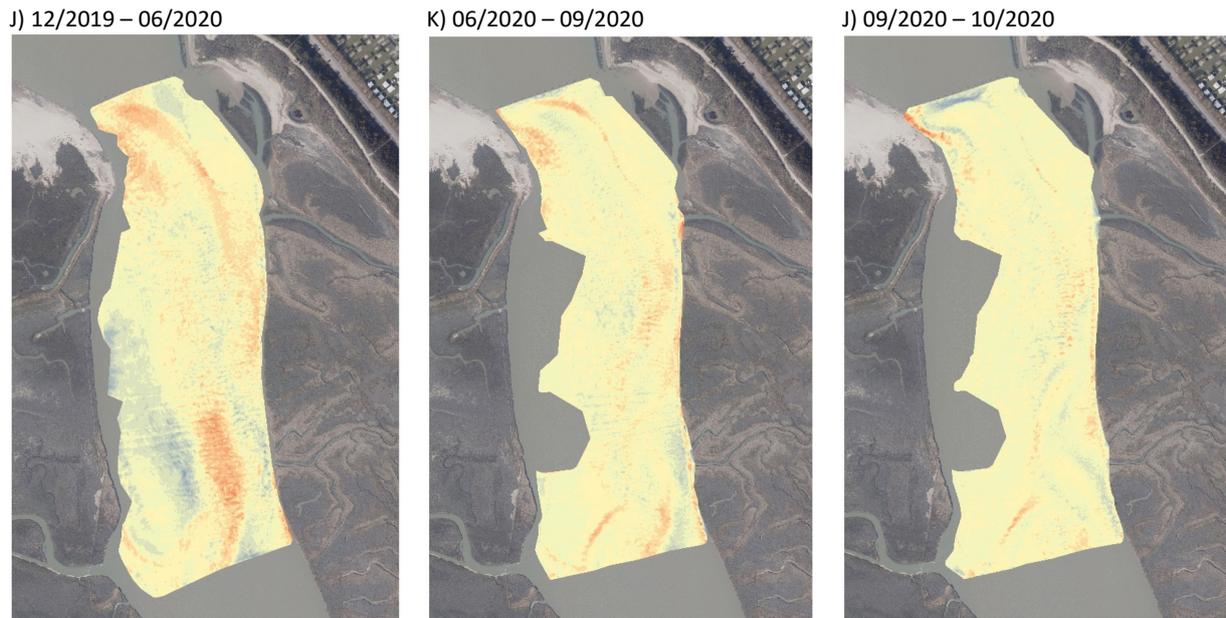
Figure 7 – Consecutive Qboat DoDs of the inland of the Zwin.

The consecutive DoDs show elevation change between surveys (Figure 7). A high spatial and temporal variability of morphological change in the inland inlet is observed. Generally, erosion occurs in the main channel and along its banks. Also, erosion is observed in the seaward part of the inland inlet except between 09-10/2020 when eroded sand from the sand bank was transported to the middle of the channel. In contrast, the large tidal bank on the west side generally experiences positive elevation change, and thus the sand volume increased. Interestingly, large morphological changes occurred from 03/2019 to 06/2019 when energetic wave conditions were recorded (Montreuil et al., 2020). The comparison between the pre- and post-opening dyke bathymetric surveys clearly shows two opposite morphodynamics trends occurring in the inland inlet namely a sediment gain westward, while erosion dominates in the east and middle of the survey area (Figure 8). Over the 1.9 year period (01/2019-10/2020), the inland inlet has become deeper with an average of nearly 0.6 m, which corresponds to a decrease of elevation of 0.032 m/year (Table 6). The deepest part of the channel was 0 m TAW in 10/2020, while it was above 1 m TAW before the opening of the dyke.

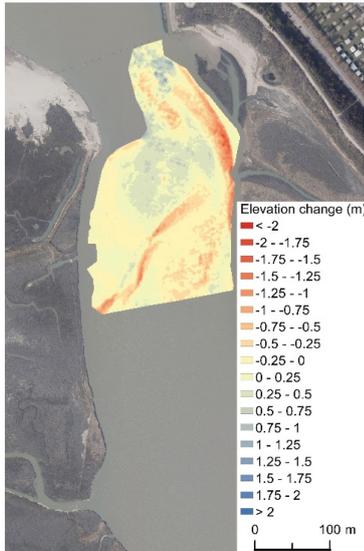
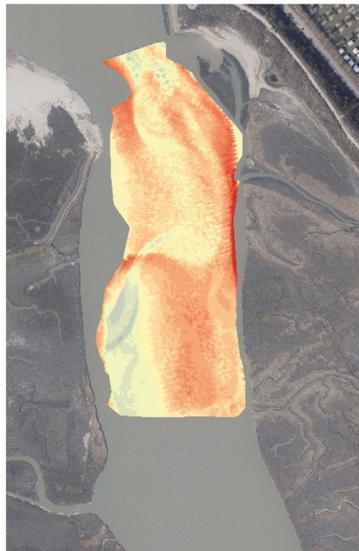
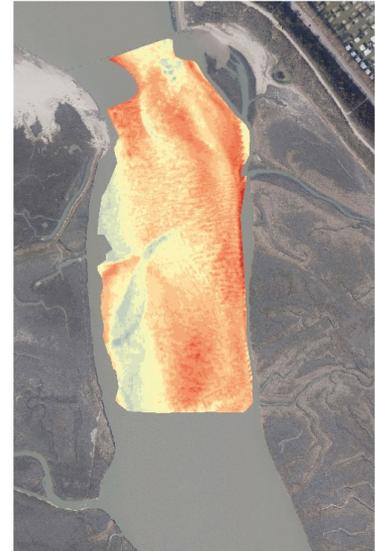
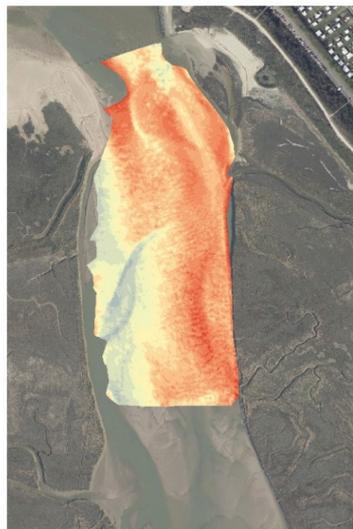
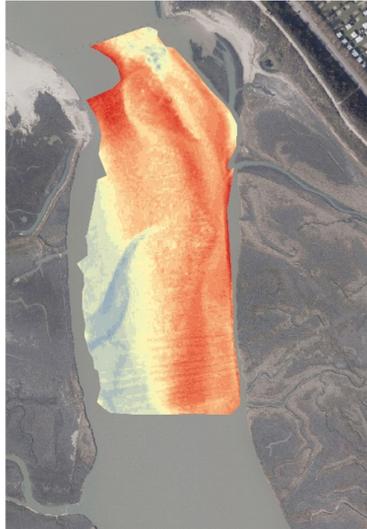
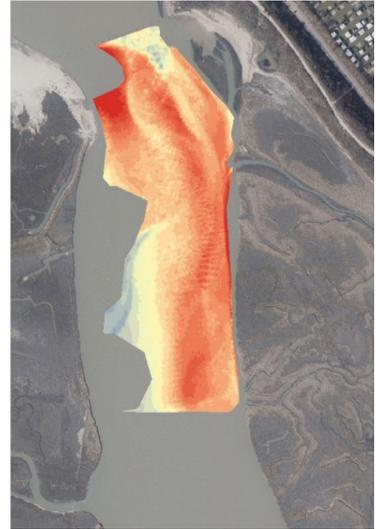
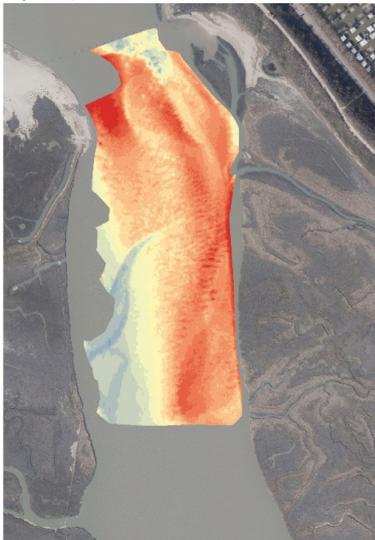
Figure 8 – Qboat DoDs of the inland of the Zwin based on a reference survey on 30/01/2019 (pre-opening dyke survey).

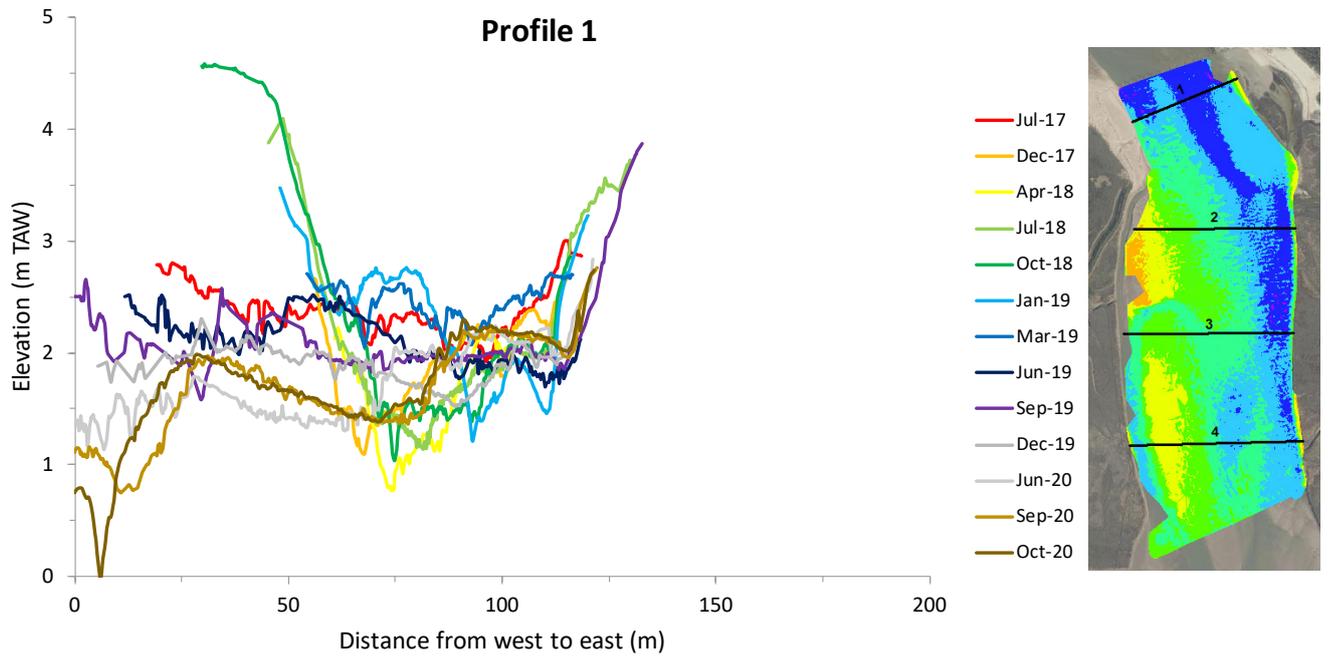
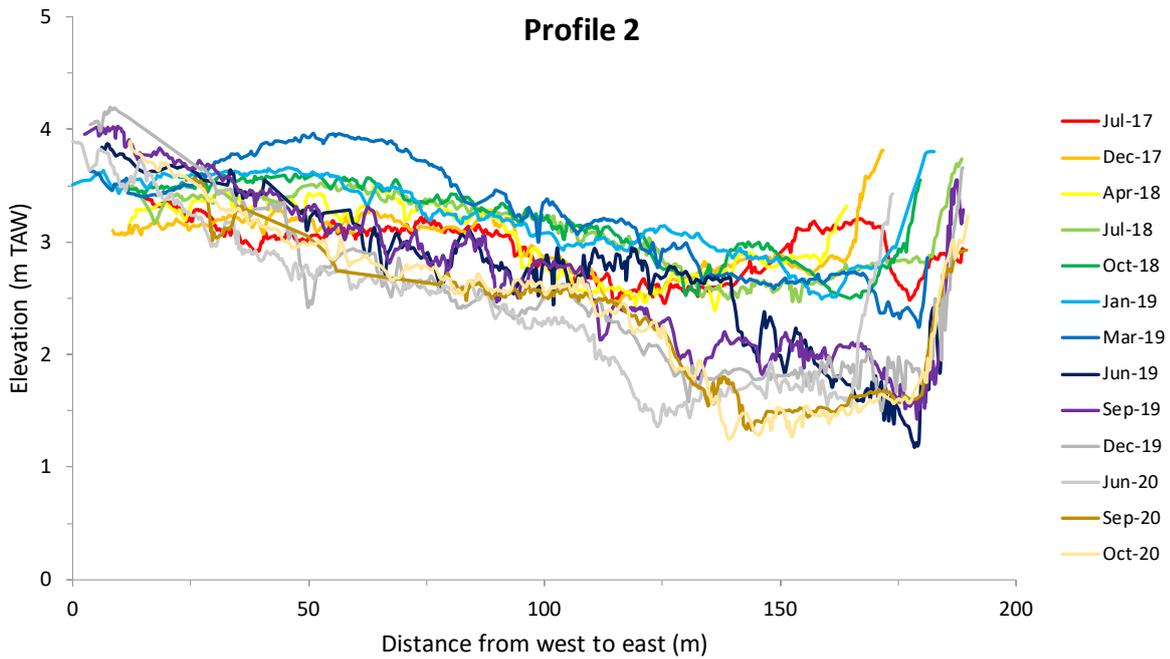
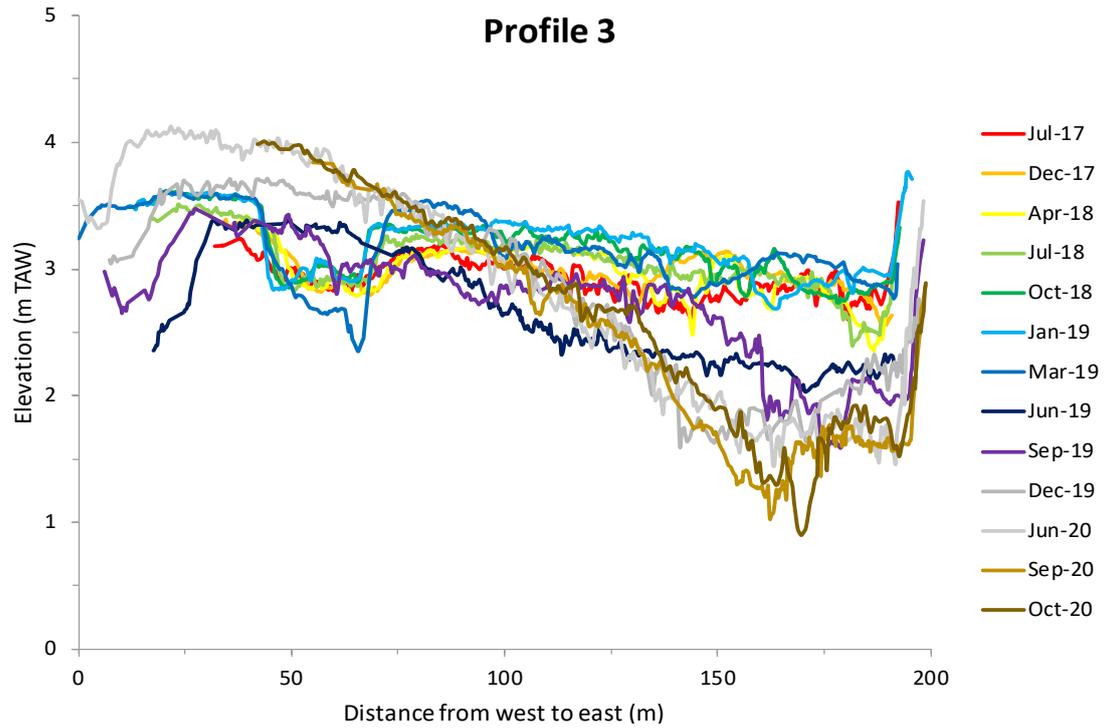
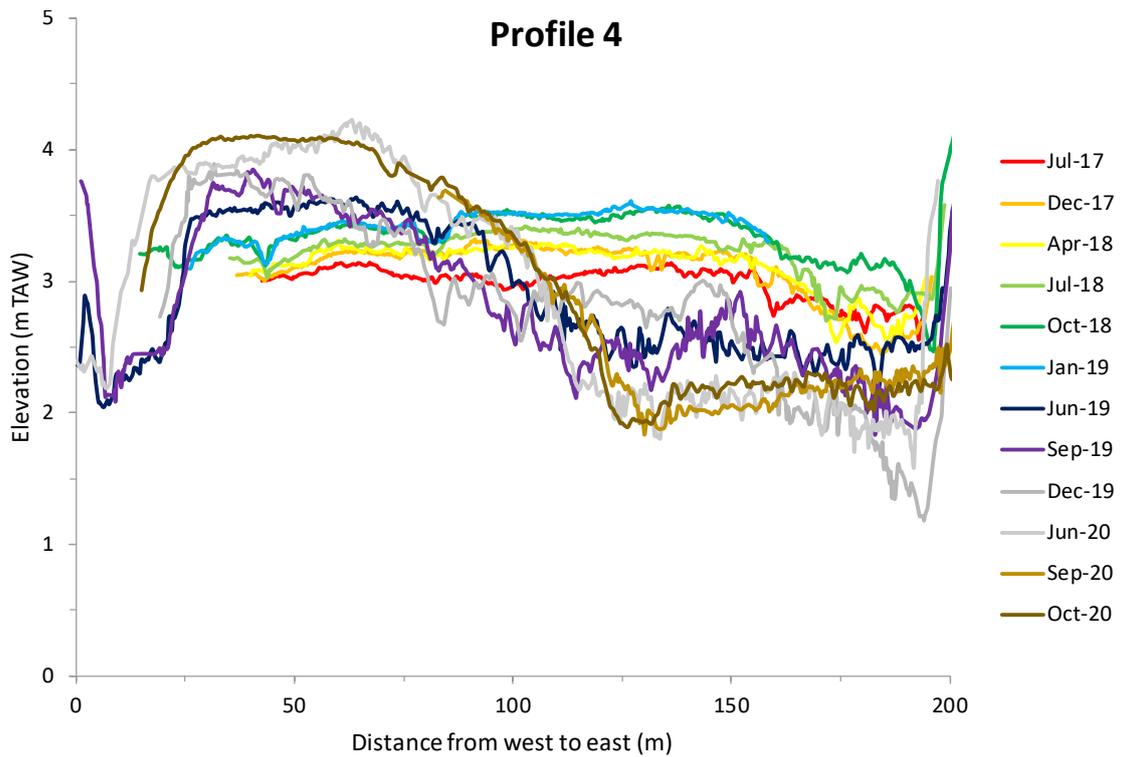
Figure 9 – Extracted profiles from the Qboat DoDs.

Results of the four extracted profiles from 07/2017 to 10/2020 are shown in Figure 9. Profile 1 located at the seaward side of the inland inlet indicates that the bed elevation of the channel after the opening has progressively become deeper. The lowest elevation just before the opening of the dyke was of 1.21 m TAW, while it was below 0 m TAW in 10/2020. In addition, the channel is more than two times wider nowadays than before the opening (based on the 2 m contour line). Profile 2, 3 and 4 also indicate a similar trend with the channel becoming deeper and wider in the middle and southward side of the inland inlet over time. Another observation is the development of sand banks and their dynamics, which likely influence the topographic evolution of the channel. Decametre mega-ripples, also called submerged dunes, are observed in the channel along the four profiles. These mega-ripples indicate an active sediment transport driven by tidal currents.
