16_089_2
FHR reports

Monitoring the morphodynamics of the Zwin inlet

Interim report
2 years after the extension works

Montreuil, A-L.; Dan, S.; Houthuys, R.; Verwaest, T.

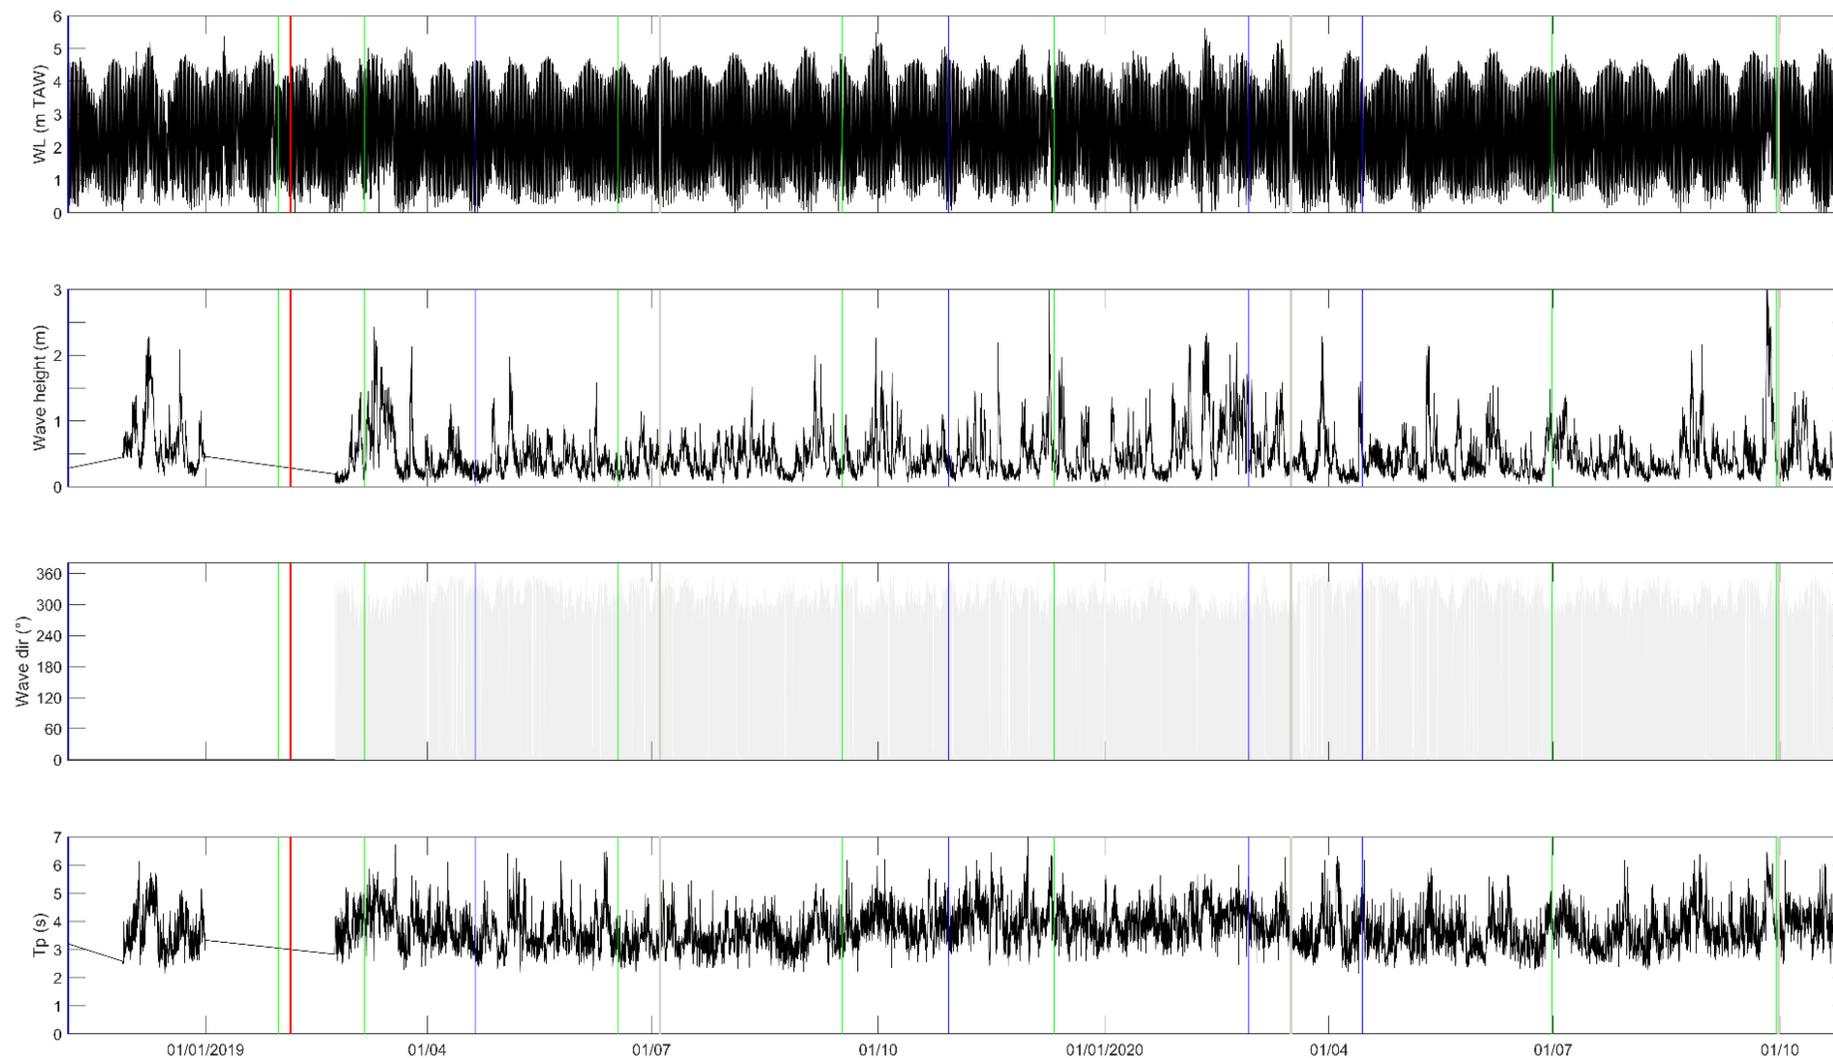
Figure 10 – Time series of water level at Scheur, average wave height, wave direction and wave period at at Scheur in 2018 and at Zwin from 02/2019. Blue vertical lines correspond to the LiDAR surveys, green lines to the Qboat surveys, grey lines to the RTK-GPS profile surveys and red line to the opening of the dyke.

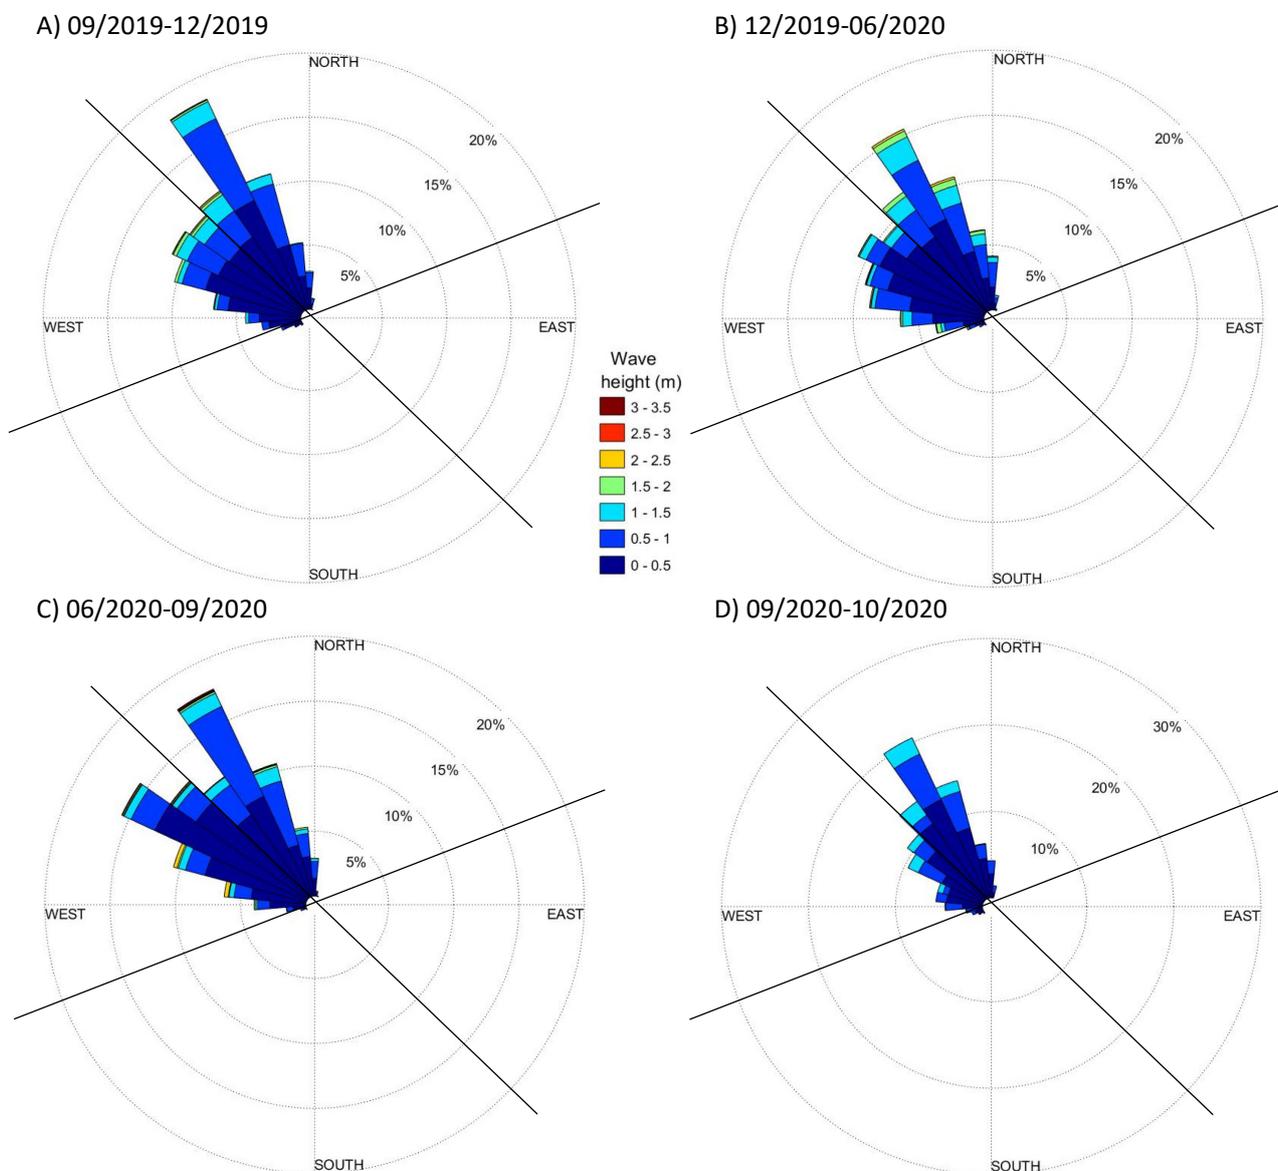
Figure 11 – Average wave distributions per Qboat survey periods measured from the Zwin buoy. The coastline and the Zwin entrance channel are oriented WSW-ENE (70-250°) and NW-SE (130-310°) respectively.

Forcing conditions were analysed to get insights about the hydrodynamics driven the morphodynamics of the Zwin inlet before and after the opening of the dyke. Figure 11 presents wave height and direction statistics for the periods between Qboat surveys starting from 09/2019. Previous periods are presented in the first progress report (Montreuil et al., 2020). Generally, the waves are coming from the sector 290-340° (WNW-NNW) and the average wave height is normally below 0.5 m. The dominant wave direction is 330-320° (NW) which is aligned with the entrance of the Zwin channel. Under energetic conditions, high waves are thus likely to enter in the inlet and then to influence the local morphology. Wave regimes from 16/09/2019-29/09/2020 was relatively similar with the highest wave ranging from 2.34 m between 11/12/2019-03/06/2020 to 3.41 between 06/2020-09/2020. Wave heights between 29/09-28/10/2020, were however lower (maximum 1.41 m) and also the spreading of waves exceeding 1 m high was limited. This short monitoring period was thus characterized by calm wave energy.

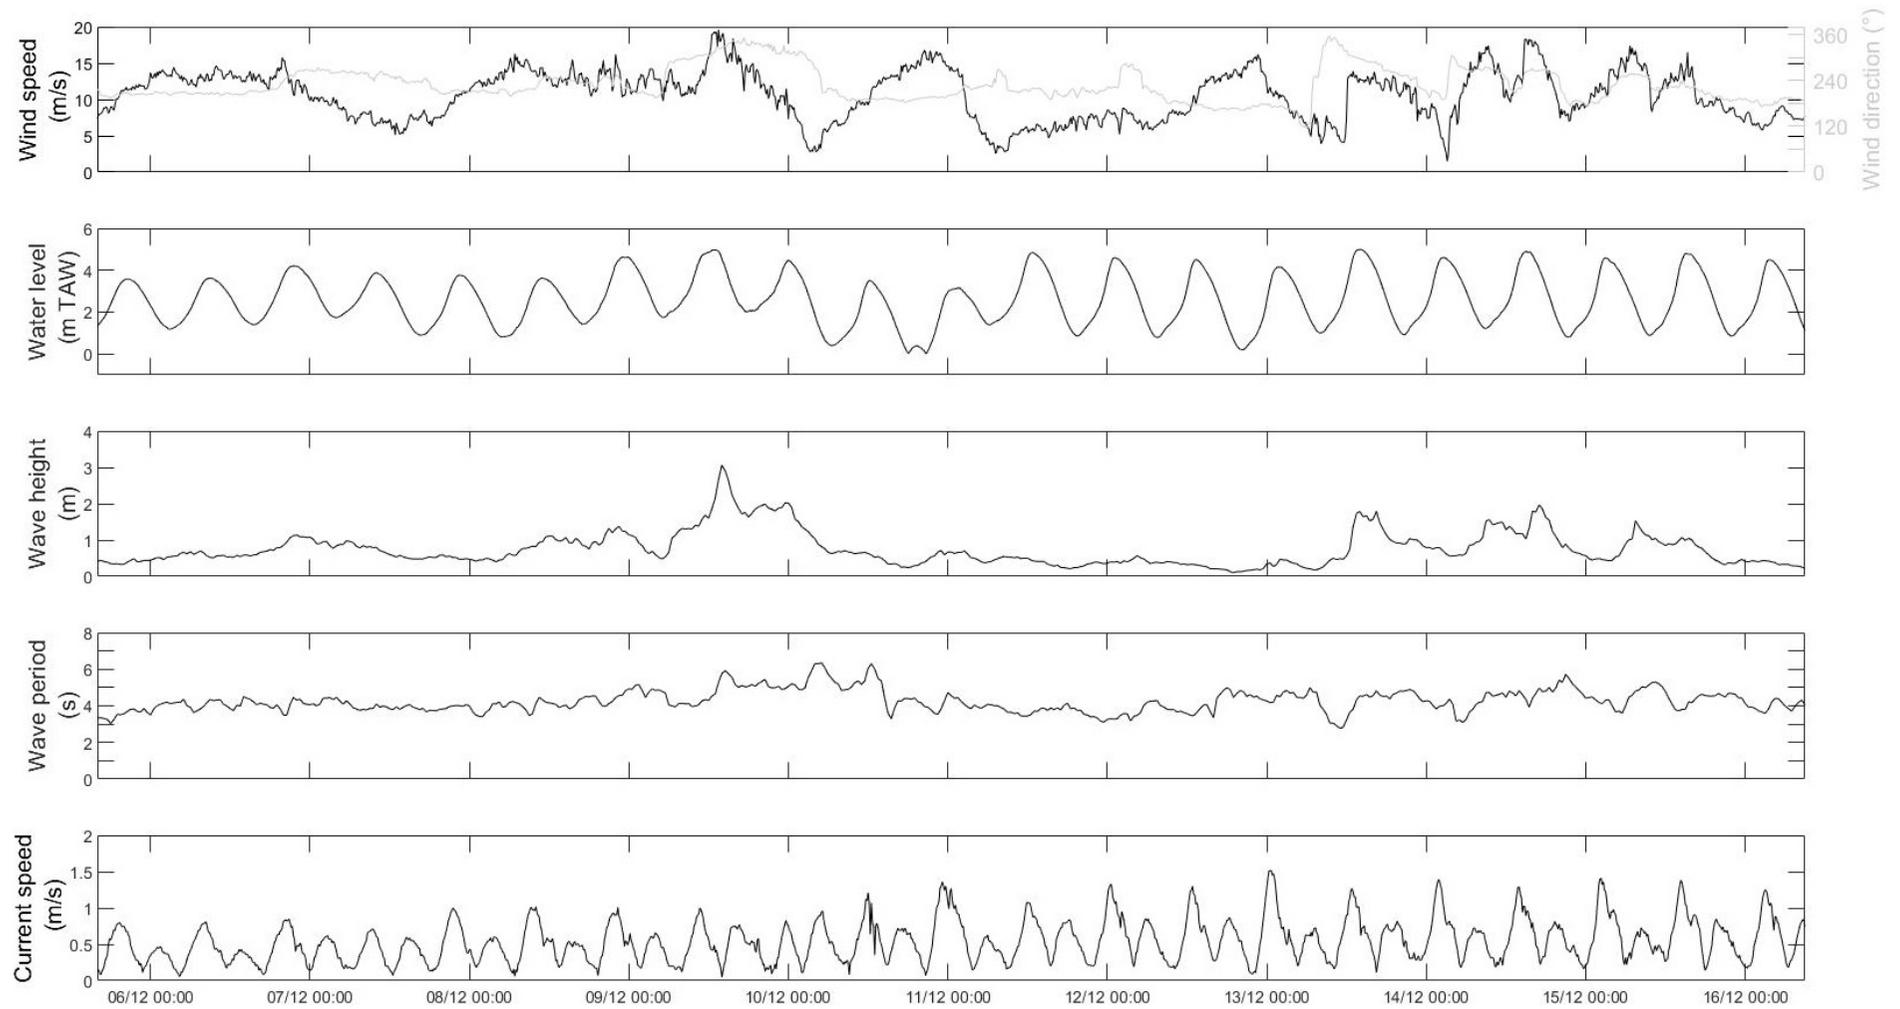
Figure 12 – Summary of meteo-marine conditions recorded at the stations during the December 2019 ad-hoc measurement campaign.

Figure 12 and Table 9 present the recorded meteo-marine parameters at Scheur and Zwin buoy (Source: Meetnet Vlaamse Banken) during the ad-hoc measurement campaign. Energetic weather conditions prevailed with an average wind of 10.64 m/s coming from SW-WNW. A maximum wind speed of 19.6 m/s occurred on 9/12 at 12:00 which led to high waves reaching up to 3.06 m. In general, the average wave height recorded by the Zwin buoy station was 0.75 m (average Hs 0.95 m). The highest water level was 5 m TAW at the Scheur station which took place on 13/12 at 12:00. There, the current velocity ranged from 0.05 to 1.52 m/s with an average of 0.54 m/s during the entire duration of the measurement campaign.

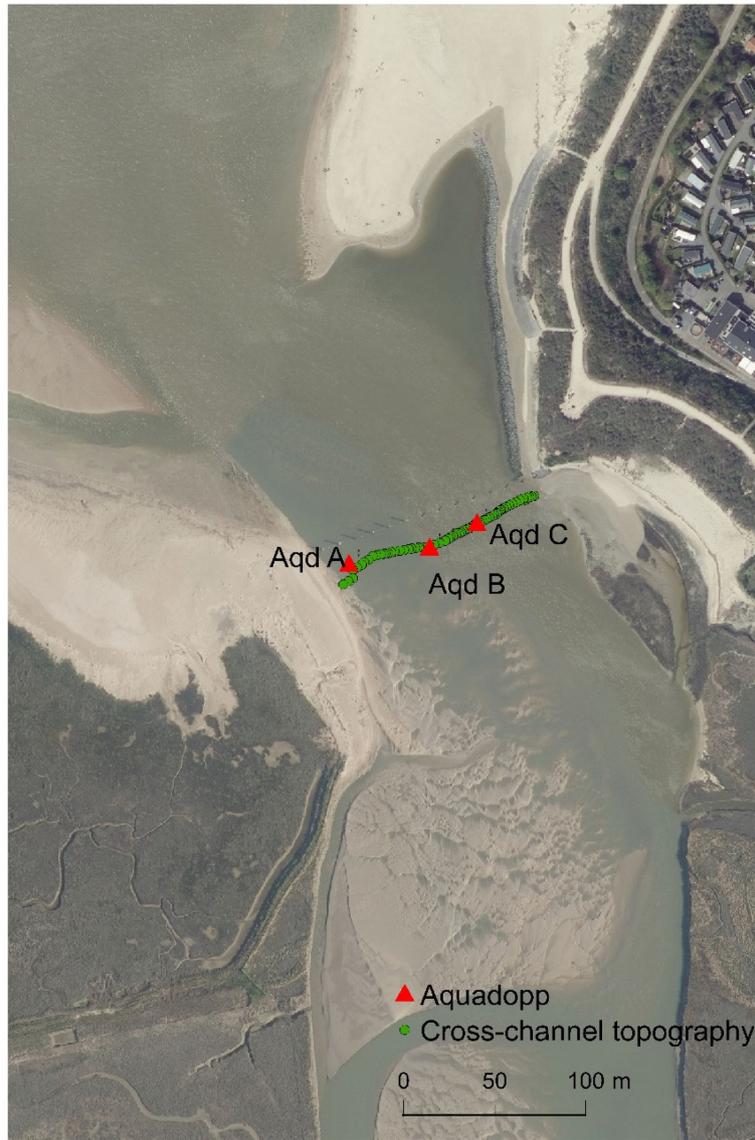
Figure 13 – Location of the ad-hoc measurement with cross-shore profile (green dots) and Aquadopp sensors (red triangles).

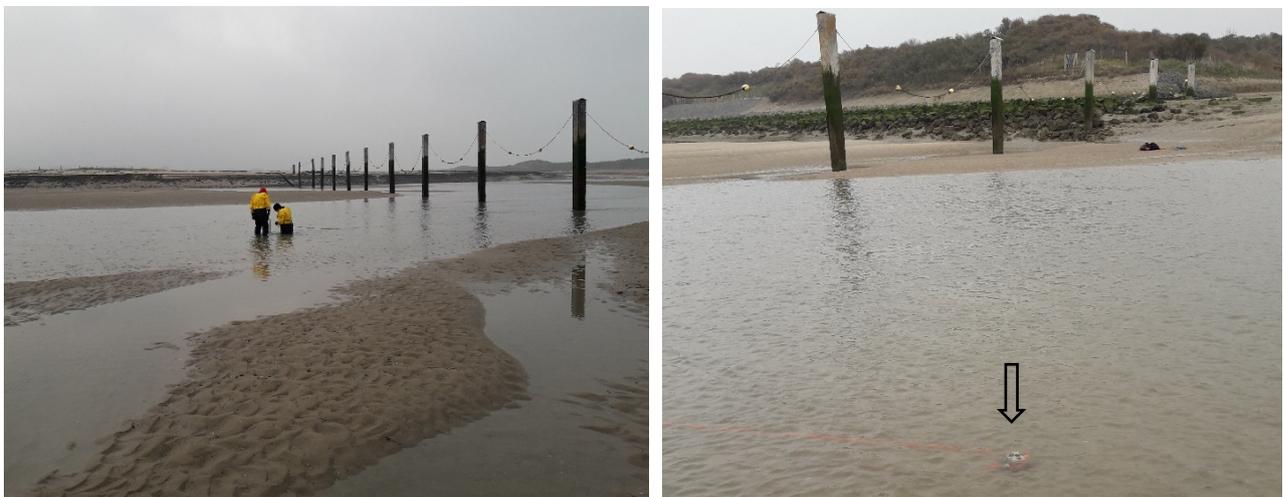
Figure 14 – Photographs taken during the deployment of the Aquadopp sensors.

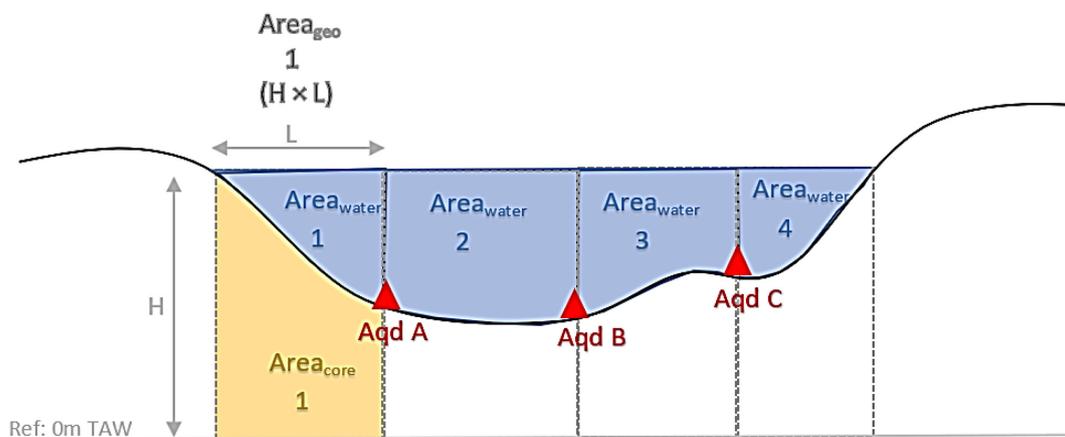
Figure 15 – Method of estimating water discharge.

Water discharge was estimated by dividing the cross-channel topographic profile in 4 sections to calculate the water area (A_{water}) (Figure 15). For this, the estimated geometric area (A_{geo}) was subtracted from the core area (A_{core}) for each section. Then, the water discharge per section was calculated by multiplying A_{water} and the depth-averaged velocity current measured by the Aquadopps for the respectively section. Finally, the water discharge of the four sections was summed. The cross-channel topographic profile was interpolated with a distance interval of 0.1 m to extract representative water level with the side bank reaching an elevation of 4.85 m TAW (i.e. high water level). Also, the depth-averaged velocity current and water level was averaged every 30 min for the campaign period. Here, we assume that the current velocity measured by the Aquadopps at a specific location is representative for the velocity of the entire section while it is likely to be lower near the channel bank. Due to the limitation of the GPS profile coverage, extended elevations aligned with the profile were extracted from the LiDAR survey on 29/10/2019. Appendix A presents the extended profile and a map overlapping of the Qboat, GPS and LiDAR surveys. It was thus assumed that the sand bank did not change between October and December. The topographic elevation was compared between the GPS and Qboat in this appendix. Also, records from Aqd B were used in the water discharge estimation when there was any records from Aqd A due to the absence of water at its location.

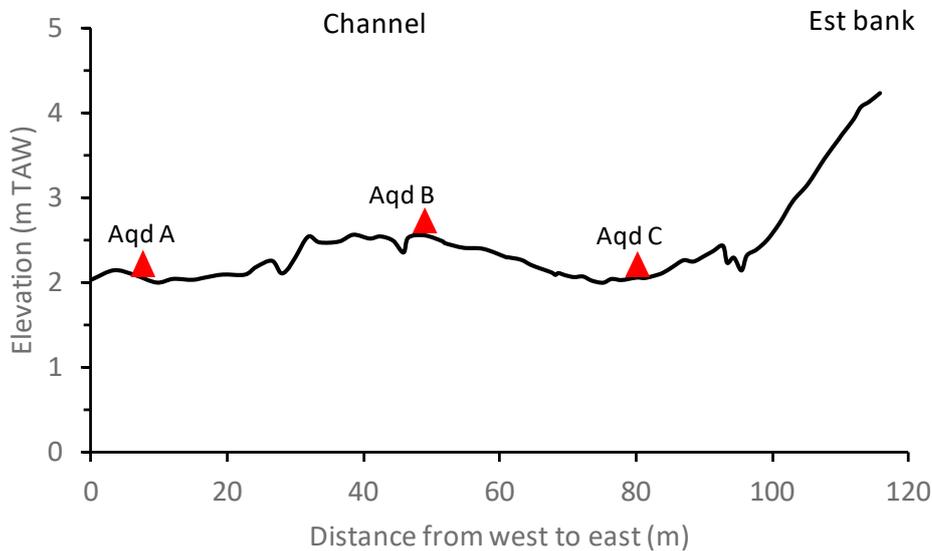
Figure 16 – Cross-channel topographic profile with the Aquadopp locations.

Figure 16 presents the cross-channel topographic profile acquired on 5/12. This profile was aligned with the Aquadopp sensors located in the channel and south of the permanent poles (Figure 12). The elevation in the channel was usually above 2 m TAW. The centre of the channel at a distance from 30 to 60 m was characterized by an elevation > 2.3 m TAW, which was higher than its sides. The east bank is characterized by a gentle intertidal slope while the west bank was steep and high (not surveyed due to a technical problem of receiving satellite signal).

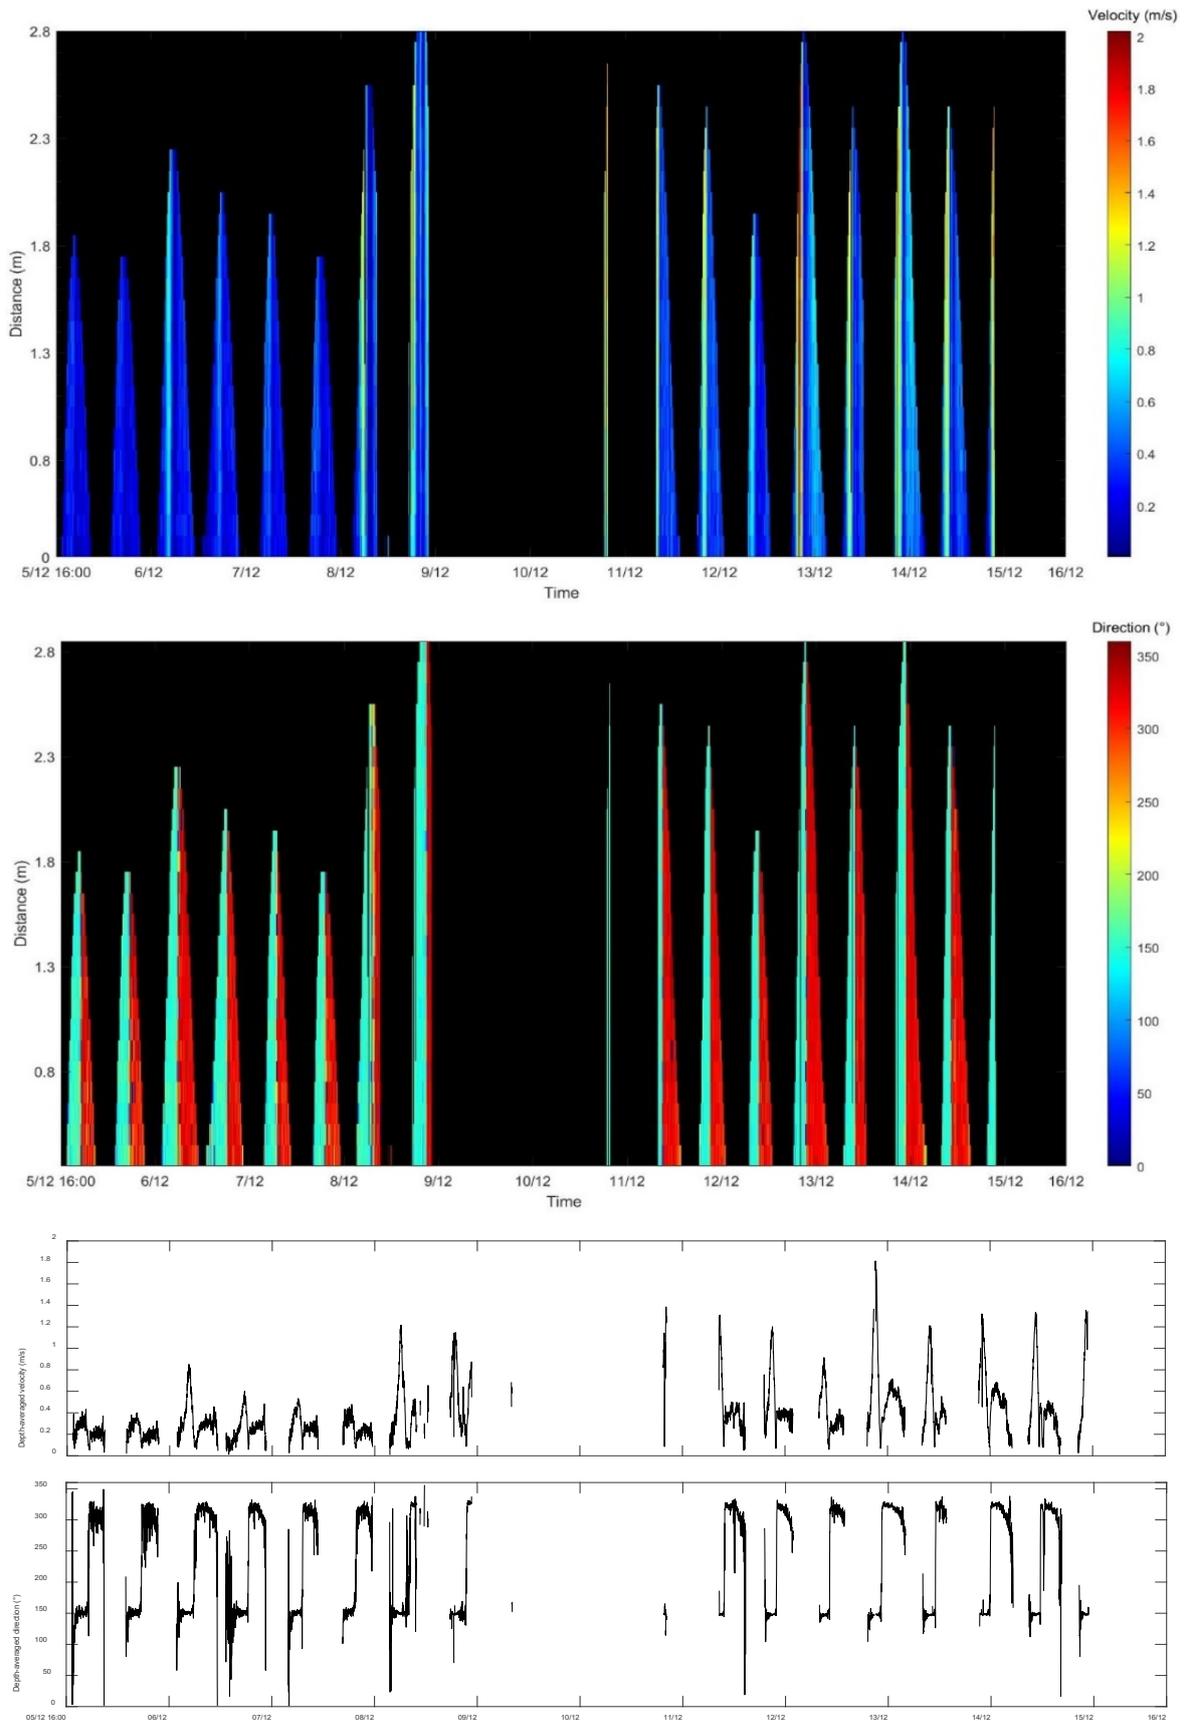
Figure 17 – Time series of current velocity profile, direction profile, and depth-averaged values for the Aquadopp A.
 Note: Gaps in the time series are due to missing data.

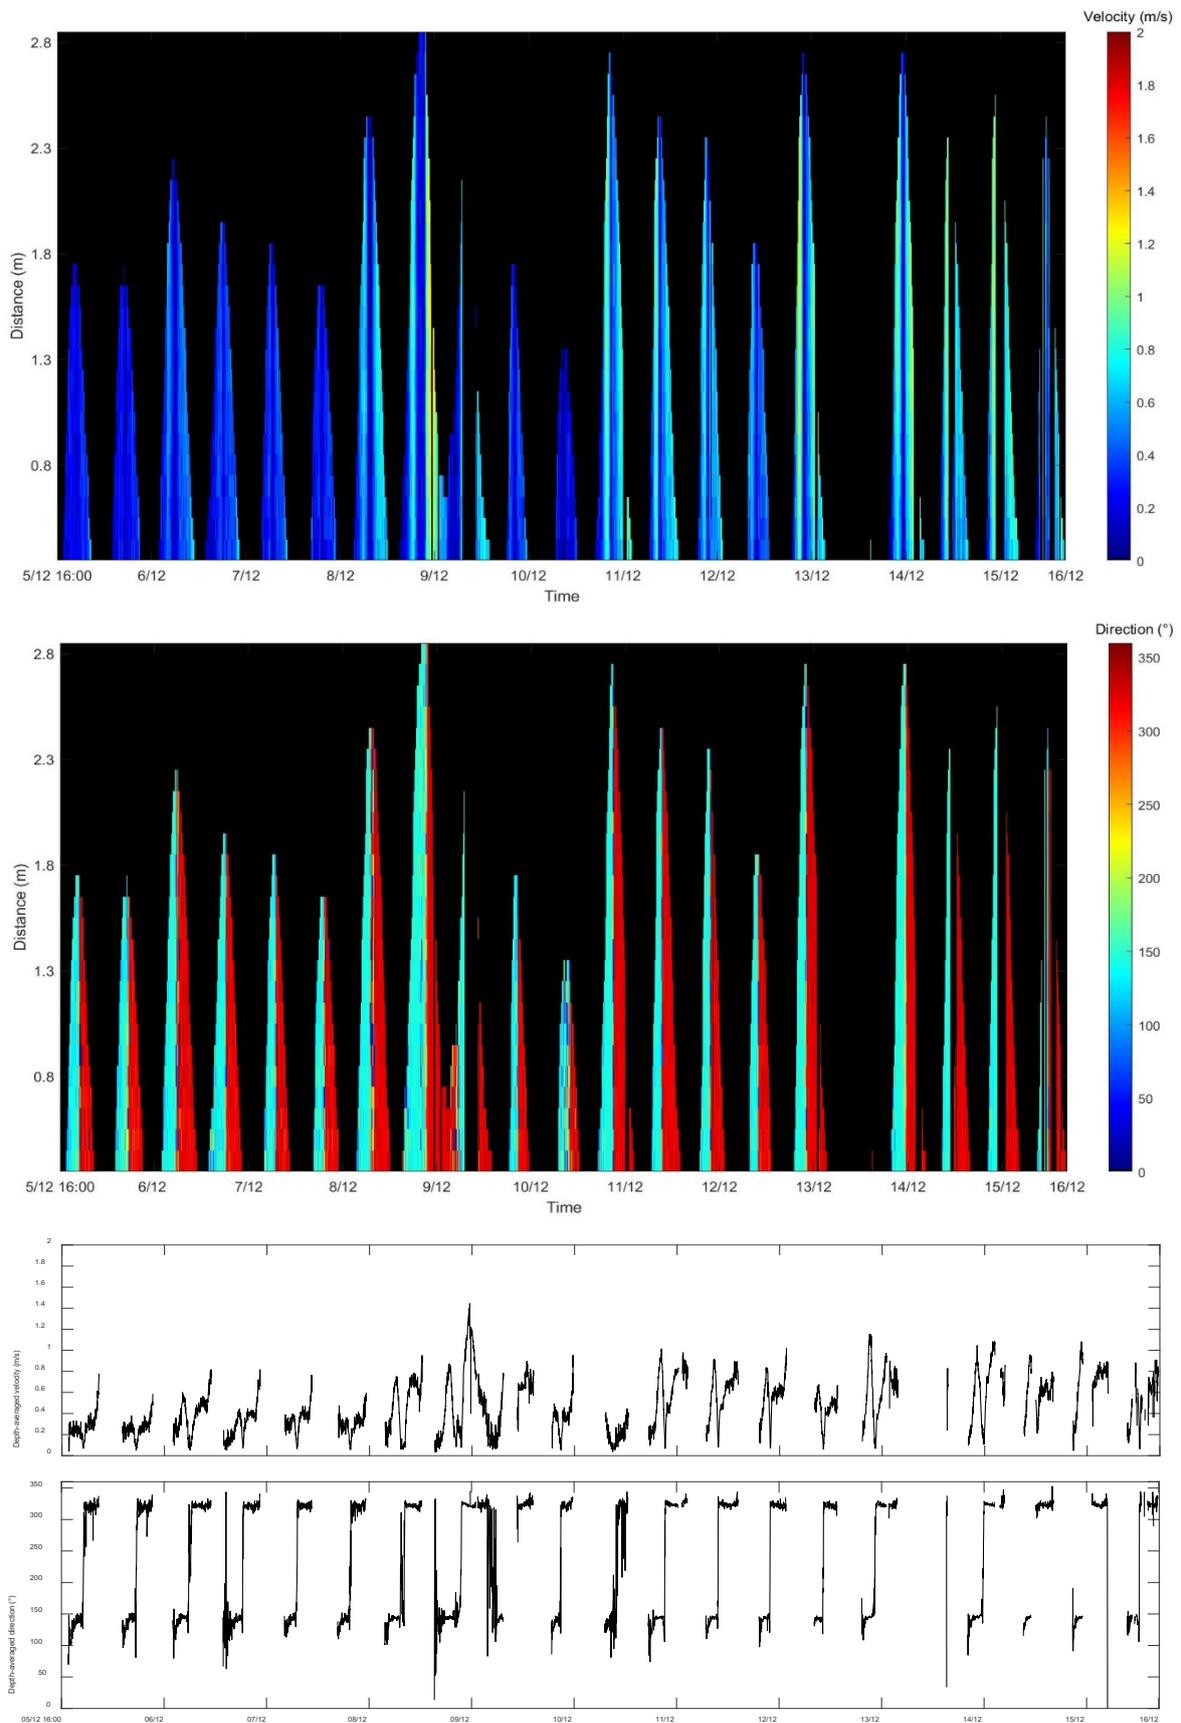
Figure 18 – Time series of current velocity profile, direction profile, and depth-averaged values for the Aquadopp B.
 Note: Gaps in the time series are due to missing data.

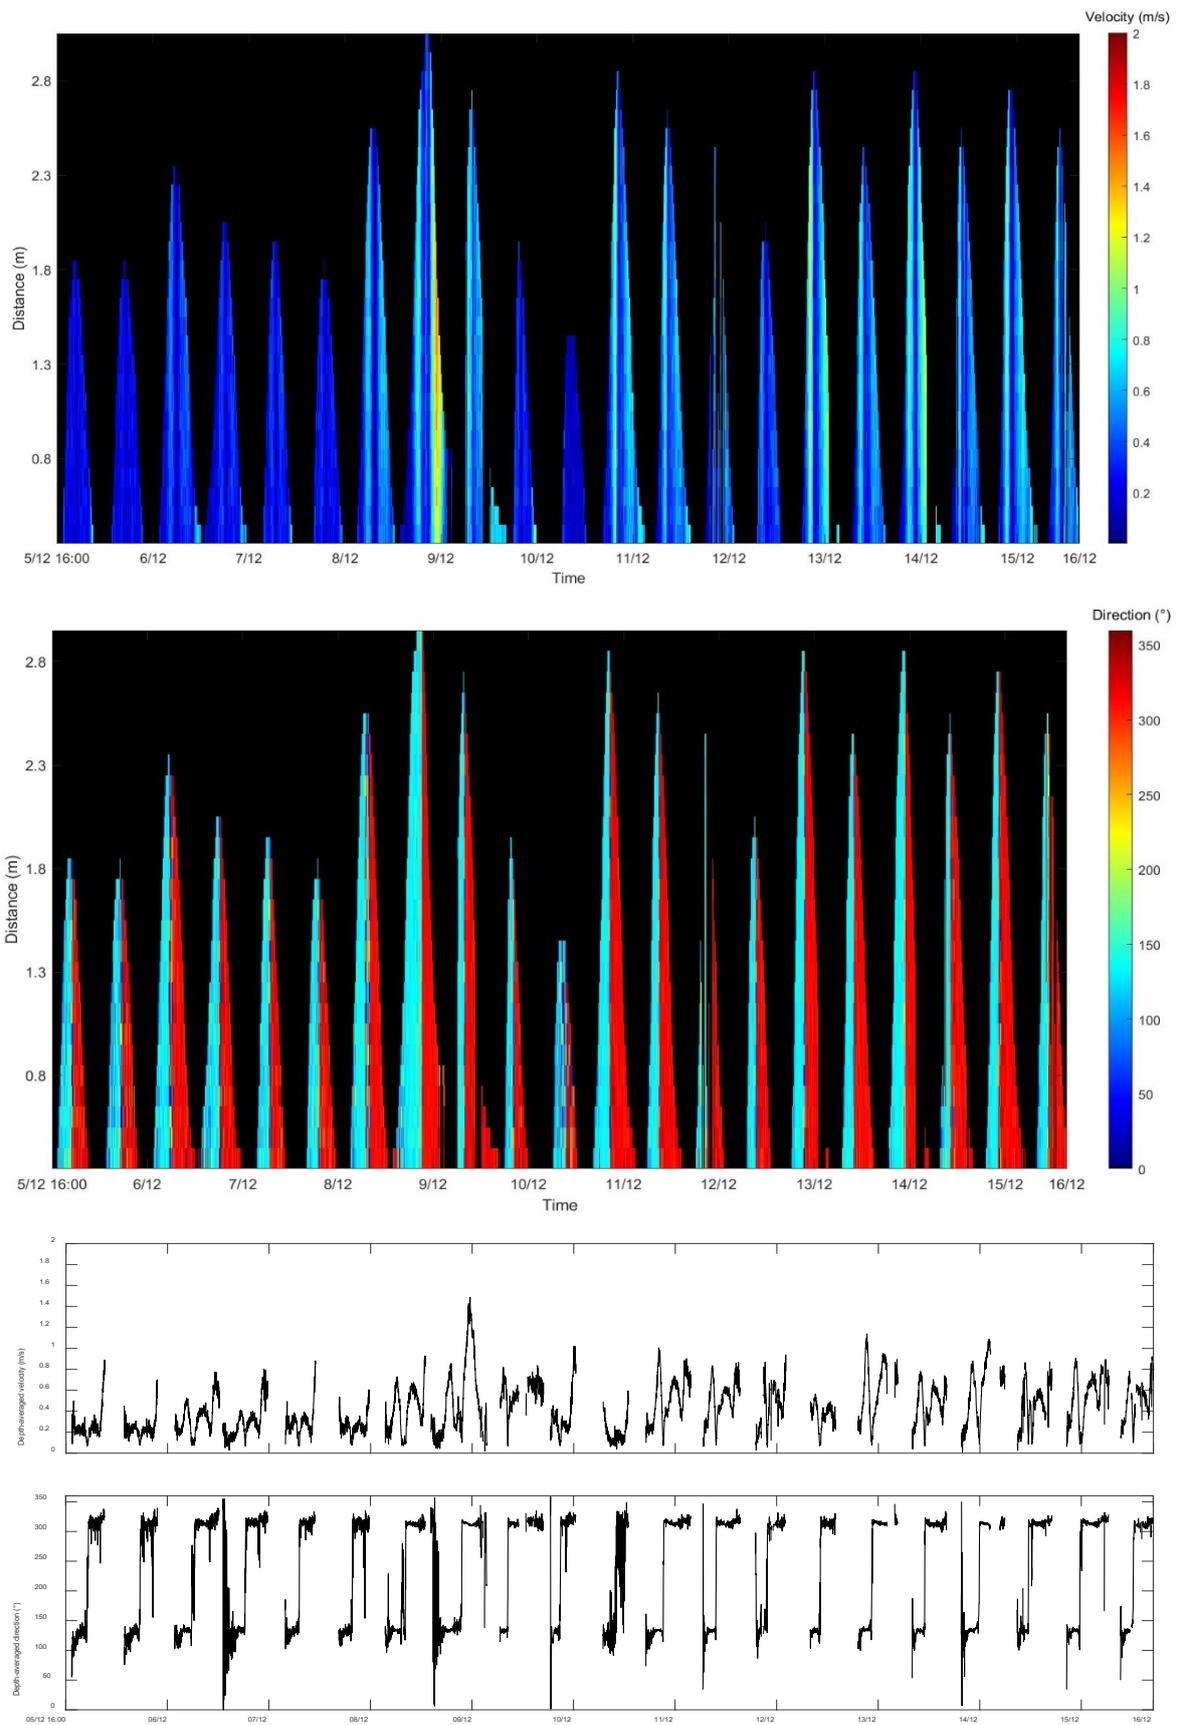
Figure 19 – Time series of current velocity profile, direction profile, and depth-averaged values for the Aquadopp C. Note: Gaps in the time series are due to missing data.

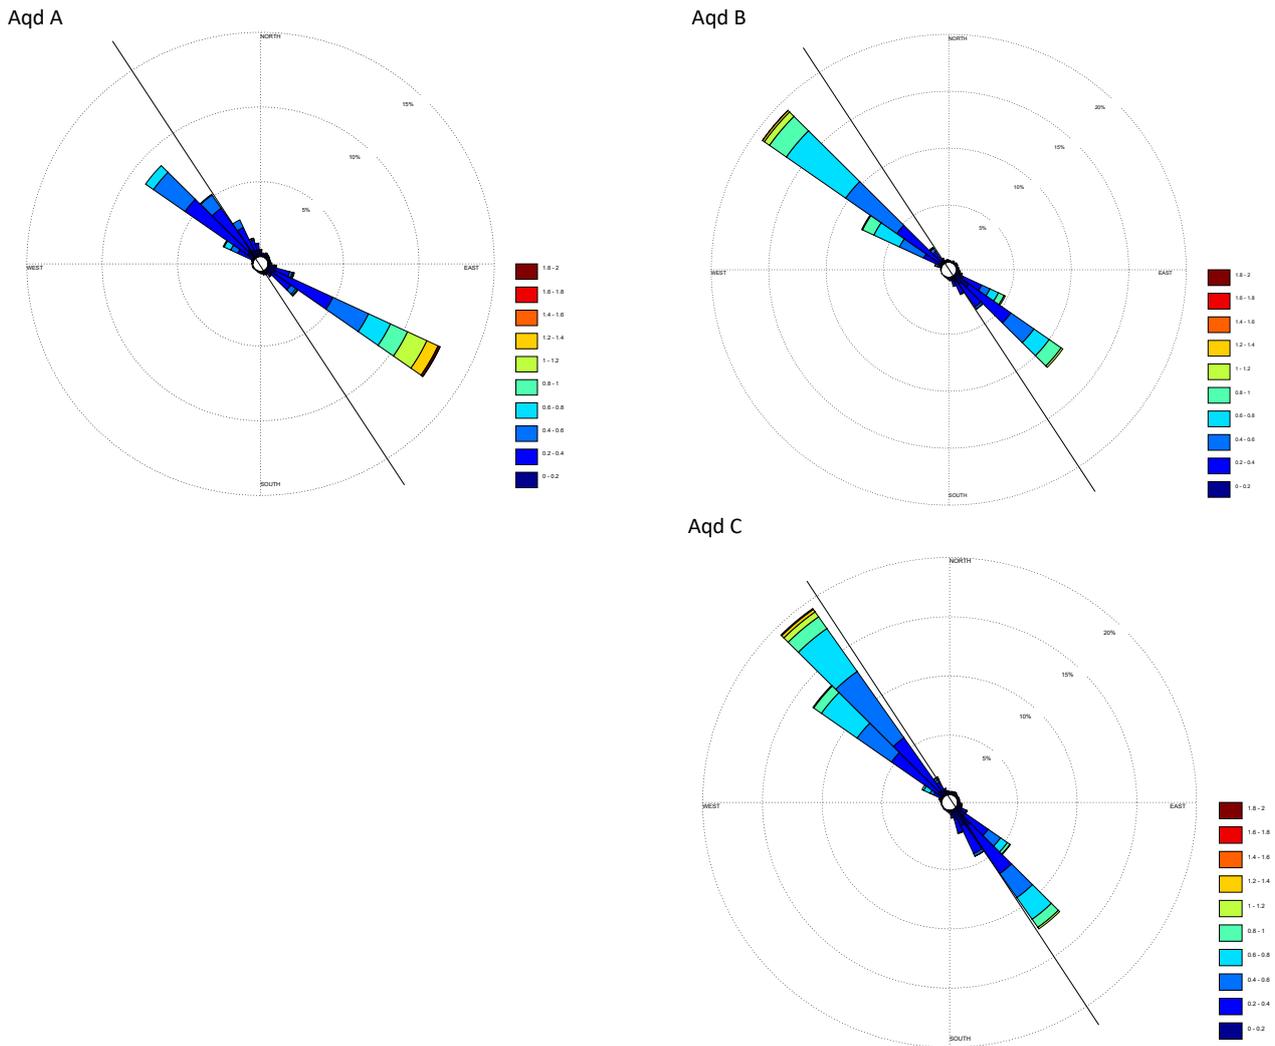
Figure 20 – Roses of current velocity (m/s) from the 3 Aquadopps. Black lines correspond to the main channel orientation (130°-310°).

The three current roses clearly indicate an asymmetry of the tidal tide (Figure 20). The trend of Aqd B and Aqd C is very similar with a dominance of NW currents (310°) characterized by a maximum speed up to 1.4 m/s. This indicates that the current outflow is faster than the inflow there, suggesting that the east side and the middle of the channel are ebb-dominated (Figure 21). This process is similar to the entrance of the inlet (Montreuil et al., 2020). In contrast, the current rose of Aqd A shows a dominance of SE currents (150°) so that the inflow is the strongest there. Thus, the west side of the channel is flood dominated which is due to the local configuration with the presence of the sand bank and the steep west bank. These features are probably steered the tidal currents (i.e. secondary topographic effect). The segmentation of the sand bank morphology and its orientation of 175° (ebb-dominated) reflect this process as well.

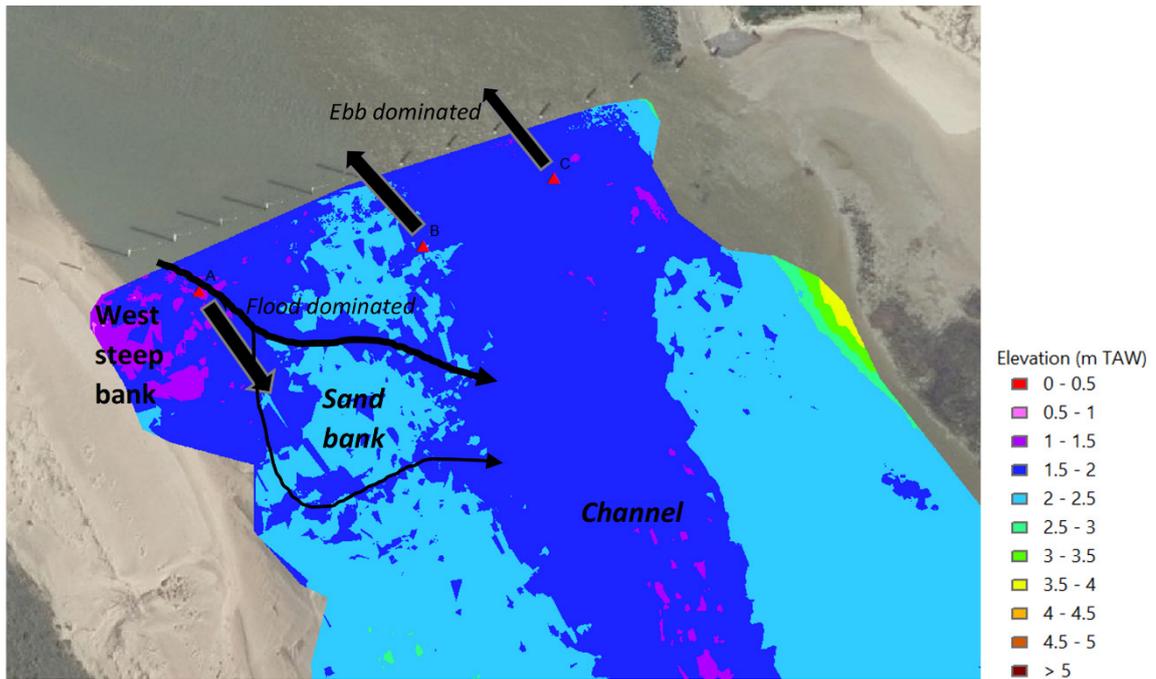
Figure 21 – Sketch of processes in the inland inlet.

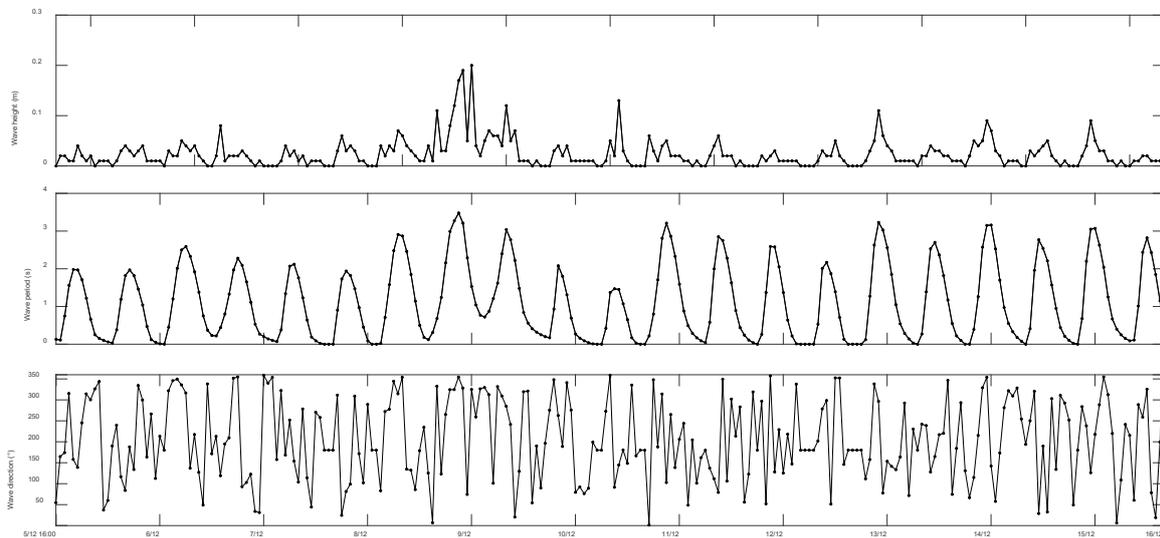
Figure 22 – Time series of significant wave height (Hm0), period (Tm0) and direction at the Aquadopp B.

The average of significant wave height was of 0.024 m with a maximum of 0.2 m during the entire campaign (Figure 22 and Table 13). Wave period was below 3.5 s which is lower than the typical values recorded along the coast (5-6 s). Also, wave direction was subject to a high variability, which might be biased and not representative.

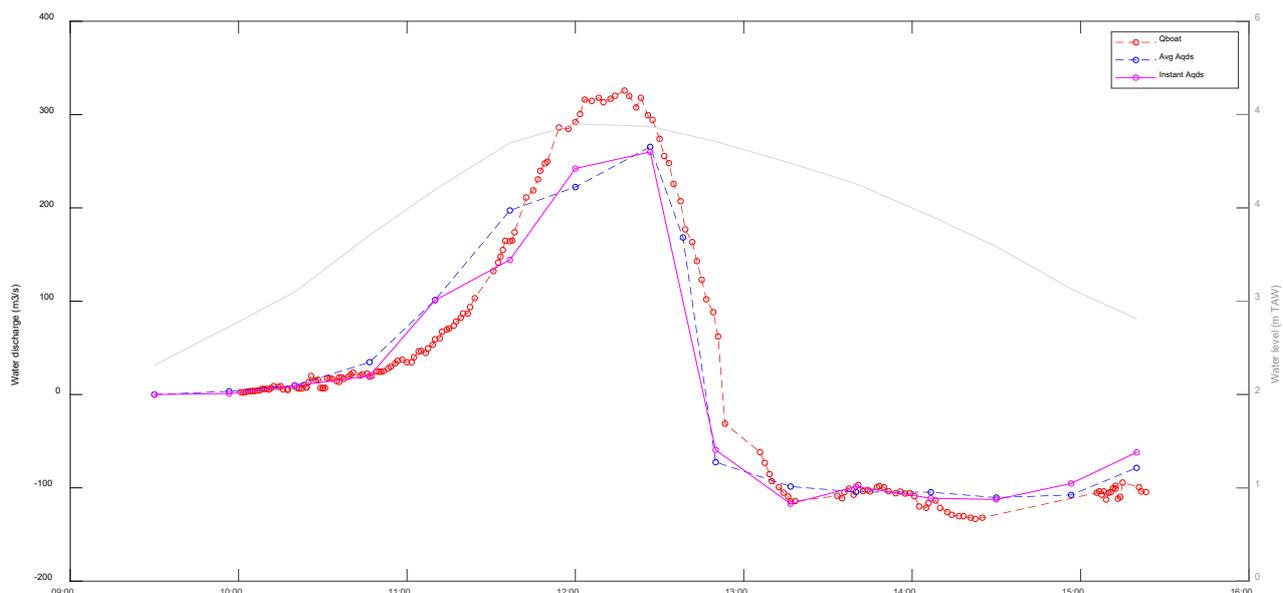
Figure 23 – Comparison of time series of water level (grey line) and estimated water discharge on 11/12/2019.

Figure 23 presents time series of water level and estimated water discharge from the Qboat and Aquadopps measurements. The time series called "average Aquadopps" (Avg Aqds) correspond to the water discharge estimations based on 30 minutes average current velocity and corresponding water level measurements, while "instantaneous Aquadopps" (Instant Aqds) are the immediate measurements of current velocity and water level measurements in the entire water column with an interval of 30 minutes. The results show the same pattern for the three types of water discharge time series. However, the Qboat estimation is systematically higher at high tide compared to the Aquadopps ones. A peak of 325.73 m^3 was found for the Qboat at high tide, while it was 259.99 m^3 and 265.3625 m^3 respectively for Instant and Average Aquadopp. The difference is probably due to the Qboat water discharge estimated at a specific point and not along the whole transect and without extrapolation for the side banks. Another reason for the difference of water discharges may be the difference of the bed topography (average 0.5 m) along the cross-section between the Qboat survey on 11-12/12 and the GPS measurements on 5/12 (Appendix A). These results are in agreement with the comparison of water discharge determined Qboat and 12 Aquadopps deployed across the channel in the inlet entrance on 25/10/2018 (Aqua Vision, 2018).

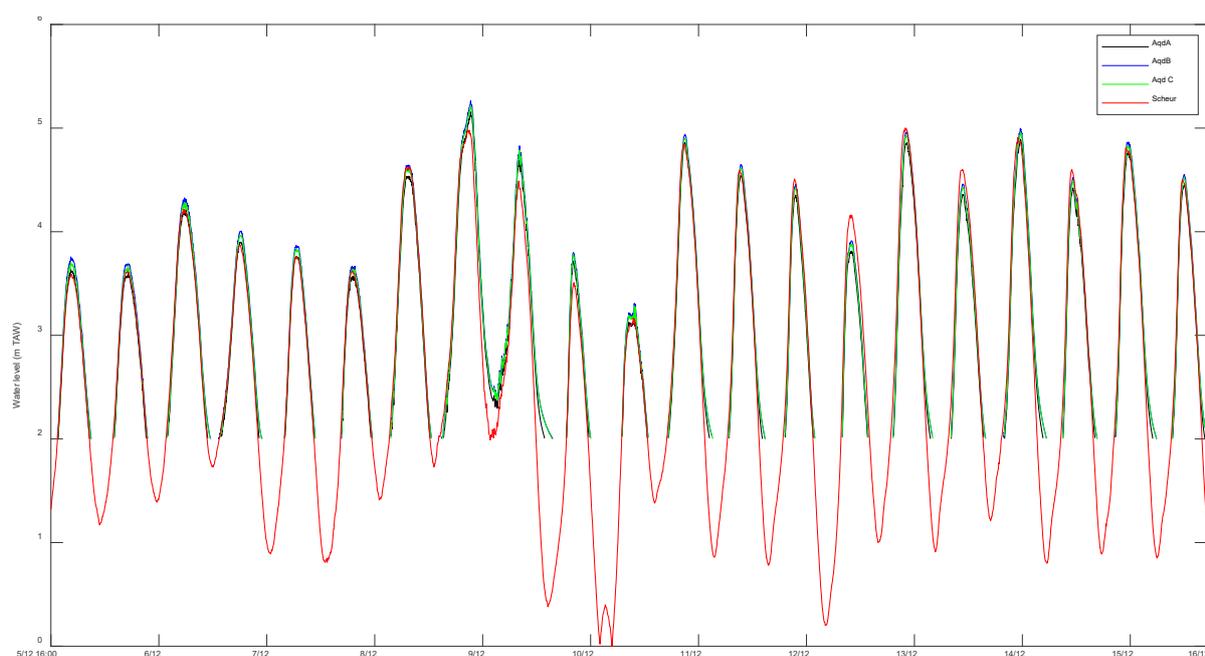
Figure 24 – Comparison of the water level recorded in the inlet and at the coast from Scheur station. Records at low water from the Aquadopps were removed.

The water level recorded by the three Aquadopps based on their internal pressure sensors were referenced to TAW by adding the elevation of their position. Then they were compared to the Scheur monitoring station (Figure 24). The erroneous data below 2 m TAW were removed from the times series of the Aquadopps. The same pattern reflecting the tidal cycles was observed for the four sensors of recorded data. The water level records from AqdB and AqdC were nearly identical while they were slightly lower (<0.10 m) for Aqd A. The reason is probably due to a bias of the topographic measurement close to the west side bank where the satellite reception quality was poor.

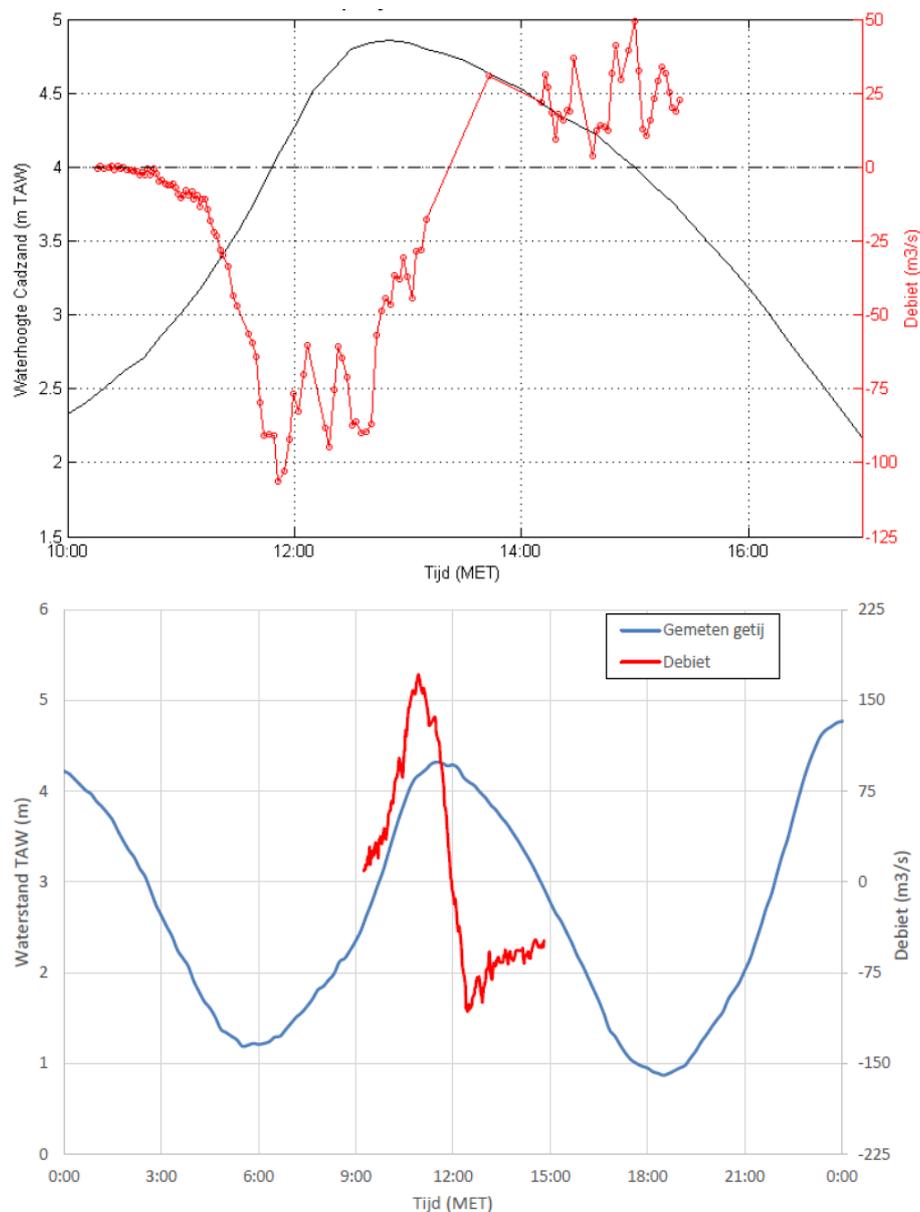
Figure 25 – Comparison of water discharge and water level for the Qboat surveys on 23/10/2018, before the opening of the dyke (top) and 28/10/2020 (bottom) (Aqua Vision, 2018, 2020b).

Flow rates in the main channel of the inland inlet recorded during the Qboat surveys before the opening of the dyke and 10/2020 are displayed in Figure 25 and Table 15. It is clear that the water discharge patterns have changed, characterized after opening by a longer flood phase of 2h30 with a flow peak of 171 m^3 while it was just 1h45 in 10/2018 with a flow peak of 106 m^3 . In 10/2020, the estimated total water volume entering during the flood phase is of 6000 m^3 which is two times larger than before the opening of the dyke. The ebb flow starts 45 min after high water (no change over the monitoring period). It rises rapidly to the maximum flow rates and then gradually decreases. In comparison with the records in 10/2018, the magnitude of the ebb flow rate ranges from 1.6 to 3 times higher in 10/2020. Despite the expansion of the channel area, the ebb phase still lasts longer than the flood phase. It results in a tidal asymmetry with faster flood flow rates than the ebb ones. This can result in the system silting up (tidal pumping) and in particular in those areas where the current is less concentrated and its velocity decreases rapidly over a short distance. The inlet is a flood-dominated system subject to a dynamic behaviour and fast evolution.
