16_089_2
FHR reports

Monitoring the morphodynamics of the Zwin inlet

Interim report
2 years after the extension works

Montreuil, A-L.; Dan, S.; Houthuys, R.; Verwaest, T.

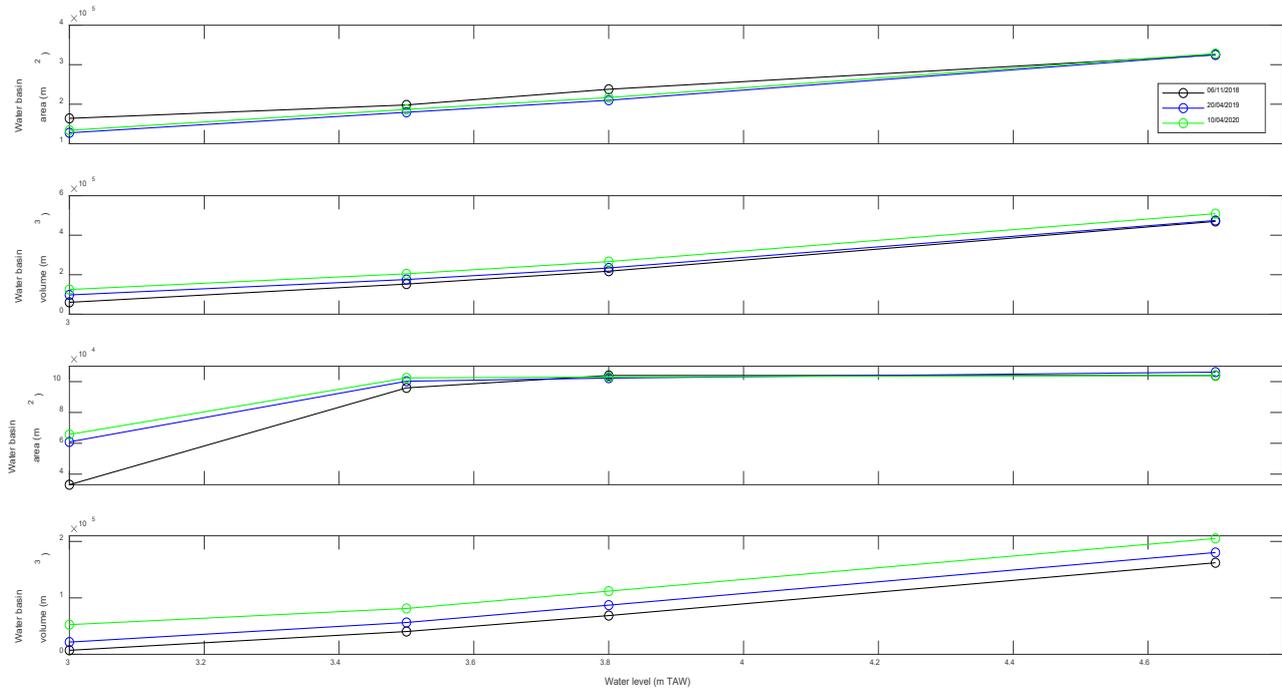
Figure 26 – Hypsometry of the entrance inlet (first two panel) and inland inlet (last two panel) as a function of water level. Note the difference of y-axes.

needs to be further investigated. After 1.2 year of the opening of the dyke, the water basin area and volume of both inlet units have gradually enlarged. Specifically, an increase of basin volume exceeding 8.3 % and 26.5 % have occurred for the entrance and inlet respectively. A growth of the tidal prism thus enhances the drainage of the inlet which gradually reduce the silting up process. An increase of tidal prism could lead to a reduction of the development of sandy bedforms (Oost, 1992). This would suggest that the decrease of the tidal prism of the Zwin might favour the disappearance of the sand bars and banks along the channel. Further investigations needs to be done to confirm this hypothesis.

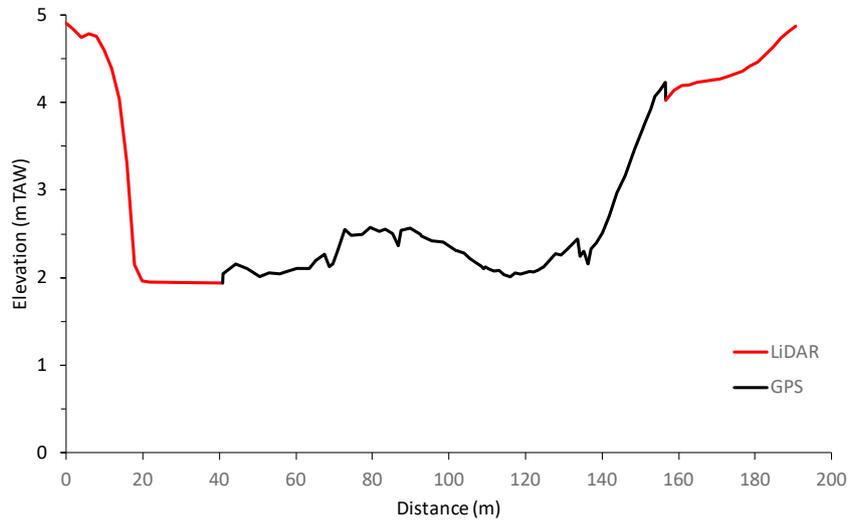
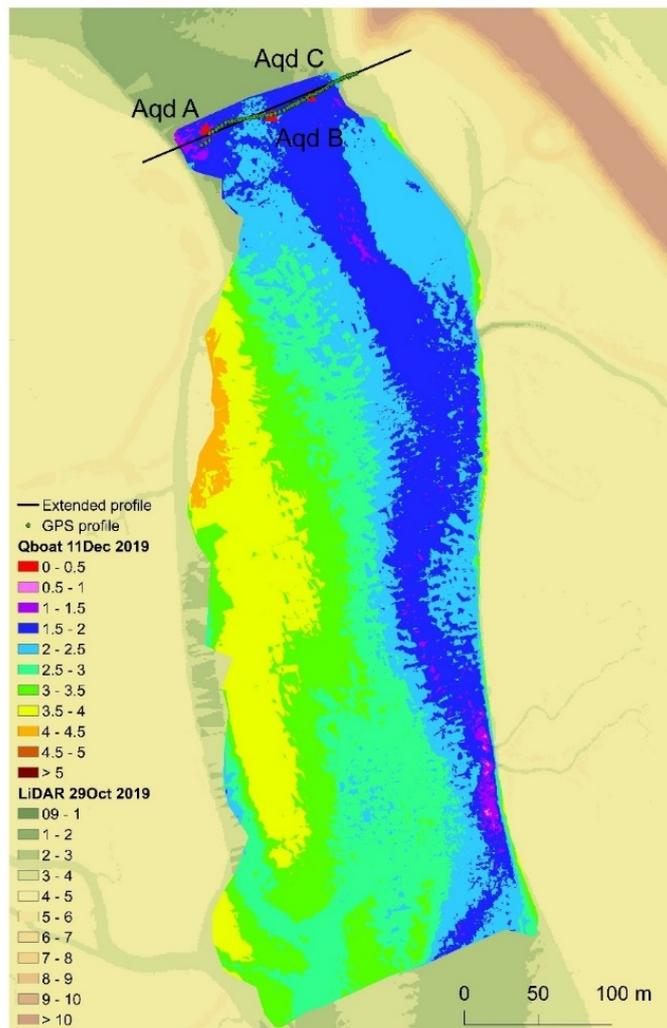
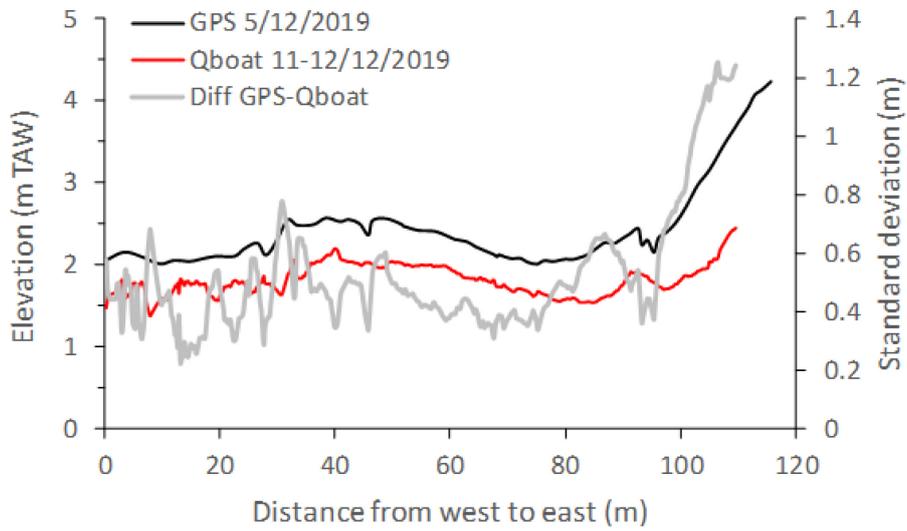
Appendix – GPS, Qboat and LiDAR surveys for water discharge estimation, profile and map

Difference between the GPS and Qboat survey:

Elevation difference (m)	
Mean	0.53
Max	1.25
Min	0.22
SD	0.21
