19\_118\_1  
FHR reports

# Evolution of a large coastal nourishment at Knokke

First year progress report

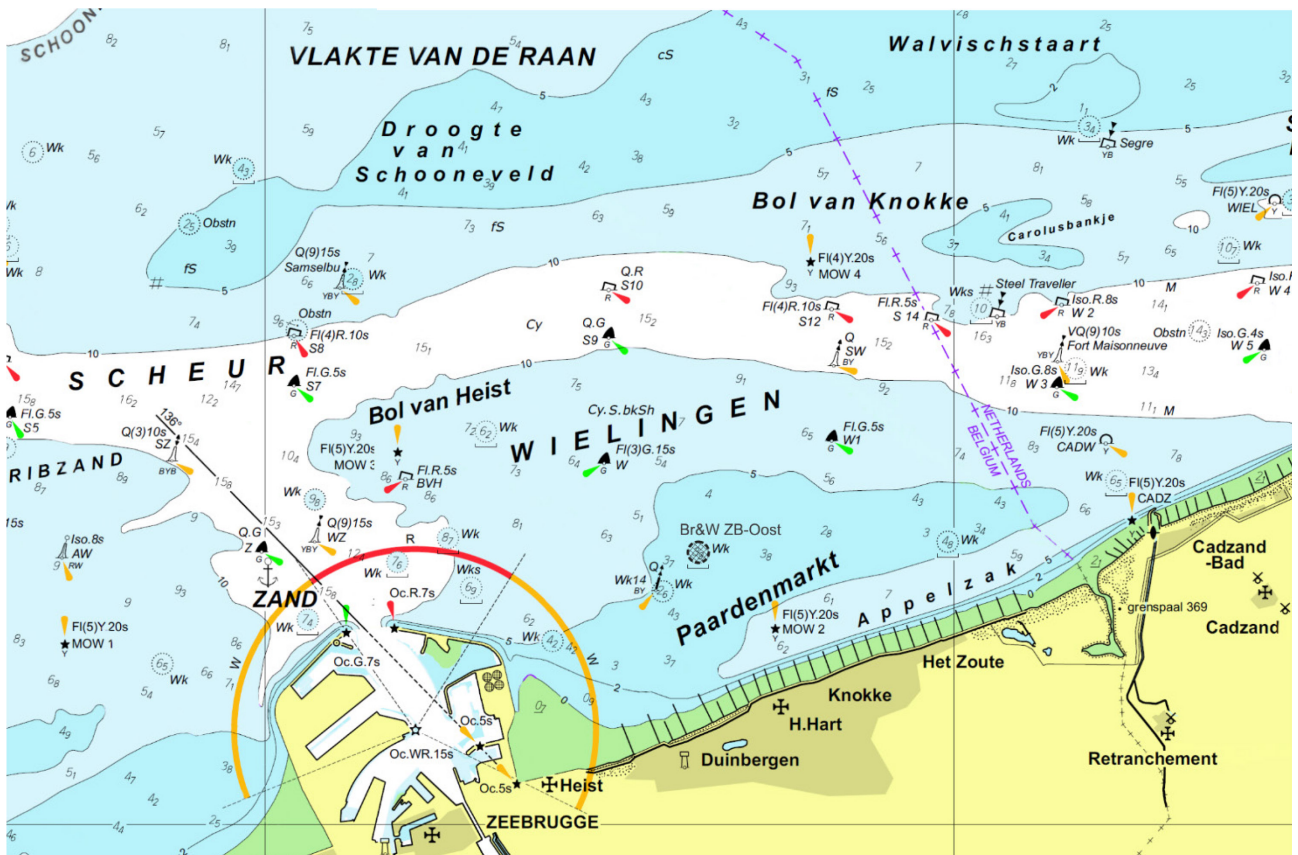
Figure 2 – Nautical map with distinct geomorphological marine bedforms.

The eastern part of the Belgian coast, stretching from the outer port of Zeebrugge to the Zwin inlet has a complex dynamics (Figure 2 and Figure 3). The morphodynamics are influenced by the presence of the Zeebrugge breakwaters where a large accretional area extends up to 4 km at the Baai van Heist due to wave sheltering effect as well as the asymmetry of the tidal currents. Blockage of the eastward directed littoral drift results in a positive gradient of longshore sediment in Knokke-Heist which drives erosion. The coastline at Knokke locally protrudes seaward due to the position of the sea dike. Sand loss further increases due to the presence of regional geomorphologic marine bedforms such as the Appelzak tidal channel which in turn seems to be controlled by the influence of the Paardenmarkt sand bank. The cumulative effect of beforementioned 3 driving mechanisms is severe erosion in Knokke. The coastal stretches west of the Zwin inlet also experience long-term erosion. In general, the seabed has eroded along the east coast over the last decades. The morphological trends of the emerged beach and the shoreface vary in time and space. Although on average the sediment budget is stable along the east coast, erosion is locally problematic. This chapter aims to summarize the available information on morphodynamics and evolution of the east coast.

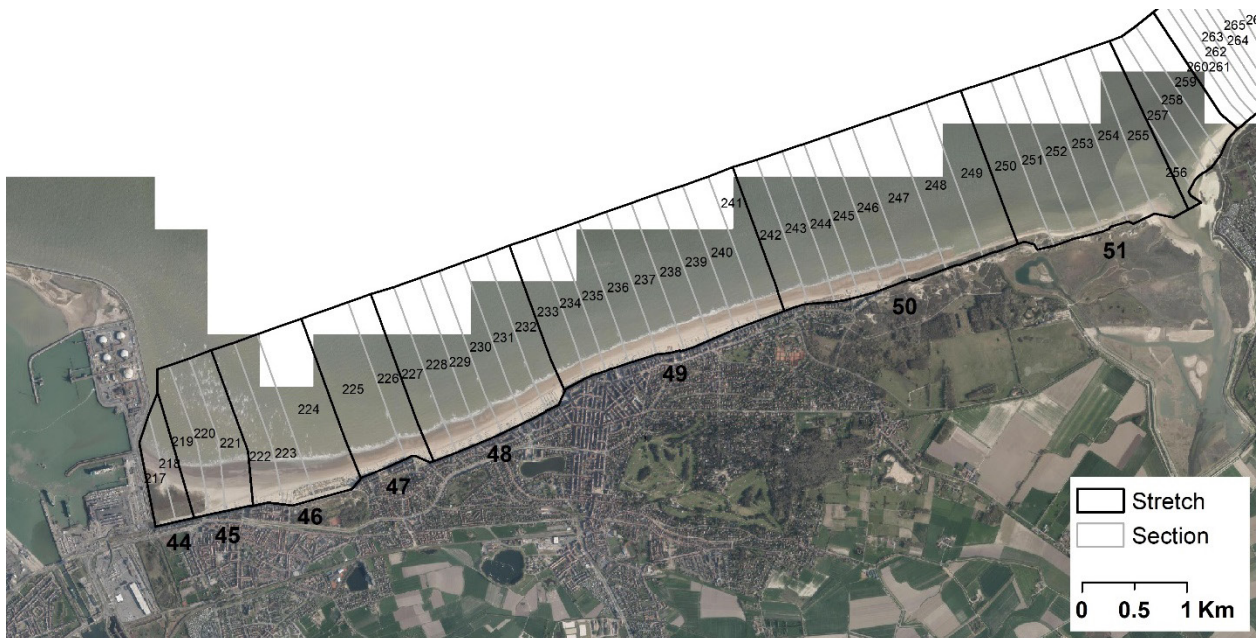
Figure 4 – Division of the east coast.

The east coast is divided into sections from 217 to 255 (Figure 4). These administrative sub-units cover the cross-shore domain from the foredune or the sea dike up to 1500 m offshore and span approximately 200-300 m longshore. Their boundaries are determined by the position of 24 groynes and the port of Zeebrugge, but a more uniform spacing is adopted in the case of absence of engineering structure. These sections are merged to 8 coastal stretches numbered from 44 to 51 (Table 1) for morphological studies (Houthuys, 2012).

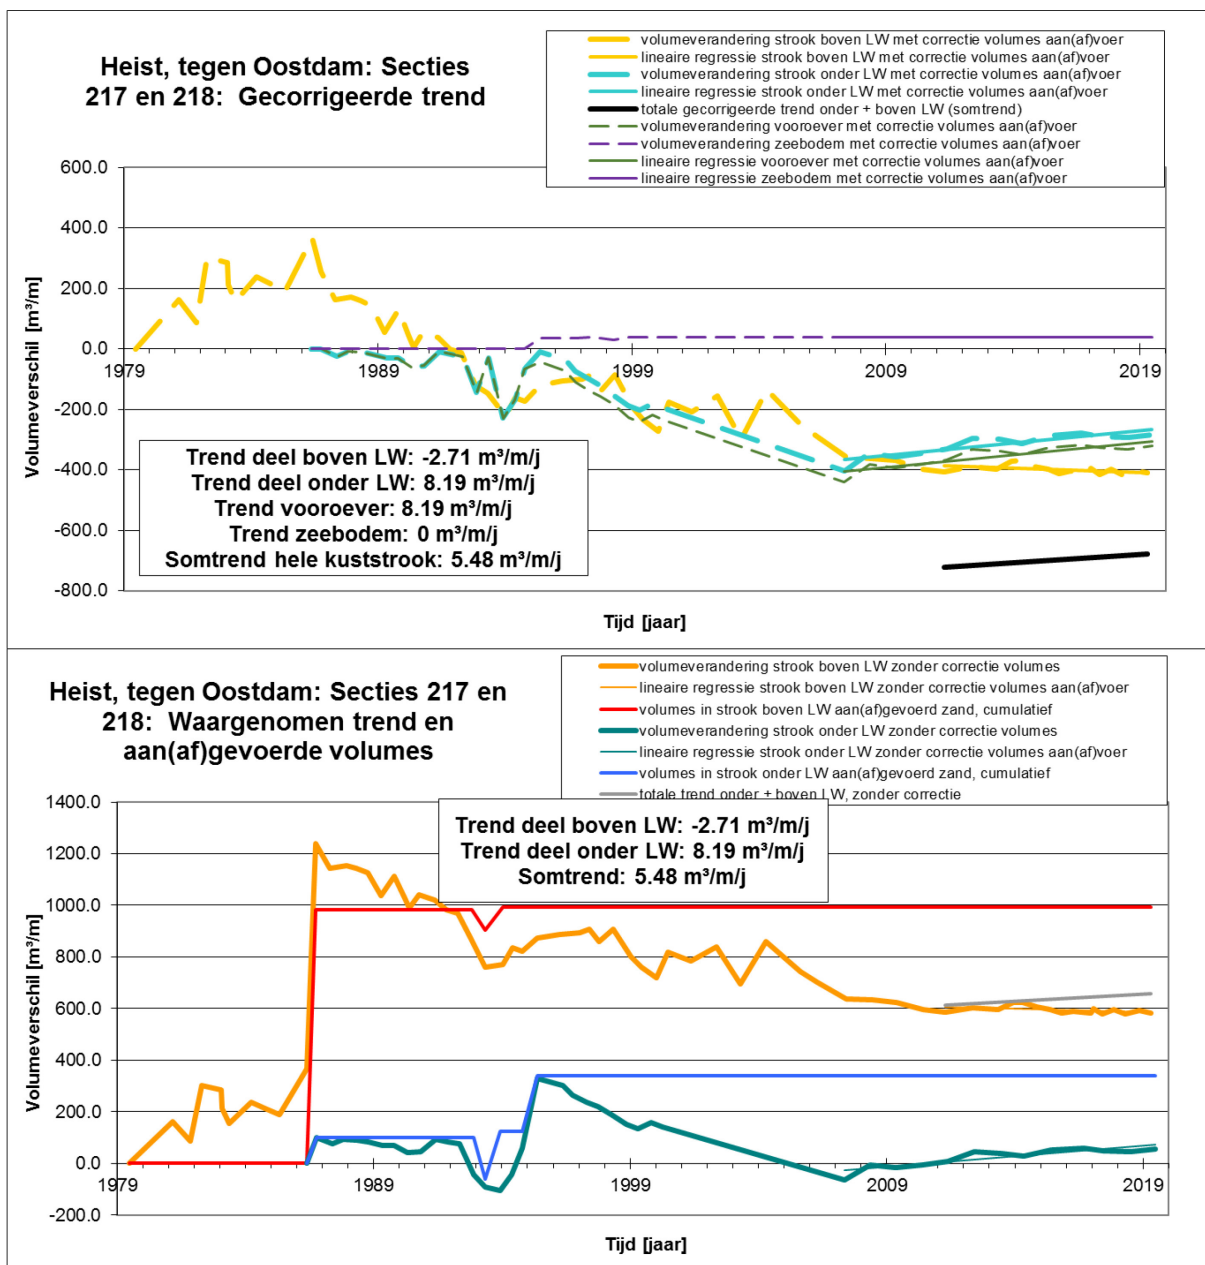
Figure 14 – Morphological trend for stretch 44: Heist – Oostdam.

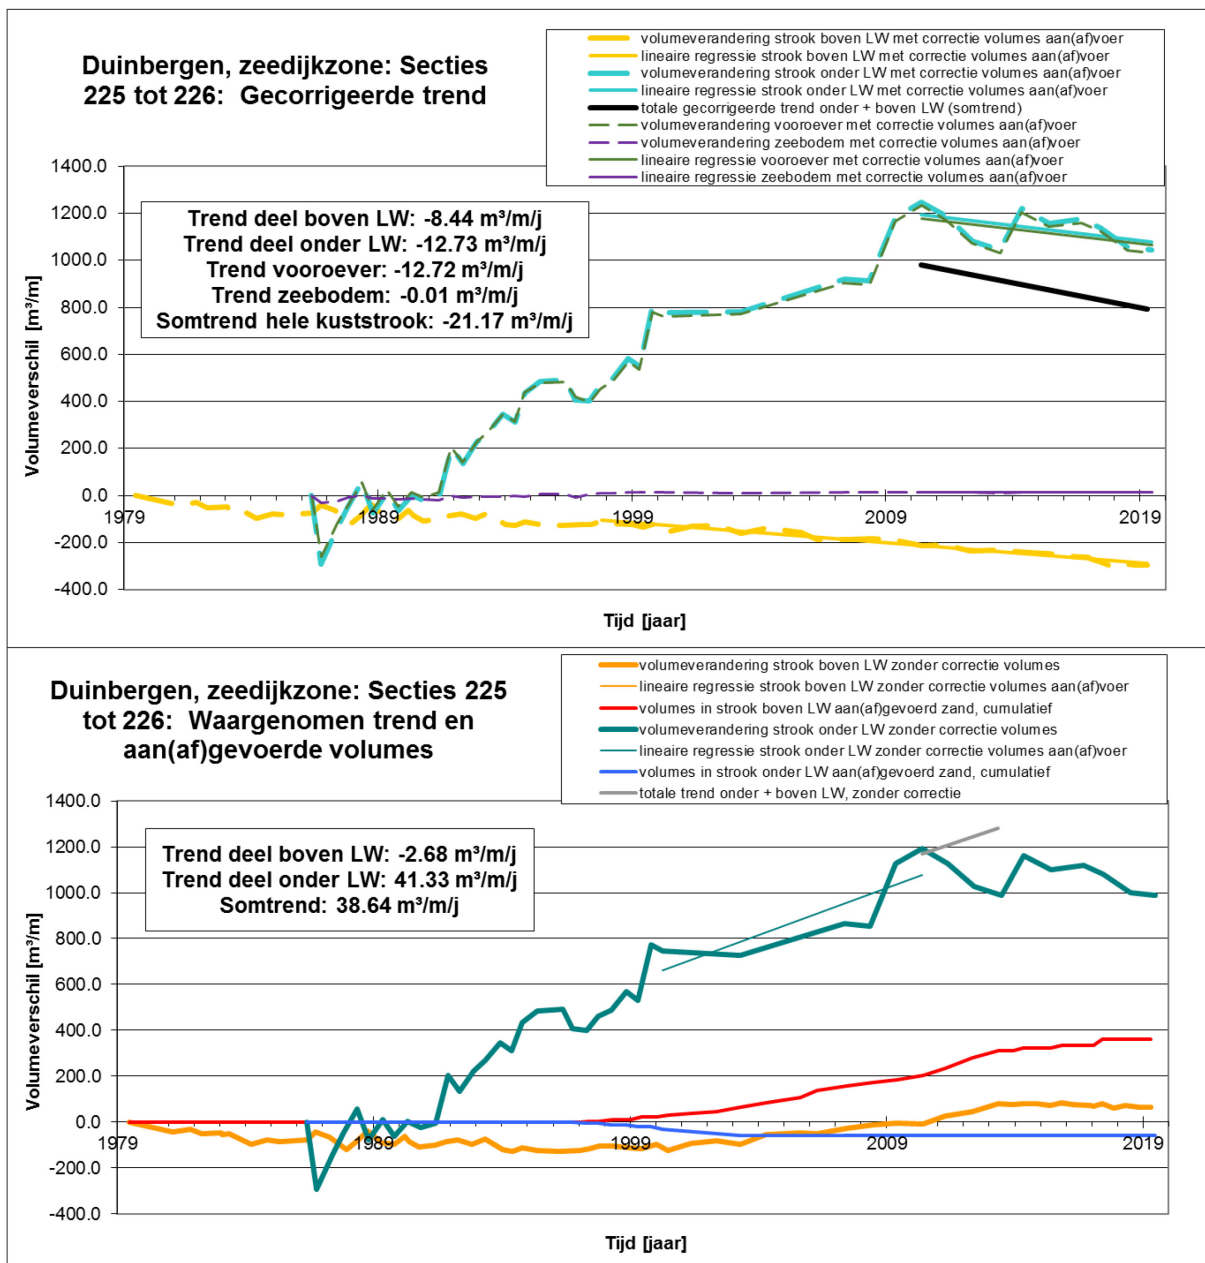
Figure 20 – Morphological trend for stretch 47: Duinbergen-centrum.

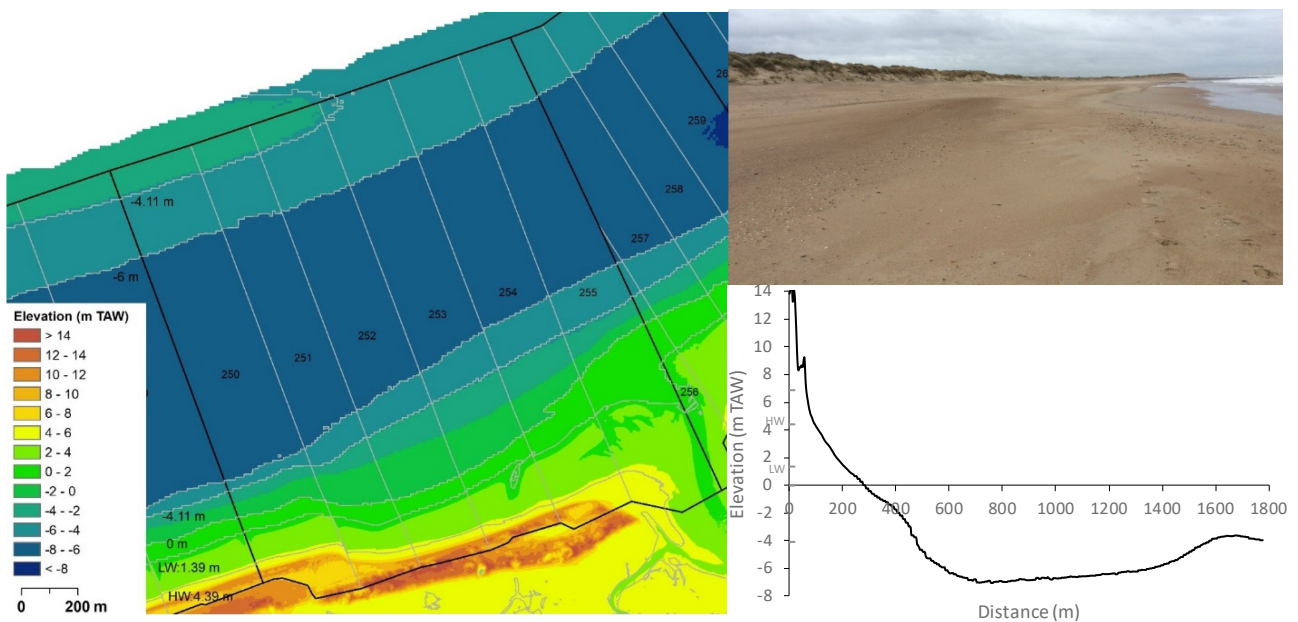
Figure 27 – General characteristics of the coast for stretch 51, Zwin:  
 A) Ground photograph, B) Profile, C) Elevation model in 2019.

The stretch 51 (section 250-255) of 1590 m in length is located at the Zwin. The beach ranges from 200 to 410 m, backed by foredunes (Figure 27). Intertidal bars are present at some locations. Section 255 is characterized by the mouth of Zwin associated with a channel, small meanders, bars and sand spits. A general sand loss of nearly  $-7.72 \text{ m}^3/\text{m}/\text{y}$  occurs in this stretch where no artificial supplies are carried out (Figure 29). The emerged beach has been subject to a temporal variability of negative or positive morphological changes over time. Accretion dominated between 1979 and 1987 due to the influence of the large supplementation of 1977-1979 in Knokke-Heist, which was followed by rapid erosion there. It was reported that the silting up of the Zwin saltmarshes accelerated during this period. The following years were characterized by sand gain and loss mainly due to human interventions. After a major dune erosion caused by the storms in 1993-1995, a sand nourishment was carried out on the upper part of the emerged beach in sections 252 and 253. After the large expansion of the Zwin inlet between 2016 and 2019, more intense morphodynamics and increased sediment movement occurred. In particular, significant morphological changes occurred in the channel at the inlet entrance which becomes nearly 0.5 m deeper and wider up to 18 m (Figure 28, Montreuil et al., 2020b). Also, the channel becomes wider and migrates toward east. However, the west side of the inland inlet is accreting with the development of sand banks. On the beach, the sand spit at the Belgian side located above 4 m TAW is a formed and dynamic bedform for which the development depends mainly on the longshore sediment transport. It probably benefits from the nourishments in Knokke-Zoute. The submerged beach, positive and negative morphological changes have alternated over time. Therefore, no clear long-term evolutionary trend can be drawn there, although erosion has dominated with a rate of  $-15 \text{ m}^3/\text{m}/\text{y}$  after 2010. The behavior and evolution of the shoreface vary spatially. The growth and spatial development of the shoreface were observed for the period of 1998 and 2010, and in 2012-2013. The source of supply was likely from the beach between the Zwin channel and the Uitwateringskanaal (Netherlands). Also, the sand supplied frequently at Cadzand beach around the low water might have been transported by the longshore drift toward west and then deposited to the shoreface of this stretch (i.e. local influence on the direction of sediment transport due to the shift of the coastline orientation near Cadzand). In general, the regional evolution of the shoreface-seabed with the Appelzak channel and Paardenmarkt sand bank influences the morphodynamics of stretch 51.

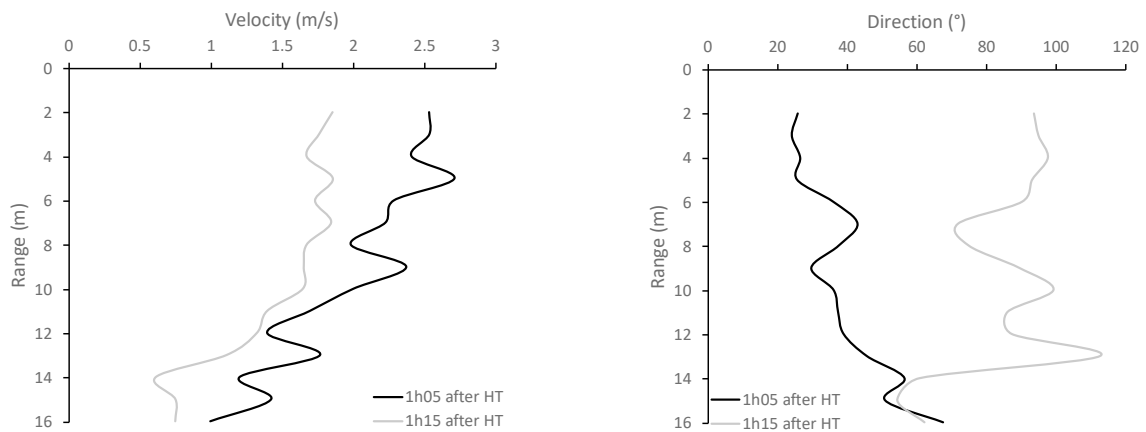
Location A: depth -6 m TAW

Location B: -6.5 m TAW

Location C: -6.5 m TAW

Figure 44 – Comparison of current velocity and direction (0° (North), 90° (East), 180° (South), 270° (West) measurements at two period intervals along a cross-shore transect at 3 locations (bottom panels) and location (top panel).

The current velocity and direction measurements are compared at two period intervals at the same location along a cross-shore transect (Figure 44). The boat speed was consistent, ranging from 3.38 to 5.62 knot. The marine conditions during the measurements are presented in Appendix E.2. A spatial and temporal variability of the current velocity and direction is clearly observed as well as through the water column (Figure 44). To further investigate these, more repeated records should be measured at the same location over time under the same navigation speed. It was suggested to measure the same point every 40 min, this appears to be coherent and realistic, but the length of the measured track has to be smaller.
