21\_014\_2  
FH reports

# Ostend-Middelkerke, Monitoring of the dune for dike pilots

Evolution after 2 years

Montreuil, A-L.; Dan, S.; Verwaest, T.

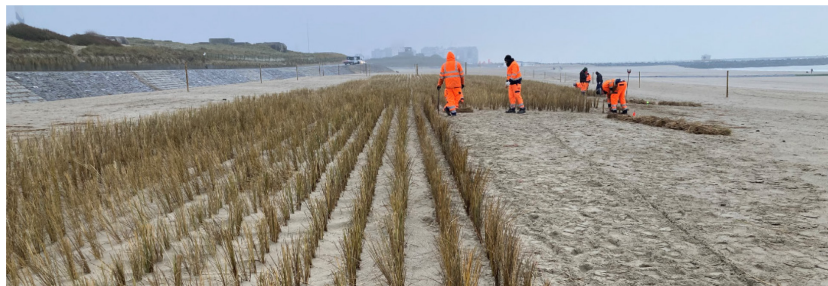
Figure 1 - A) orthophoto, B) digital elevation model in T0 (11/01/2021), C) ground photograph at Spinoladijk

A small zone of marram of 120 m long was planted on the dry beach in section 120 (near Fort Napoleon in Ostend) in January-February 2021. The marram planting was performed in 6 plots of 20 m x 20 m in the center of the section and at a distance of 20-25 m from the dike (Figure 1). For protection, the zone was demarcated by wire fences to prevent entry which might cause the deterioration of the vegetation. The density of the marram plantation is different in each plot. For more description of the setting, refer to Verwaest et al., 2022. The implemented interventions are intended to promote dune formation and ecology. In addition, the planted zone is a pilot site for dune construction on the dry beach in front of a sea dike. When the dunes were constructed for the dike pilot, the dry beach in this section was 50 to 60 m wide (measured from the + 6 m TAW line to the sea dike). The elevation of the planted zone with an elevation ranging from 6.5 to 8 m TAW (Figure 1).

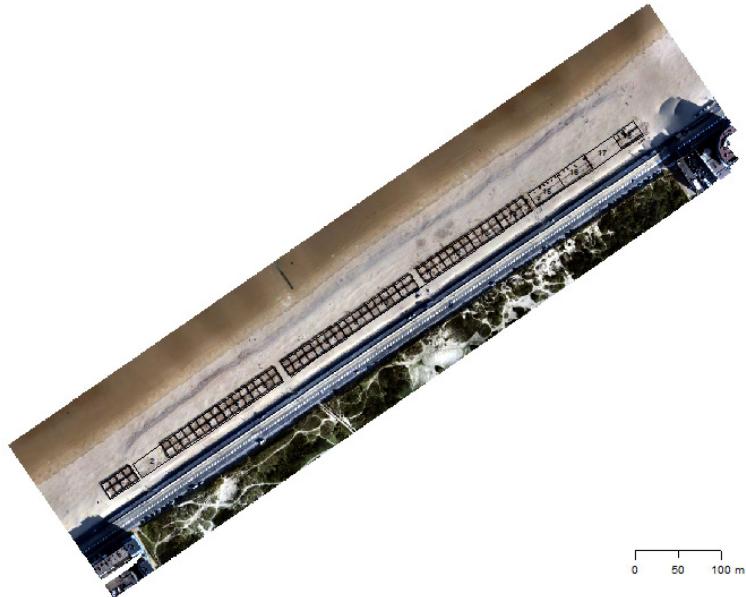
Figure 2 - A) Orthophoto, B) digital elevation model on TO (31/03/2021) at Raversijde

The pilot site at Raversijde is about 750 m long and is located in sections from 100 to 102. Brushwood fences were placed on the dry beach (from 10/03/2021 to 02/04/2021) and, similar to Spinoladijk area, marram grass was planted with different densities (from 15/03/2021 to 02/04/2021) after a beach nourishment and beach reshaping in early 2021 (Figure 2). For further description of the setting of brushwood and vegetation planting as well as the nourishment refer to Verwaest et al. (2022). The main aim of this intervention is to limit nuisance caused by aeolian sand on the coastal road/tram line/sea dike. In addition, it is a pilot for dune construction on the dry beach in front of a sea dike.

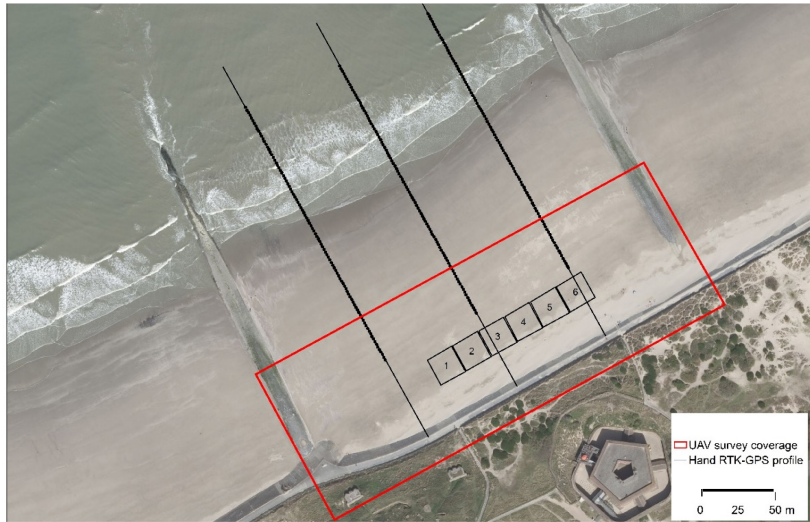
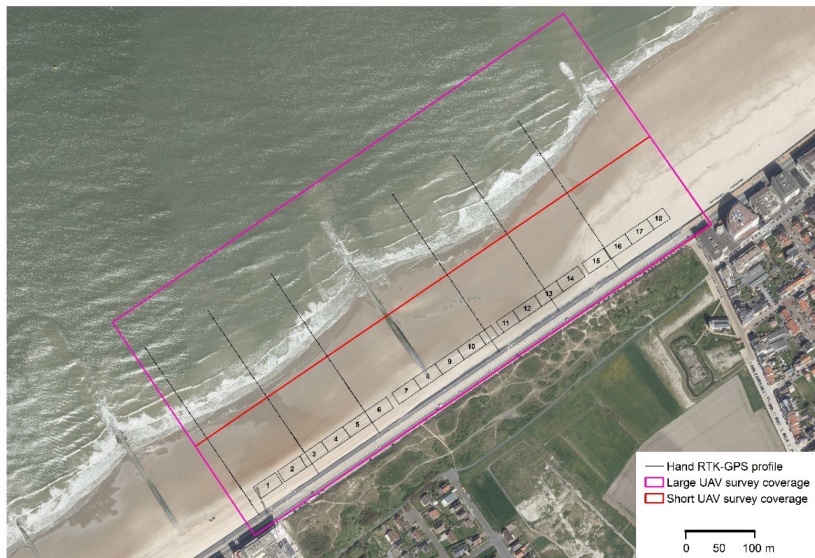
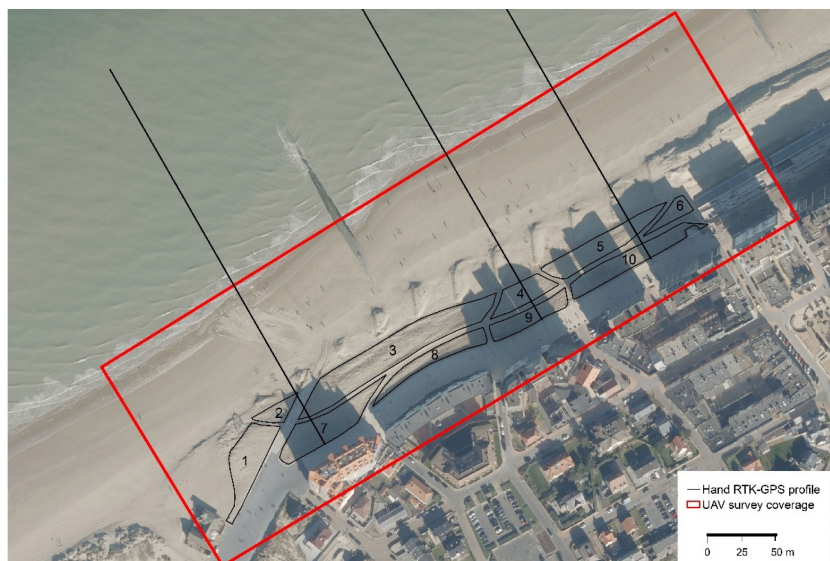
Figure 4 - Pilot sites with location of the profiles: A) Spinoladijk, B) Raversijde and C) Westende

In addition to aerial measurements, field topographic measurements with RTK-GPS were carried out along 3 profiles at Spinoladijk and Westende as well as 6 profiles at Raversijde (Figure 4). Generally, the survey profiles extended from the seaward side of the vegetated boxes to the low water line (Table 1 and Figure 3). Each profile extends from the seaward vegetation boxes to the low water line over a length of ca. 250 m. The distance from the first RTK-GPS survey points (i.e. the most inland measurement) to the dike is approximately 40 m. The interval between profiles is from 110 to 215 m. Since the measurements are not always located along a straight line, they have been re-projected on planned profiles in ArcGIS using the linear reference tool. Then, they were interpolated at a distance of 1 m. This allows easier comparison of the profiles over time. Finally, the upper-beach was extracted along the profiles from the UAV survey and then it was merged with the reprojected RTK-GPS profiles in order to cover the entire beach.

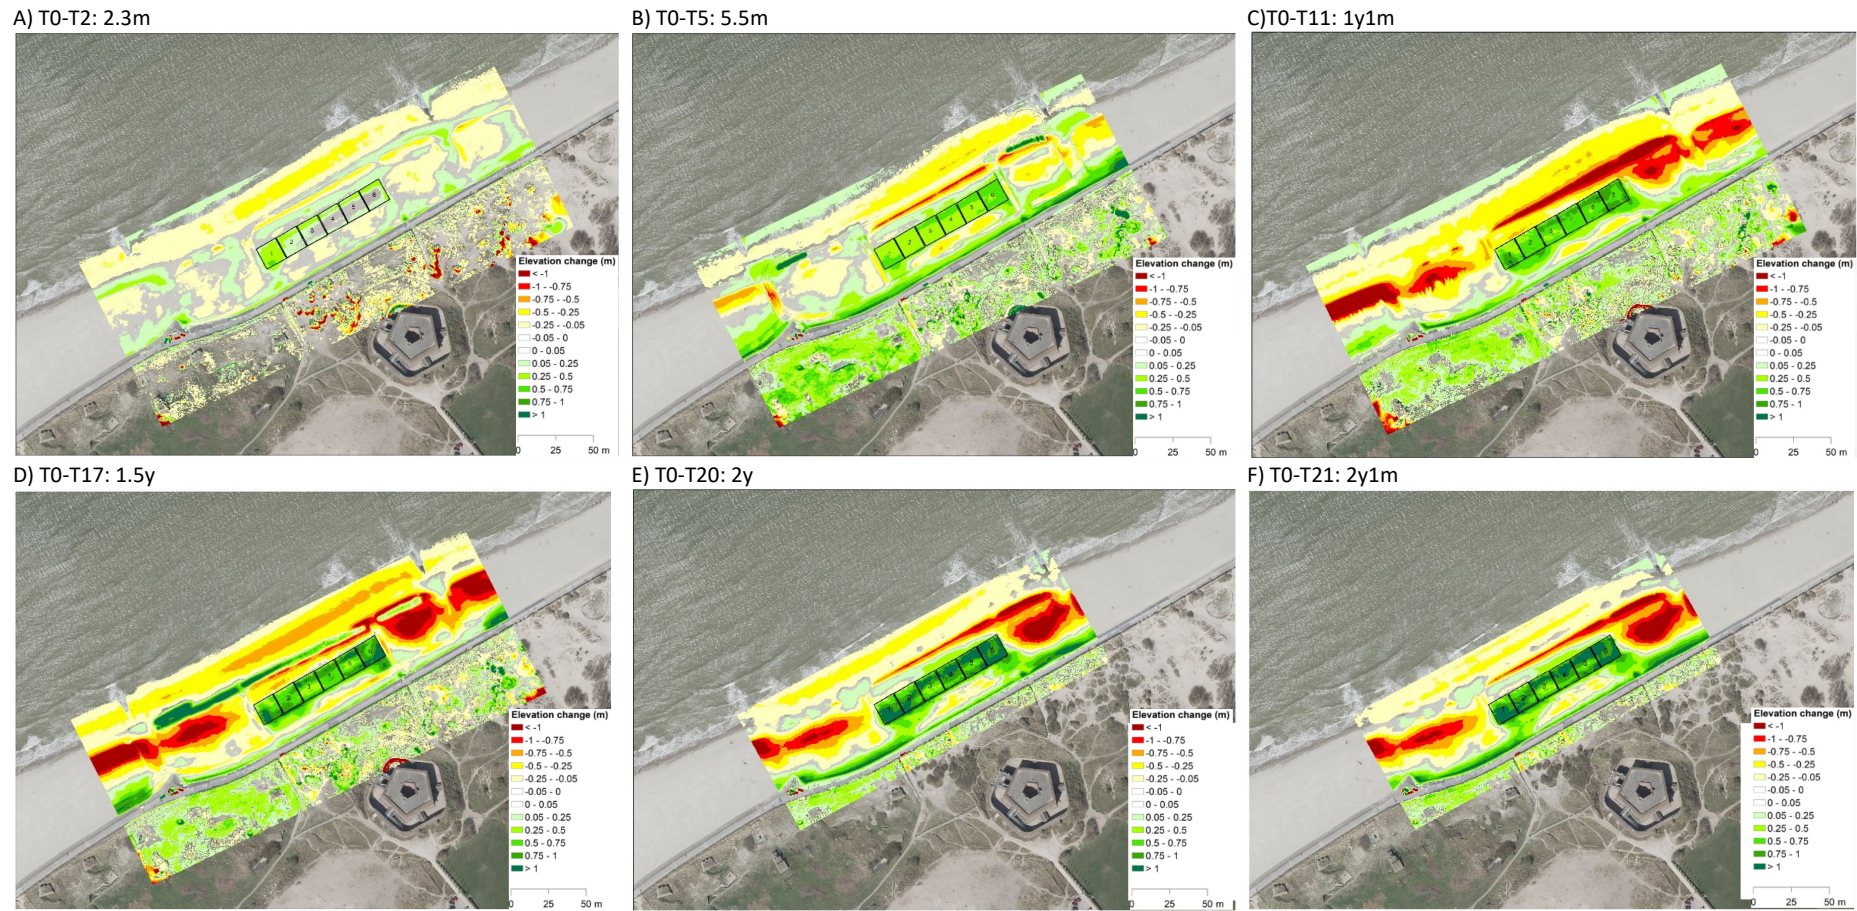
Figure 6 - Global evolution based on Ref DoDs of the UAV surveys at Spinoladijk

Figure 6 presents the morphological evolution of the entire beach DoDs from months to years. Refer to Figure 1B for the elevation across the beach. DoD clearly indicates the gradual accretion in the vegetated boxes between Box 1 and 6 from 2.3 month to 2.08 year. The boxes have gained sand material nearly up to 2 m high till the last survey (Figure 6F). The upper part of the dry beach located landward of the boxes shows a large sand accumulation up to 1 m high along the dike, which contrast with negative morphological changes on the beach located just east and west of the vegetated boxes. These are likely due to the surroundings of the excavation works were carried out several times by the city of Ostend in this zone as part of the policy to reduce the nuisance caused by sand transport over the dike (i.e. observation of the truck tires tracks on the UAV orthophotos). The lower part of the dry beach and seaward of the boxes and below 5 m TAW indicates erosion up to 0.4 m, but here too it should be mentioned that there were interferences from the activities of the city of Ostend. Noteworthy, there is a line of morphological stability where the changes was below +/- 0.05 m at 7.5 to 7.7 m TAW and also at 6 and 5 m TAW delimiting the different spatial morphological trend across the beach.

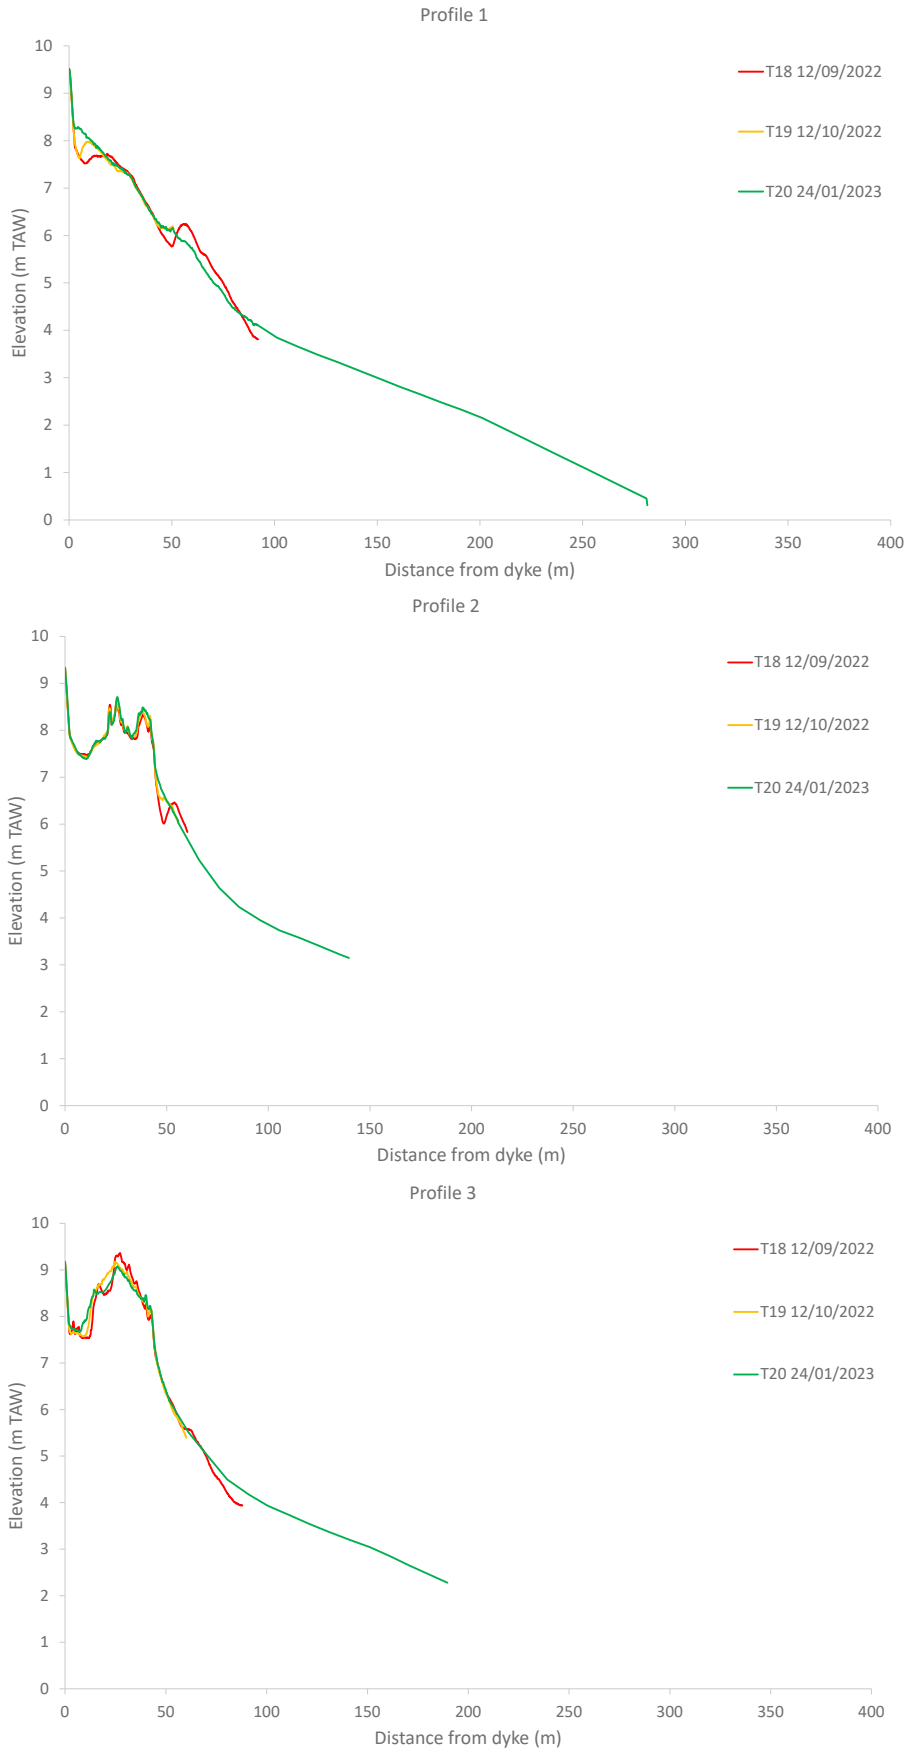
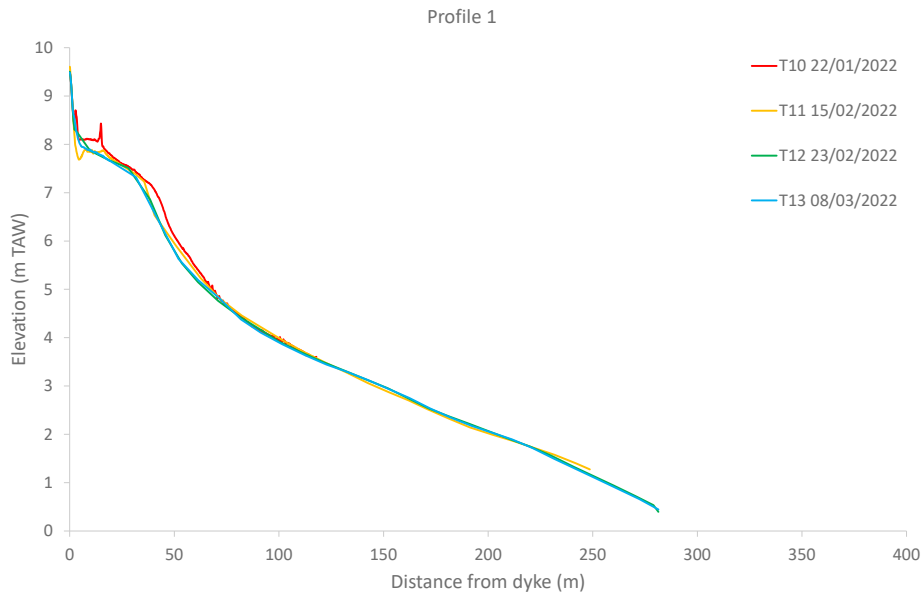
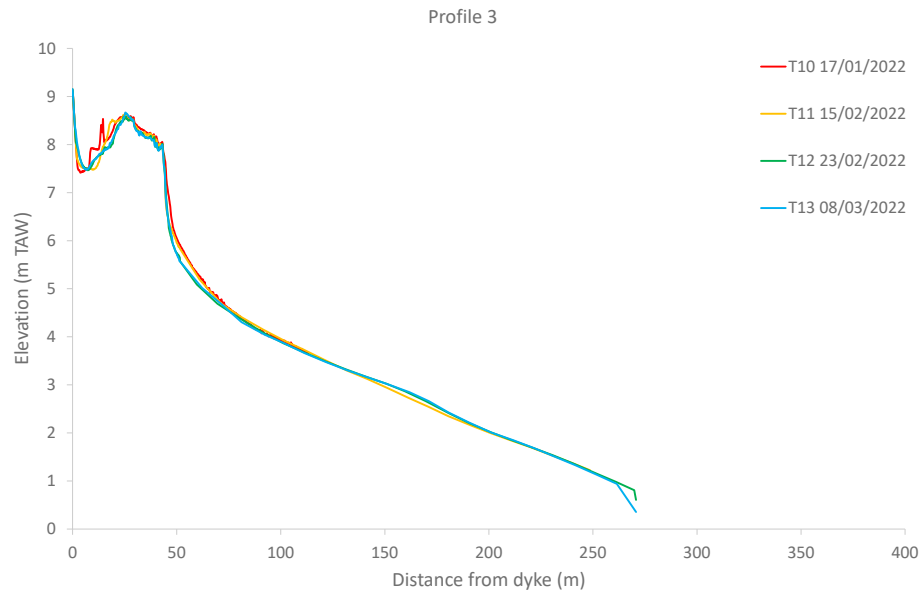
Figure 11 - Time series of the pre-, post and recovery period of the merged profiles of the UAV and RTK-GPS surveys.

Time series of the pre-, post and recovery period of the merged profiles of the UAV and RTK-GPS surveys are presented in Figure 11. Generally, the dry beach slope was eroded during 01-02/2022 while it was relatively stable during 09/2022 storm. As previously observed in the DoDs, the consecutive 01-02/2022 storm events impacted at a higher magnitude the beach than the energetic event in 09/2022.

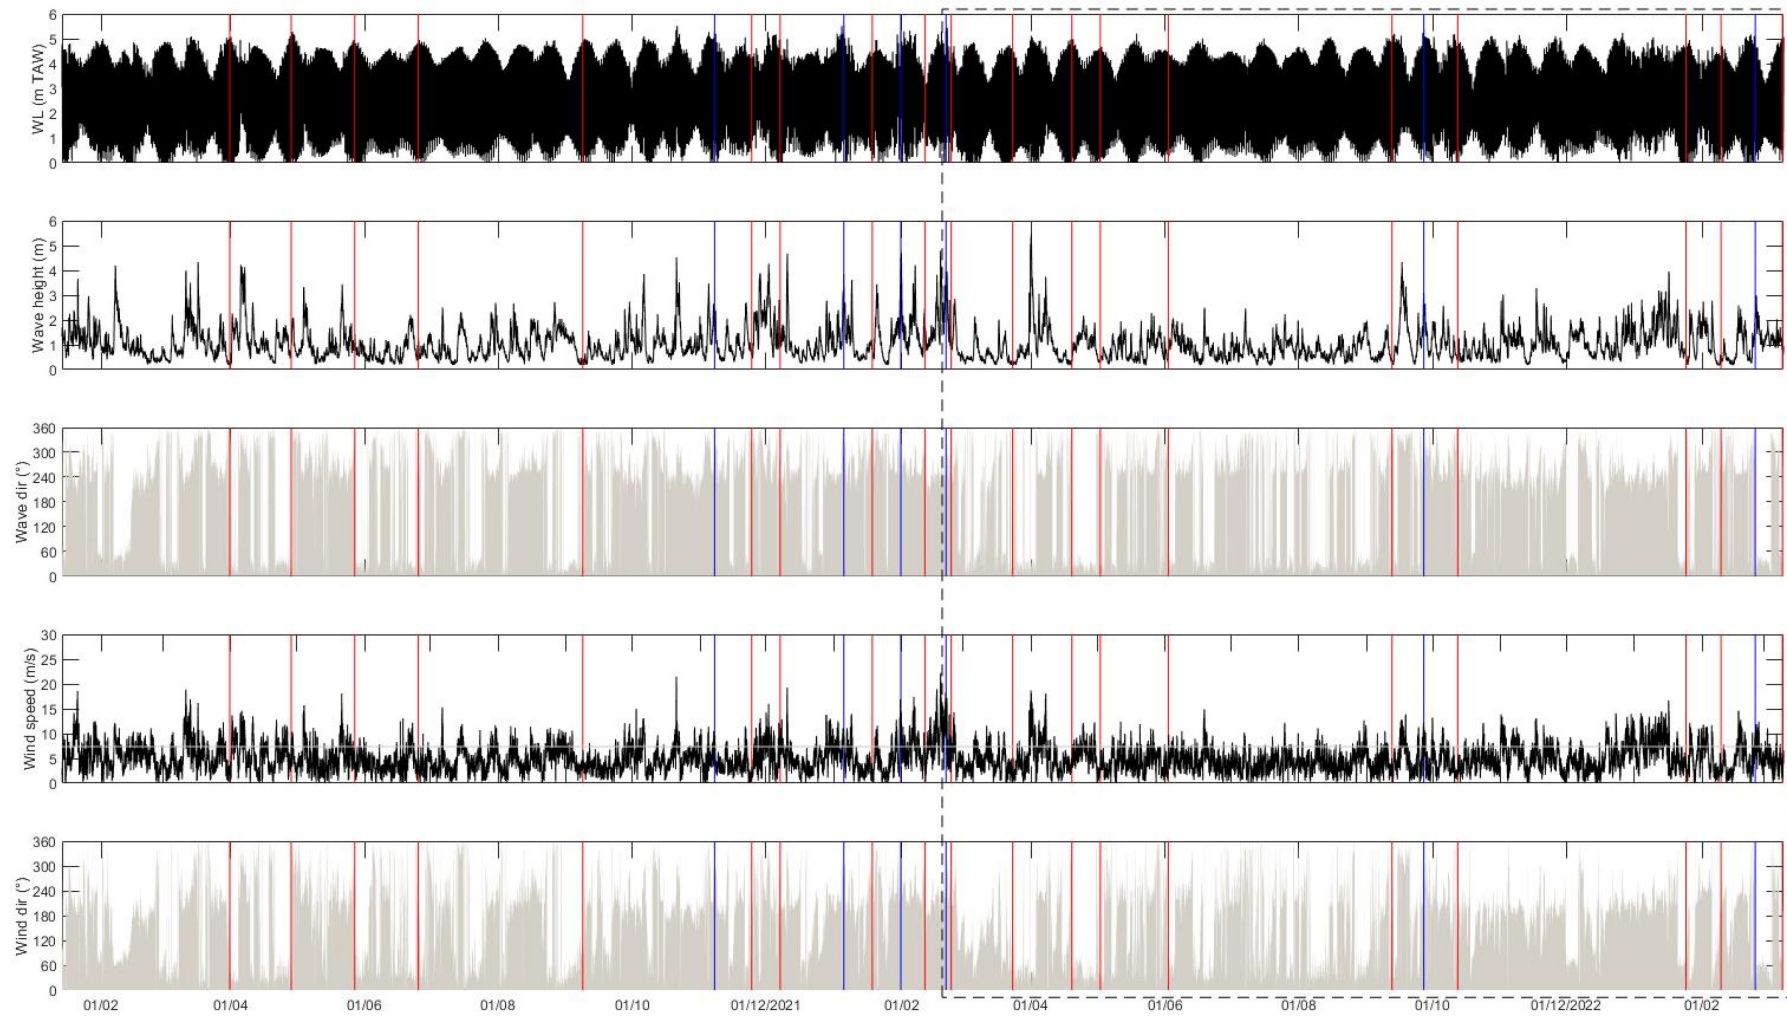
Figure 13 - Time series of the water level in Ostend, wave height 10% and wave direction in Ostend “Poortjes” (buoy located 7 km from the coast), wind speed and direction of weather station Zeebrugge (Meetnet Vlaamse Banken). Vertical red and blue lines correspond to the drone surveys and energetic events respectively. Horizontal grey line on the wind speed time series is the critical wind speed for aeolian sand transport (7 m/s). The dashed box corresponds to the 2<sup>nd</sup> year monitoring.

Figure 13 shows time series of water level in Ostend, wave height 10% and wave direction in 'Oostende Poortjes' (located 7 km from the coast), wind speed and direction of the weather station in Zeebrugge.

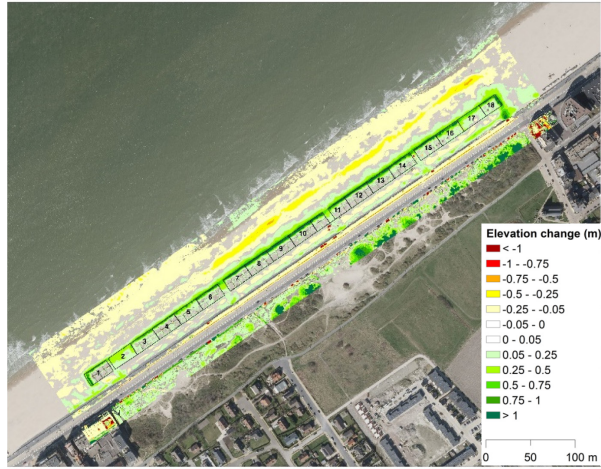
Figure 14 - Global evolution based on Ref DoDs of the UAV surveys

The DoDs indicate a progressive evolution of the pilot site (Figure 14). Refer to Figure 2B for the elevation across the beach. The net accumulation in the vegetated boxes and in their landward side clearly contrasts with erosion in the seaward side. Sand accreted in the vegetated boxes from 1.5 m to 1.2 m for the period between T0 -T10 and T10-T18 (Figure 15). It seems that the highest sand gain over the 2<sup>nd</sup> monitoring period occurred at the landward edge of the vegetated boxes while it was more in the seaward and center in the 1<sup>st</sup> period. The passages between boxes and especially Box 1 located southwest were more filled up in T0-T10 than in T10-T18. Another difference is that a significant erosion clearly dominated the beach at an elevation below 7.2 m TAW while it was much lower for the second period. Noteworthy, the extend of the UAV survey for T10-T18 makes possible to observe the accretion of the lower part of the beach between 3 to 0.5 m TAW. A stability boundary at 7.5 m TAW (i.e. morphological change below +/-0.05 m) just located in front of the vegetated boxes divides the upper and lower part of the beach profile.

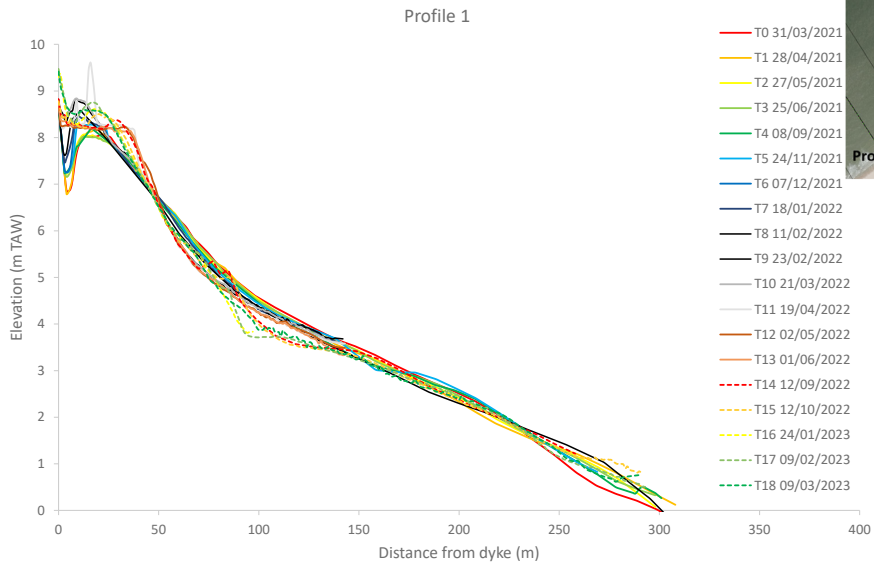
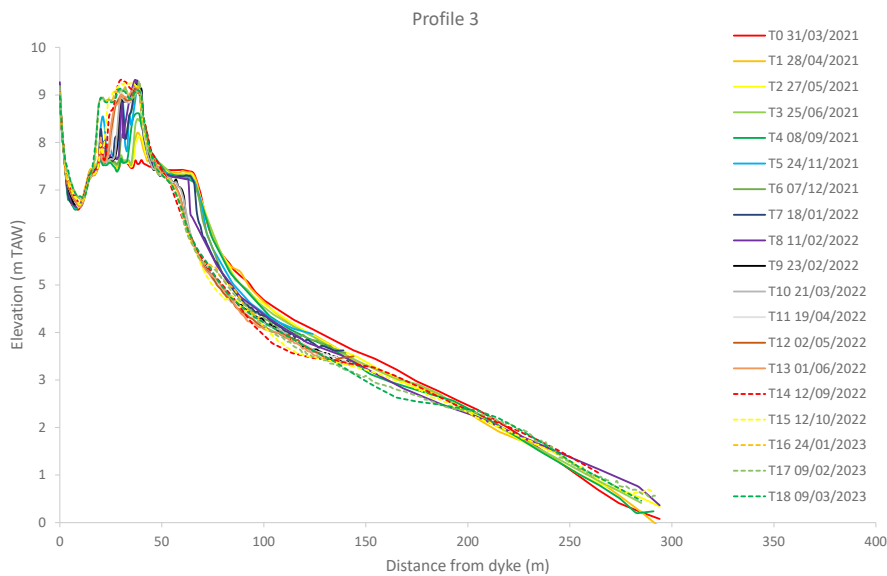
Figure 16 - Time series of all the merged profiles of the UAV and RTK-GPS surveys.

All the 6 merged profiles of the UAV and RTK-GPS surveys are presented in Figure 16. Profile 1 is located southwest of the pilot area, and Profiles 2 to 6 cross the vegetated boxes and extent to the low-water mark. Generally, the evolution of the profiles clearly indicate that the upper-dry beach where are the vegetated boxes gained a large quantity of sand up to 2 m high compared to T0 (Figure 17). This was lower for Profile 1 where no vegetated box was present. Thus, Profile 1 was relatively more stable across the dry beach than in the other profiles. This can probably be linked to the plateau that was created during the construction of the pilot, which is not present at Profile 1. The absence of brushwood fences in this area might have prevented sand capture but instead it was blown towards the hinterland. In addition, the slope of the upper-beach for the three measured profiles retreated landward with an average of 13 m over the time. Nevertheless, it seems that its steepness did not change. Erosion dominated the dry beach located seaward of the vegetated boxes and also partly in the intertidal zone. However, accretion occurred in the lowest part of the intertidal zone at a distance of > 200 m as observed by the green band located the most seaward (Figure 15B). This can be explained by the deposited sand that was eroded in the higher part of the profile during stormy conditions.

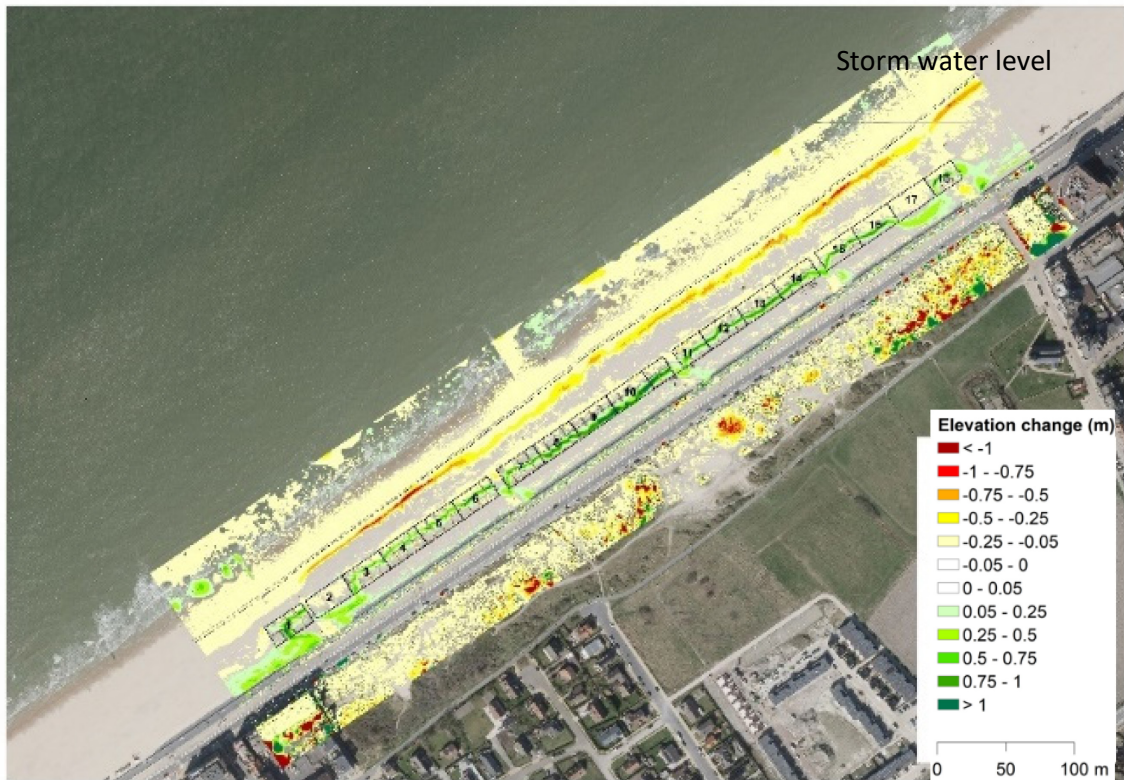
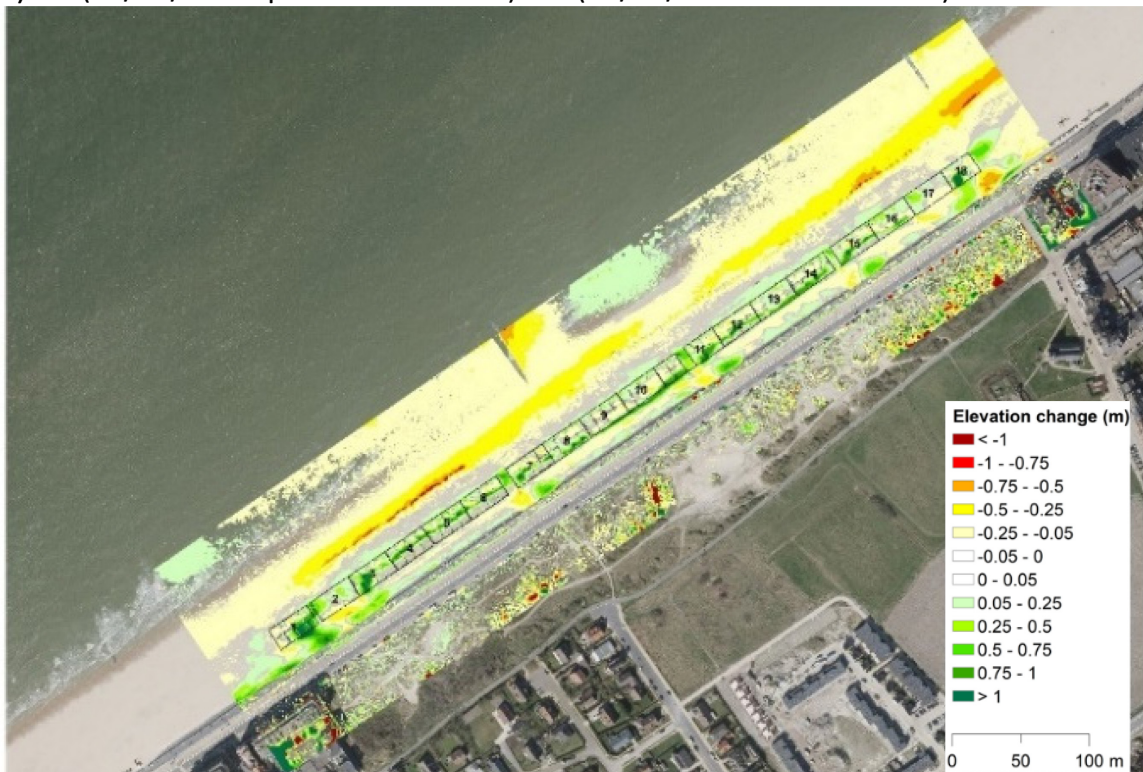
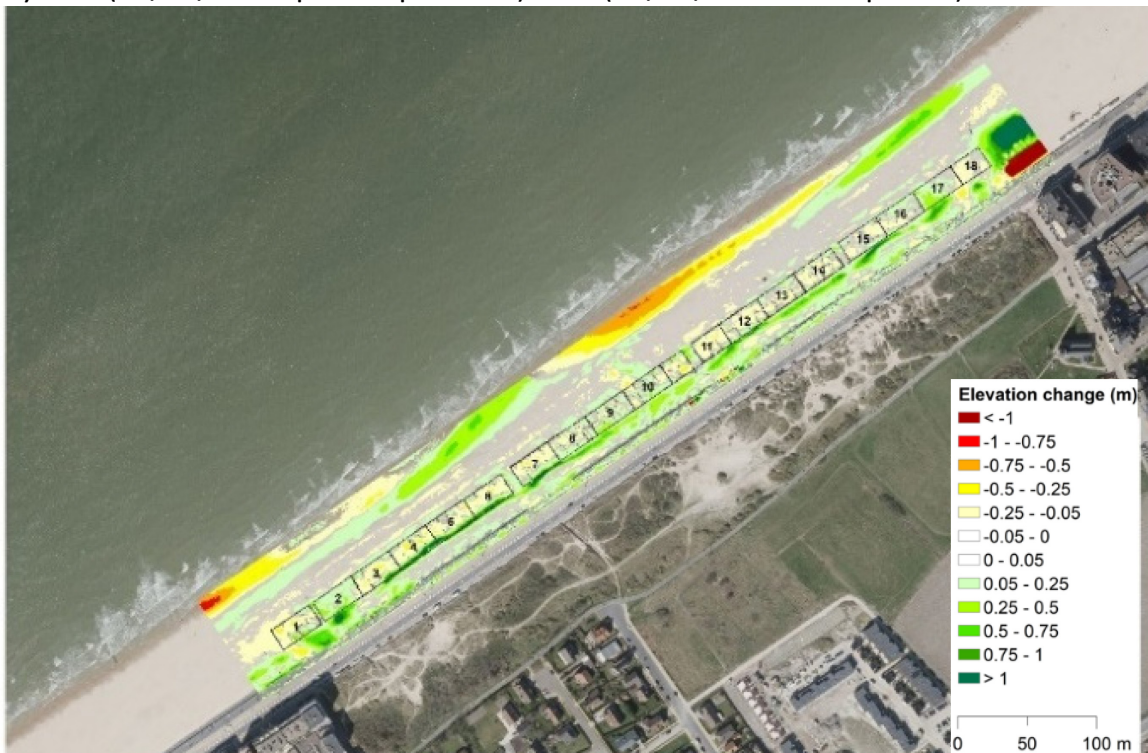
Figure 18 - DoD of pre and post-energetic events and calm period: T7-T8 (06/01/2022-11/02/2022); T8-T9 (11/02/2022-23/02/2022); T14-T15 (12/09/2022-12/10/2022); T15-T16 (12/10/2022-24/01/2023).

The dashed lines correspond to the water level reached during the energetic events.

DoDs of the pre, post and recovery period of the storm events in 01-02/2022 and 09/2022 are displayed in Figure 18. Corrie and Franklin storm reached a maximum water level of 5.73 m and 5.57 m TAW respectively in the period 01-02/2022. Cliffs were formed with a top at about 6.4 m TAW and they were located 25 to 35 m seaward from the vegetated boxes (T7-T8). The effect of these consecutive storms is also illustrated in some profiles with the retreat of the seaward slope, while the beach below 5 m TAW was stable (Figure 19). Erosion of the beach slope was amplified by Franklin storm. For the recovery period (T8-T9), sand was only gained in the vegetated boxes while the beach still suffered from erosion. The energetic event of lower magnitude in 09/2022 attained a maximum water level of 5.36 m TAW. Erosion ranging from -0.2 to -0.6 m dominated the beach below the maximum water level, while positive morphological change as well as stability was observed above it. The area seaward of the vegetated boxes experienced erosion contrasting with the sand accumulation on their landward side. Generally, the profiles indicate a sand loss along the landward beach slope caused by the energetic events. A stability of the beach between the vegetated boxes and the elevation of 5.4 m TAW occurred during the calm period (T15-T16 of 3.4 months). However, the lower part of the beach spatially alternated with positive and negative morphological changes. As observed in the DoD, the beach profiles confirm that the upper-part of the dry beach located landward of the vegetated box was not affected by the storm events. In contrast, erosion took place along the beach slope at their seaward side and in particular during the consecutive storm events in 01-02/2022.

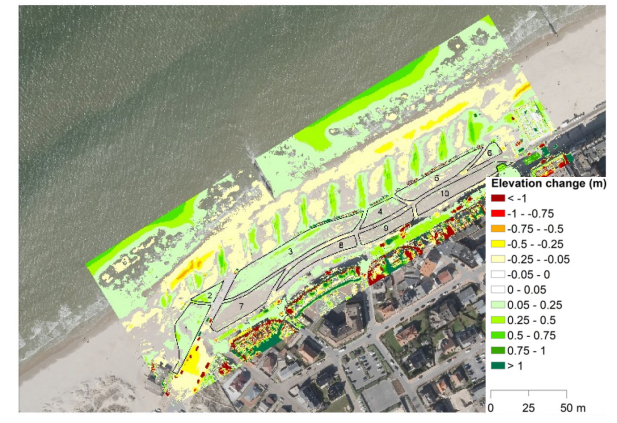
Figure 22 - Global evolution based on DoDs of the UAV and LiDAR surveys at Westende

Figure 22 presents the DoDs from months to years. Refer to Figure 3B for the elevation across the beach. A clear growth ranging from 0.1 to 0.8 m is noticeable in the seaward vegetated boxes and mainly in the most westerly ones (Box 1, 2, 3) after 1y 10.3months (Figure 22). Additionally, an accretion is noticeable around the fences in front of the vegetated boxes and obliquely orientated whereas a stability occurred in the landward vegetated boxes. Positive morphological change of the higher part of the dry beach is accompanied by erosion on its lower part. Similar trend is observed between the two monitoring periods (T0-T4 and T4-T7) with a dominance of erosion for the lower part of the beach and relative stability of the landward boxes (Figure 24). In addition, sand accumulation took place in all the seaward vegetated boxes over this period, while it was limited to the westerly boxes in the first period. It is probably related to the wind regimes between monitoring surveys, as reported in Verwaest et al. (2022). The observed high erosion in the eastward of the site is due to the work of the new seawall.

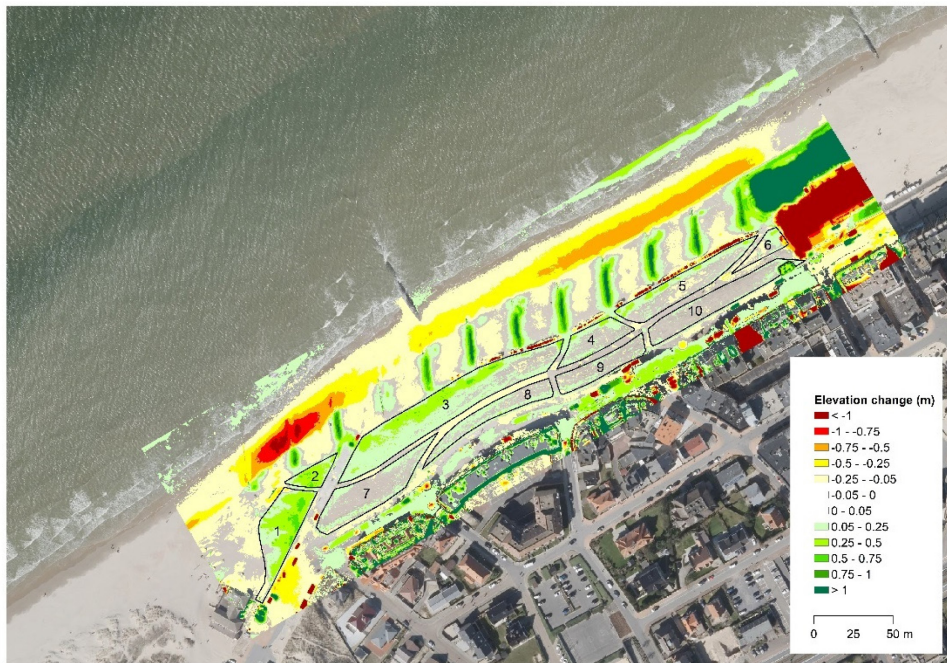
Figure 23 - Seasonal evolution based on DoDs of the UAV surveys

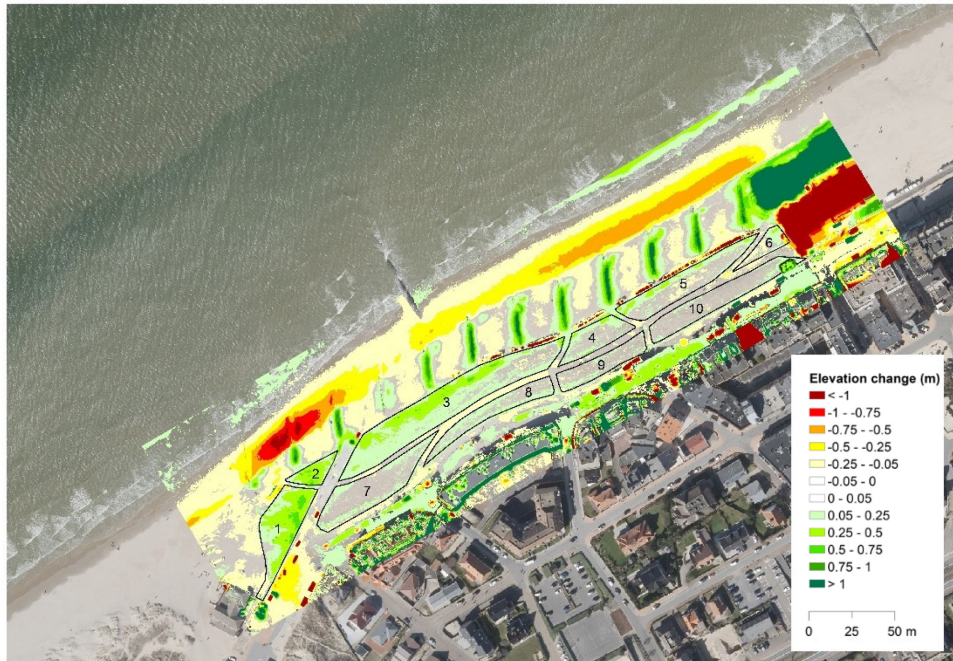
Figure 25 - Location of the contours of the defined zones at Westende

For the volumetric calculations, the study area is divided into a number of zones based on the large-scale erosion/sedimentation pattern (Figure 25). The volumetric evolution in these zones was calculated using the UAV and LiDAR surveys and the results are given in Table 5. The vegetated zone experienced an average growth of  $0.11 \text{ m}^3/\text{m}^2/\text{y}$  over the first monitoring period (T0-T4) while a stability dominated the second period (T4-T7). It suggests that the marram grass plants were very efficient to capture sand in the first period. The winter sand fences 'zandschermen' located in the zone of the middle part might have reduced the sand capture in the inland zone. Also, another difference between these two monitoring periods occurred for the middle part namely stability in the first period followed by erosion in the second period. This area could be affected by the winter fences and the cabins installed by the city. As previously observed of the DoD, the lower part experienced erosion with a similar order between the 2<sup>nd</sup> year period.
