21\_014\_3  
FH reports

# Monitoring of the dune for dike pilots

Evolution after 3 years

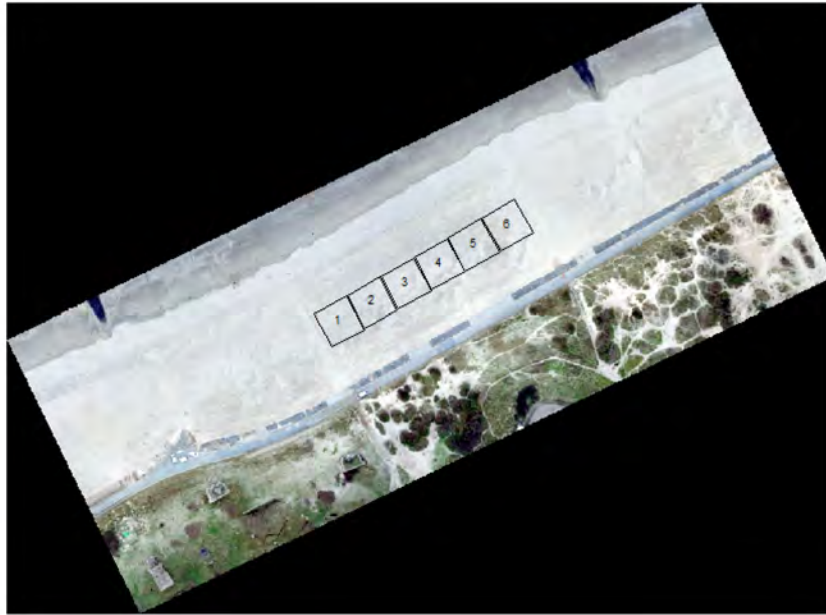
When the dunes were built up at the start of the project, the dry beach in this section was 50 to 60 m wide (measured from the + 6 m TAW line to the sea dike). The elevation of the planted zone ranged then from 6.5 to 8 m TAW (Figure 1).

Figure 1 – A) orthophoto, B) digital elevation model on T0 (11/01/2021).

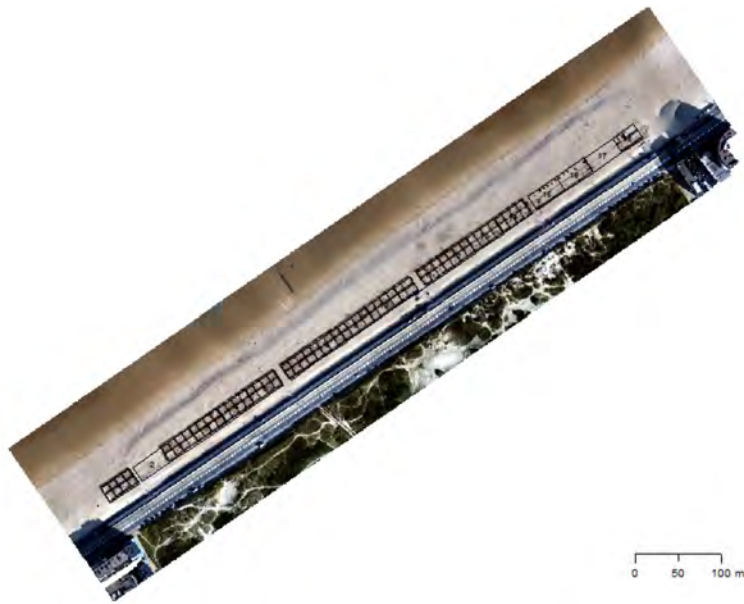
After the construction of the new dune, the width of the dry beach was 65 to 85 m wide (measured from the + 6 m TAW line to the sea dike). For the placement of the brushwood fences and marram grass plants, the beach was artificially profiled with a berm at level +7.5 m TAW. Then, two years later in February 2023, additional marram grass was planted due to the sand burial of the previous plants.

Figure 2 – A) Orthophoto, B) digital elevation model onT0 (31/03/2021) at Raversijde

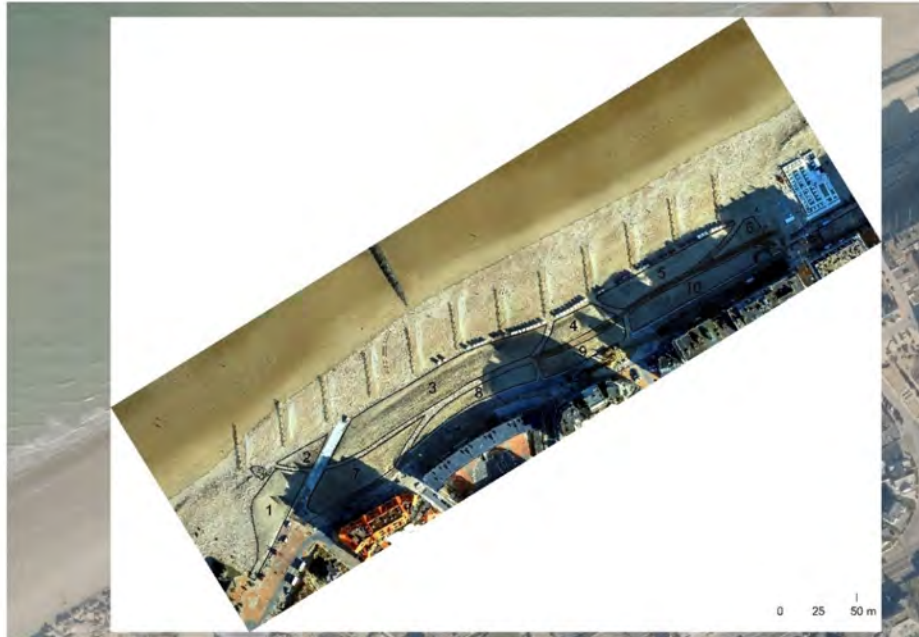
A first phase of a grass dike was planted in Westende (section 74-75) as part of the sea defense project in Middelkerke (Coastal Safety Master Plan) in January-February 2021. The site is 30 m wide and 390 m long (Figure 3) where sand fences and the applied vegetation was marram grass. When this vegetation was planted, the dry beach was approximately 75 m wide (measured from the + 6 m TAW line to the sea dike). The height of the vegetated dune site is approximately equal to the elevation of the sea dike.

Figure 3 – A) digital elevation model B) orthophoto on T0 (30/03/2021) at Westende.

Figure 23 presents the DoDs from months to nearly 3 years since T0 (refer to Figure 3B for the elevation across the beach). A clear growth up to 2.3 m is noticeable in the seaward vegetated boxes and mainly in the most westerly ones (Box 1, 2, 3) after 2y 9.6 months (T0-T9). The same trend was already observed one year earlier (T0-T7). This contrasts with the stability in the landward vegetated boxes (Box7, 8, 9, 10). Erosion on the dry beach east of the vegetated boxes is likely related to some interventions such as the setting of summer cabins and dyke expansion from the municipality of Middelkerke which were observed on the UAV orthophotos. Erosion continues on the dry beach seaward of the vegetated boxes. A narrow stability zone around 7 m TAW segments these two opposite morphological trends.

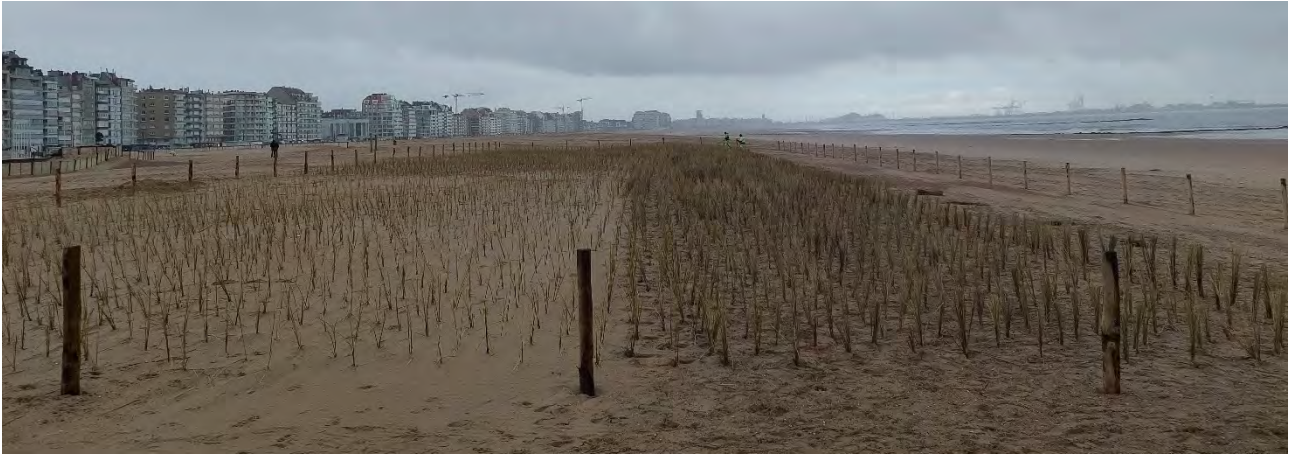
Figure 5 – Ground photograph of the plantation in 12/2023

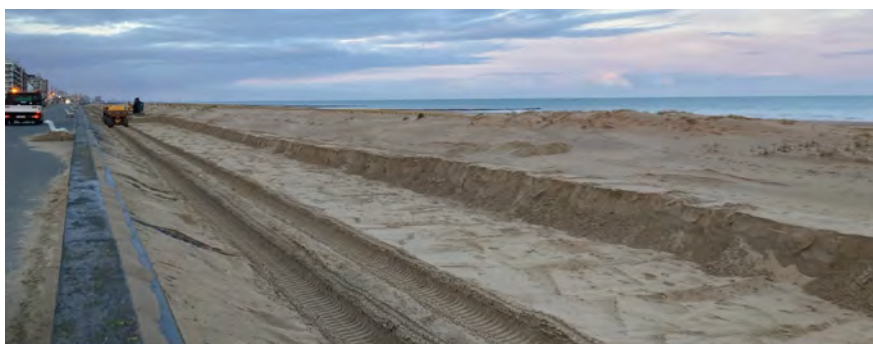
Figure 6 – A) work excavation along the seawall, B) presence of an artificial plateau in Raversijde

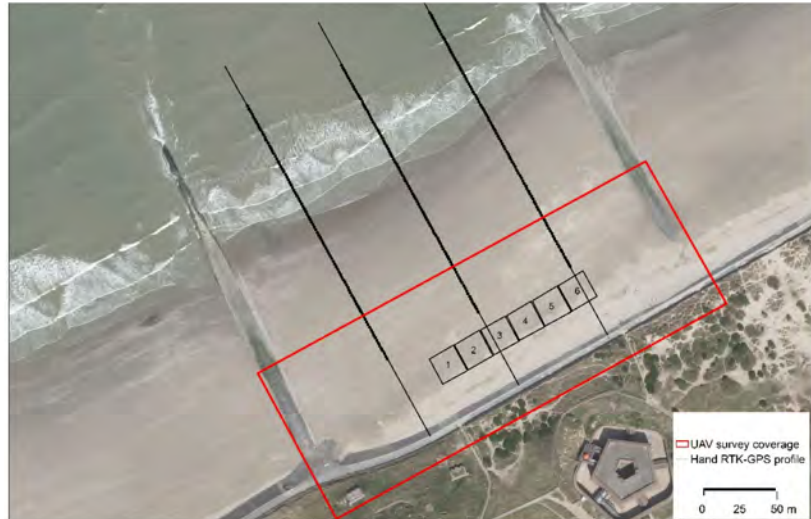
Figure 8 – UAV coverage and profiles location at Spinoladijk

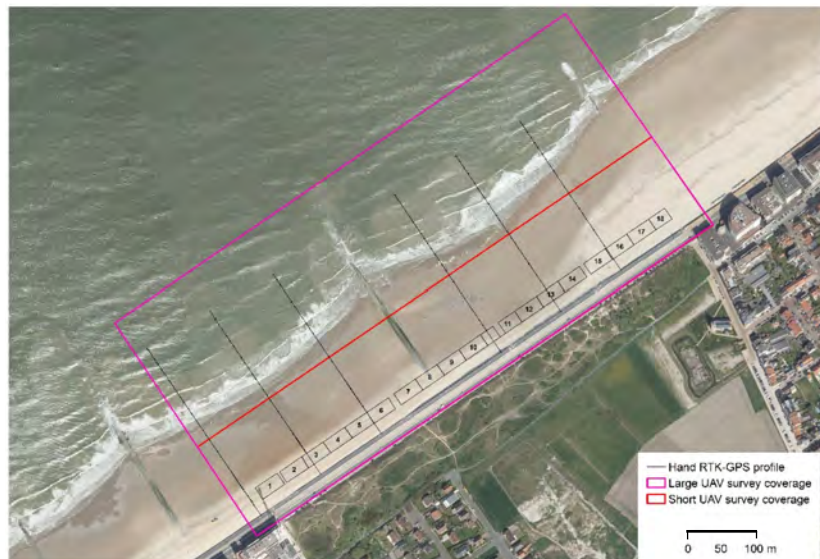
Figure 9 – UAV coverage and profiles location at Raversijde

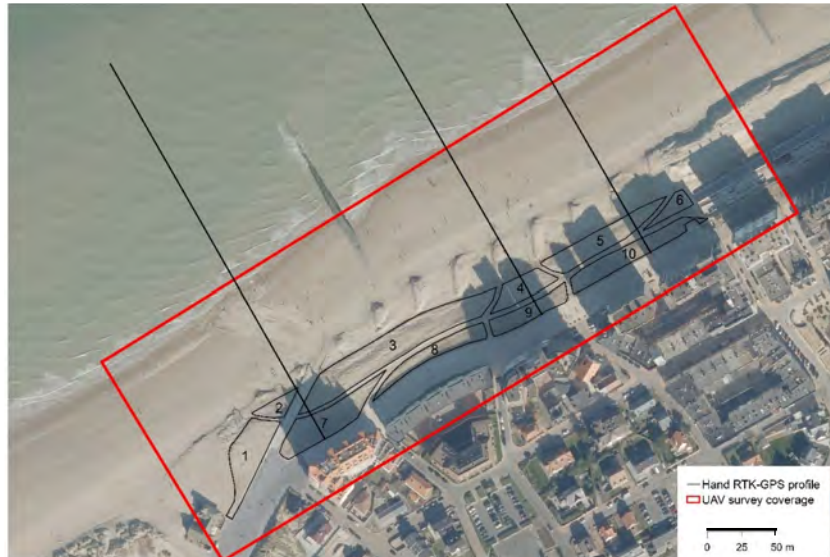
Figure 10 – UAV coverage and profiles location at Westende

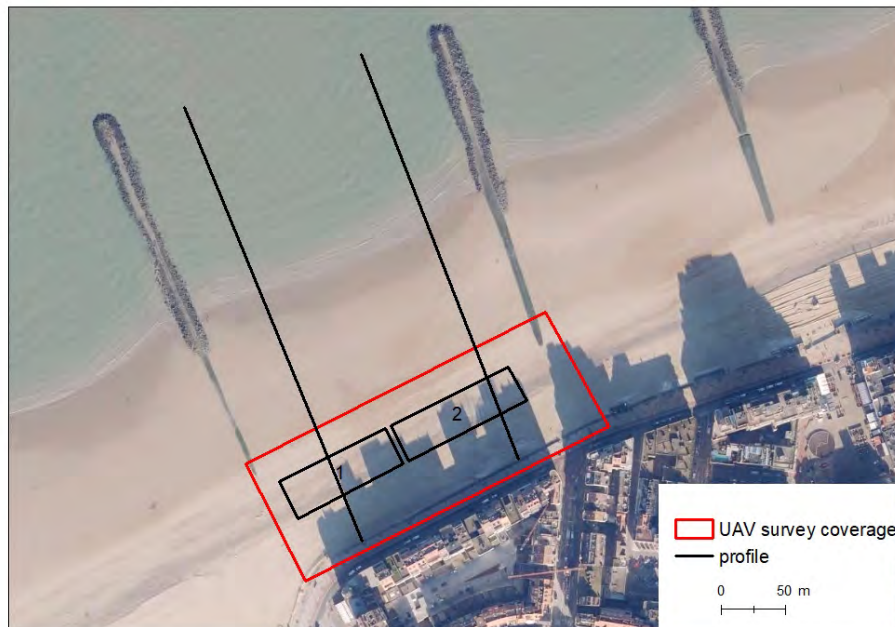
Figure 11 – UAV coverage and profiles location at Knokke

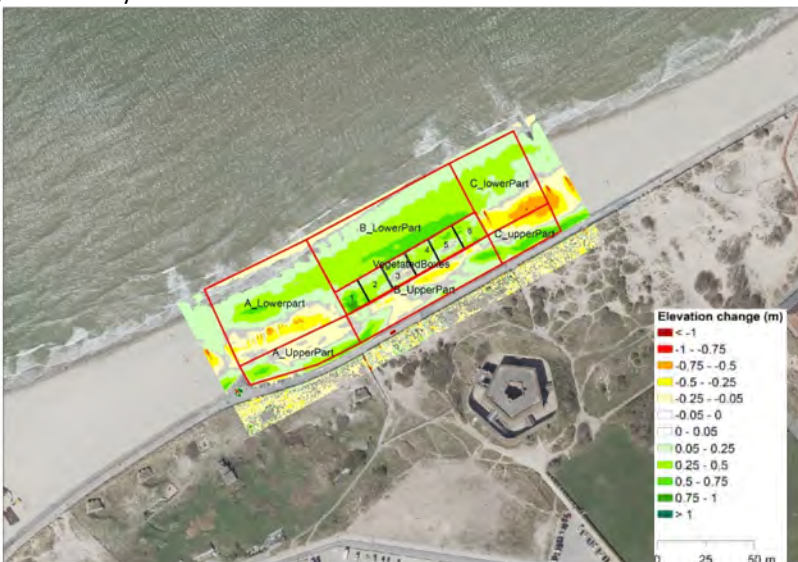
It is clear that the vegetated boxes were subject to more accretion over the 1<sup>st</sup> monitoring year (T0-T11) than the 2<sup>nd</sup> one (T11-T21) with a maximum elevation of 1.05 m and 0.9 m respectively (Figure 14). Taking into account that the 3<sup>rd</sup> year monitoring lasted 3 months longer, accretion in the vegetation boxes was disproportionately larger (1.6 m) than during the previous 2 monitoring years. This was probably related to the more efficient wind regime with oblique onshore wind above 7m/s (i.e. threshold of aeolian sand transport). Slight erosion occurred in the 3<sup>rd</sup> year on the lower dry beach and seaward of the boxes between 5 and 6 m TAW (except on the east side lower beach: C\_lower part). Strong erosion occurred in this area in the 1<sup>st</sup> year but not in the 2<sup>nd</sup> year. During the 3<sup>rd</sup> monitoring period, a gradual decrease in accretion intensity in the boxes is locally observed from Box 1 to Box 6 (from SW to NE) (Figure 14C). This is a contrast with the previous period when the side boxes (Box 1 and 6) gained more sand than the centre ones. This might be related to the dominant oblique wind directions. The boxes at the sides are catching alongshore aeolian sand transport. A common morphological pattern of the 2<sup>nd</sup> (T11-T21) and 3<sup>rd</sup> (T21-T29) monitoring year is that the upper-beach area located landward of the boxes was eroding with a line of morphological stability at 7.5 to 7.7 m TAW. This contrasts with the accretion in the first year. This might suggest that sand transport inland was prevented due to higher vegetated dunes after the preceding two years. However trench excavation works by Ostend city cannot be ruled out.

Figure 14 – Annual evolution based on DoDs of the UAV surveys with the locations of the contours of the defined volumetric zones. The UAV survey coverage was smaller in T21 explaining the difference of the DoD size.

As already observed on the DoDs (Figure 14), the westward boxes Box 1 and Box 2 received more sand than the eastward boxes over the 3<sup>rd</sup> year. For example, the difference between Box 1 and Box 6 is 0.25 m<sup>3</sup>/m<sup>2</sup>/y. This demonstrates that there is a spatial variation in the sand deposition in the vegetated boxes.

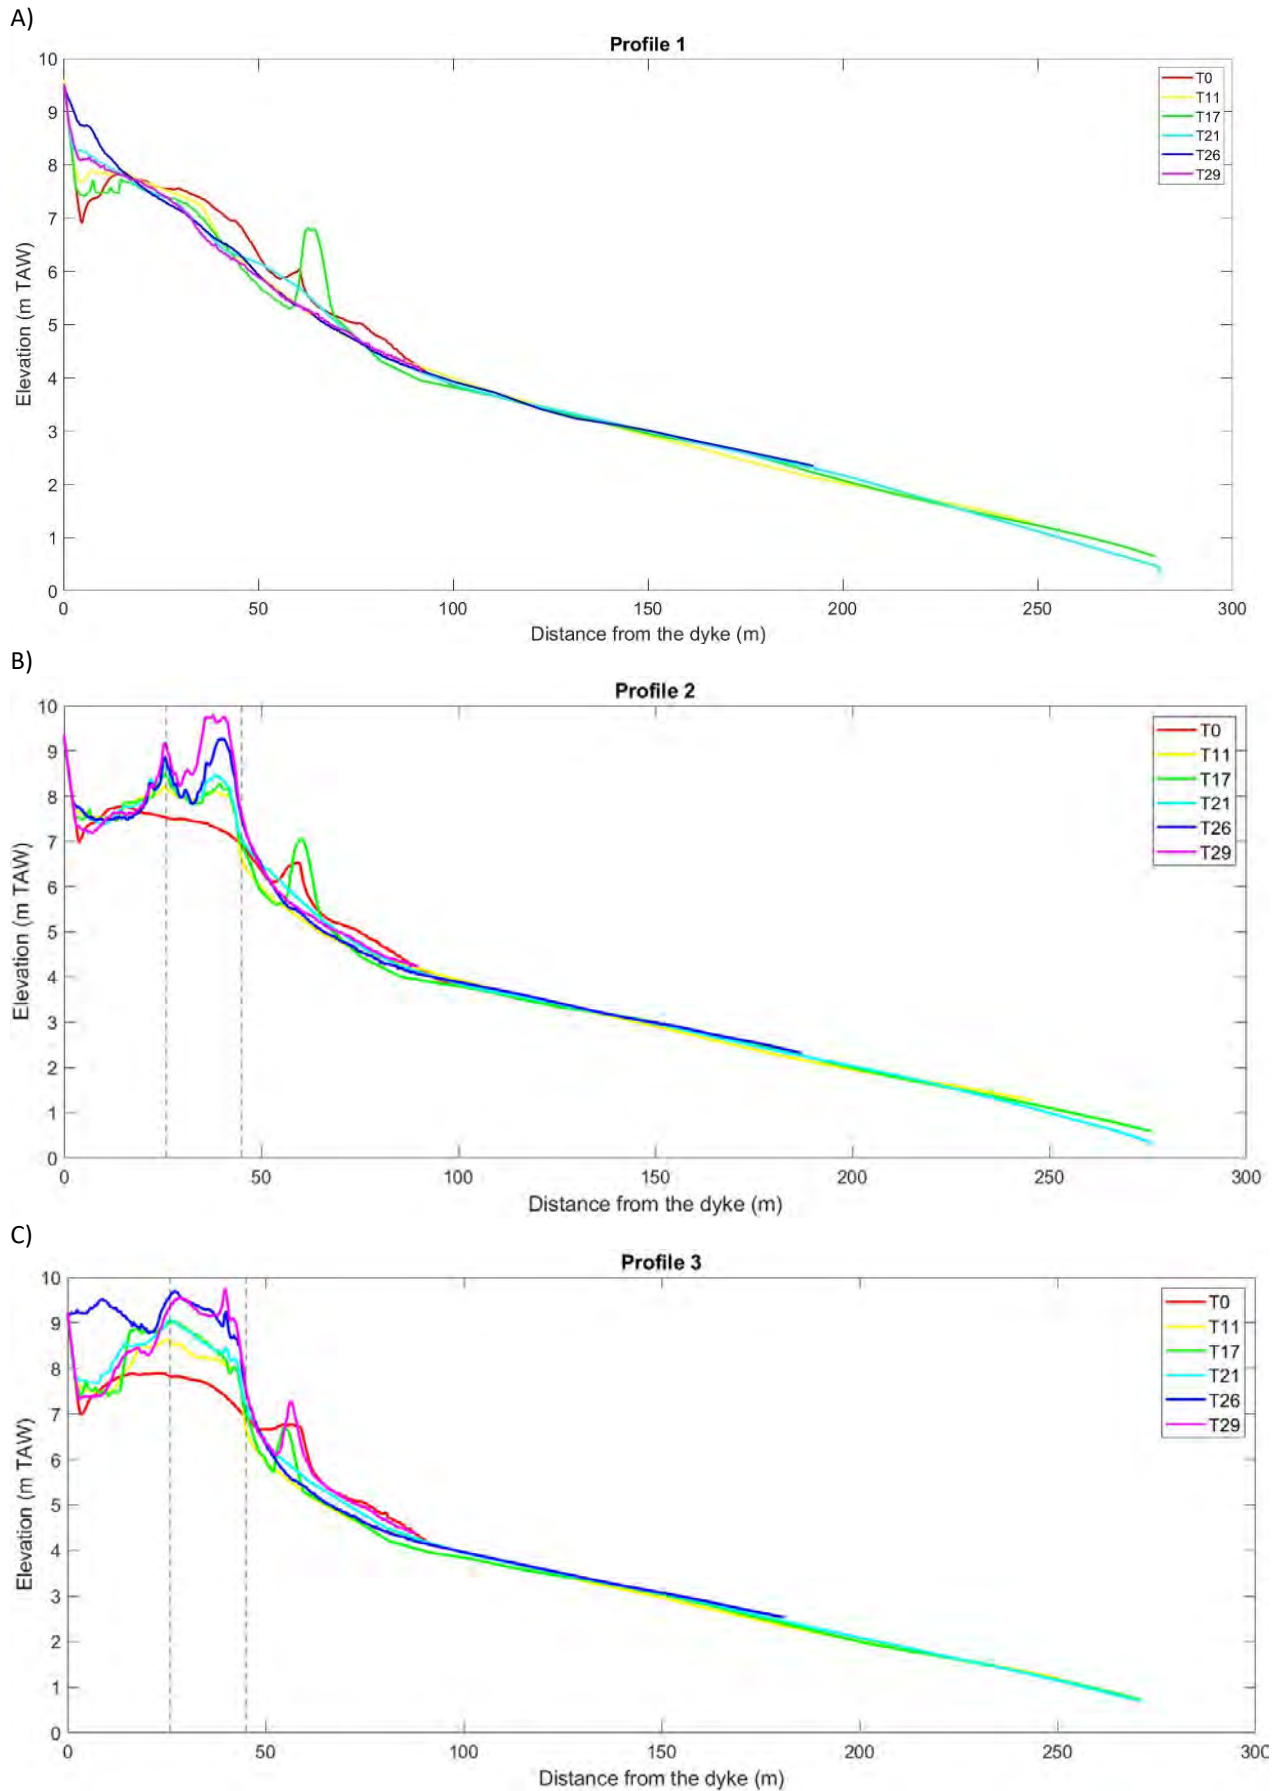
Figure 16 – Time series of evolution of the merged profiles of the UAV and RTK-GPS surveys.  
The vertical dashed lines correspond to the location of the wire fences.

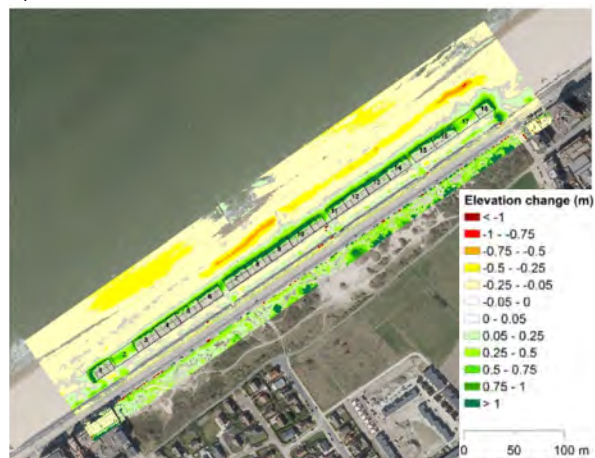
The DoDs indicate a progressive evolution of the pilot site (Figure 18). The net accumulation in the vegetated boxes and at their landward side clearly contrasts with erosion at the seaward side. Sand accretion in the vegetated boxes was above 2 m in the period T0-T28. Figure 19 displays the annual morphological evolution. It seems that the highest sand gain over the 3<sup>rd</sup> monitoring period occurred at the landward edge of the vegetated boxes. The same trend was observed for the 2<sup>nd</sup> year monitoring while it was more at the seaward margin and center in the 1<sup>st</sup> period.

The passages between boxes (Box 1- 2, Box 6-7, Box 10-11, Box 14-15) were filled up over the first monitoring year. However, it did not occur at the same extent over the last 2 years. In addition, a similar pattern of significant erosion in the seaward part of the dry beach (at an elevation below 7.2 m TAW) took place in the 1<sup>st</sup> and 3<sup>rd</sup> year monitoring while it was much lower for the 2nd period. Noteworthy, the extent of the UAV survey for T18-T28 allows to observe alternating spatial erosion and accretion on the lower part of the beach between 3 to 0.5 m TAW. A stability boundary at 7.5 m TAW (i.e. morphological change below +/-0.05 m) just located in front of the vegetated boxes divides the morphological pattern between the upper and lower part of the dry beach profile. This feature is observed over the entire monitoring period.

Figure 18 – Global evolution based on Ref DoDs of the UAV surveys

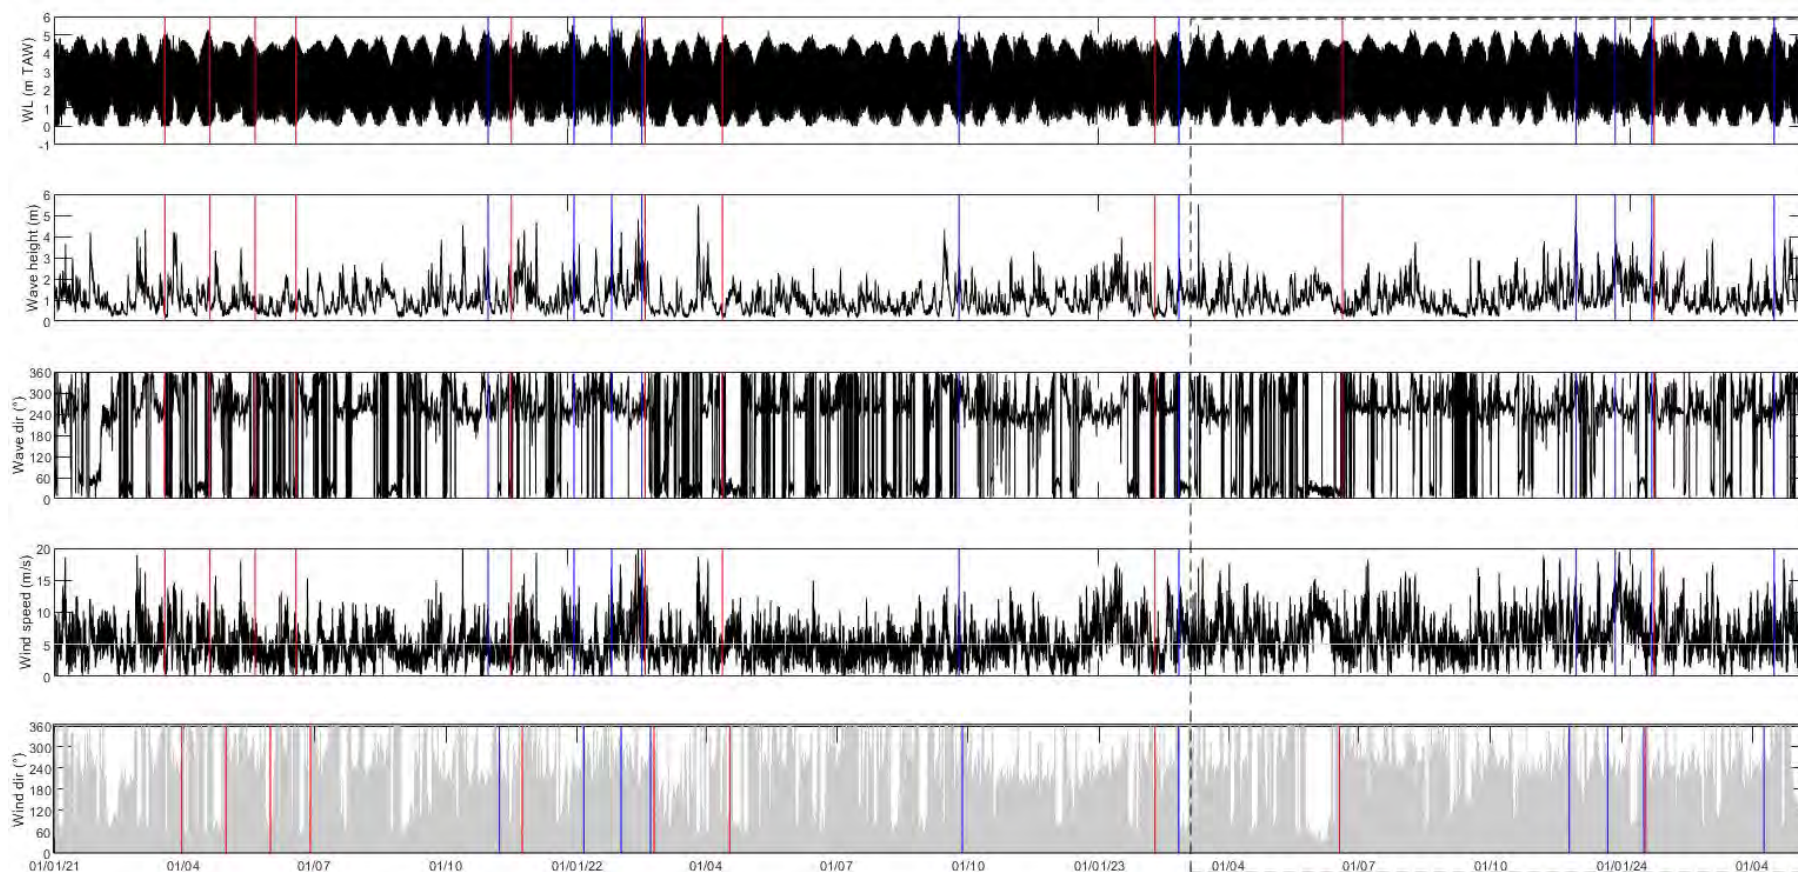
Figure 22 shows time series of water level in Ostend, wave 10% height and wave direction in 'Ostend Poortjes' (located 7 km from the coast), wind speed and direction of the weather station in Zeebrugge with the indication of the 3<sup>rd</sup> year monitoring. The surveys and energetic events are also displayed.

Figure 22 – Time series of the water level in Ostend, wave height 10% and wave direction in Ostend “Poortjes” (buoy located 7 km from the coast), wind speed and direction of weather station Zeebrugge at 10 m high (Meetnet Vlaamse Banken). Vertical red and blue lines correspond to the UAV and LiDAR surveys and energetic events respectively. Horizontal gray line on the wind speed time series is the critical wind speed for aeolian sand transport (7 m/s). The dashed box corresponds to the 3<sup>rd</sup> part of the monitoring.

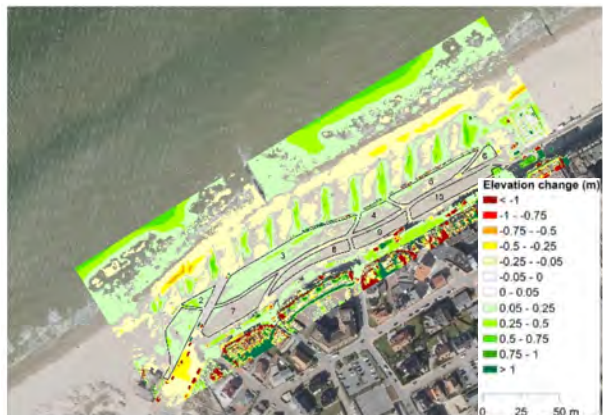
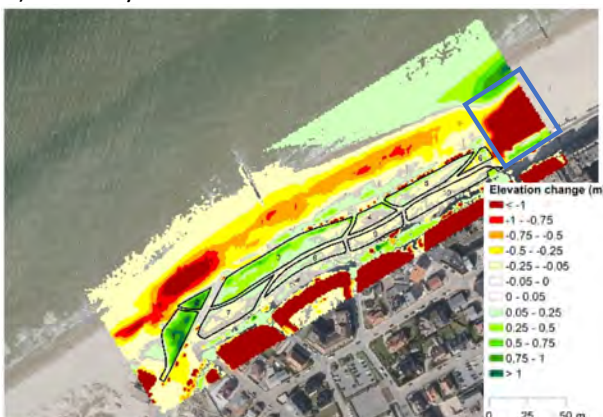
Figure 23 – Global evolution based on DoDs of the UAV and LiDAR surveys at Westende. The changes of the building (landward of the seawall) are artefacts.

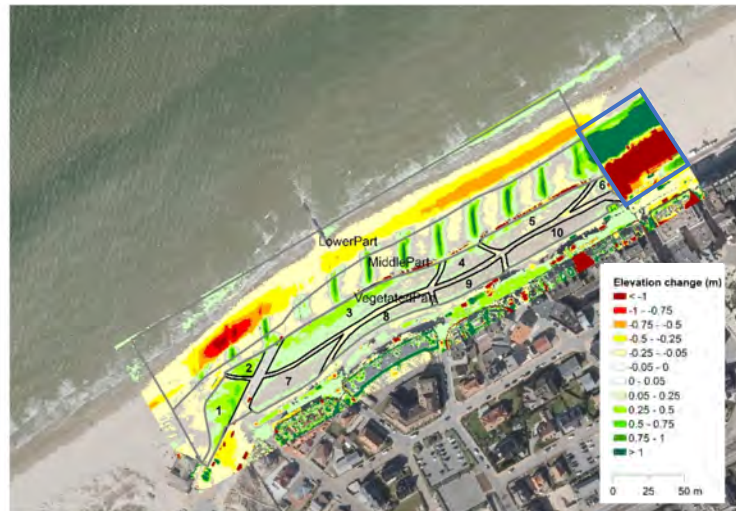
Similar morphological changes are observed between the three monitoring periods with a dominance of erosion for the lower part of the dry beach and relative stability of the landward vegetated boxes (Figure 24). Sand accumulation took place in all the seaward vegetated boxes in the 2<sup>nd</sup> year monitoring, while it was limited to the westerly boxes in the first and third period (T0-T4, T7-T9). In case of coast-parallel winds from SW, the westernmost boxes are expected to intercept sand and relatively deplete the more eastern boxes. The morphological changes around the fences in the middle part where alternating erosion and accretion occurred in T0-T4 and T4-T7 were not present in the last year (T7-T9) when the fences were removed. Therefore, these fences had only a local and temporary influence on morphology.

Figure 24 – Annual evolution based on DoDs of the UAV surveys.  
The changes of the building (landward of the seawall) are artefacts.

For the volumetric calculations, the study area is divided into a number of zones based on the large-scale erosion/sedimentation pattern (Figure 24). The volumetric evolution in these zones was calculated using the UAV and LiDAR surveys and the results are given in Table 11. The vegetated zone experienced a small growth of 0.02-0.05 m<sup>3</sup>/m<sup>2</sup>/y over the first and second monitoring periods (T0-T4; T4-T7) while a stronger growth of 0.28 m<sup>3</sup>/m<sup>2</sup>/y is observed over the 3<sup>rd</sup> period (T7-T9). The winter sand fences 'zandschermen' located in the zone of the middle part might have reduced the sand capture in the inland zone in some periods. The morphological evolution of the middle part was affected by this same winter fences and maybe also cabins installed by Middelkerke municipality. As previously observed on the DoDs, the lower part of the dry beach experienced erosion with a similar rate in the 3<sup>rd</sup> year as in the previous periods.
