# Insights from Steady overflow and Wave overtopping tests

Adaptation  
to climate  
change

WL2024R20\_047\_4\_P2C\_Overflow-Overtopping\_Insights

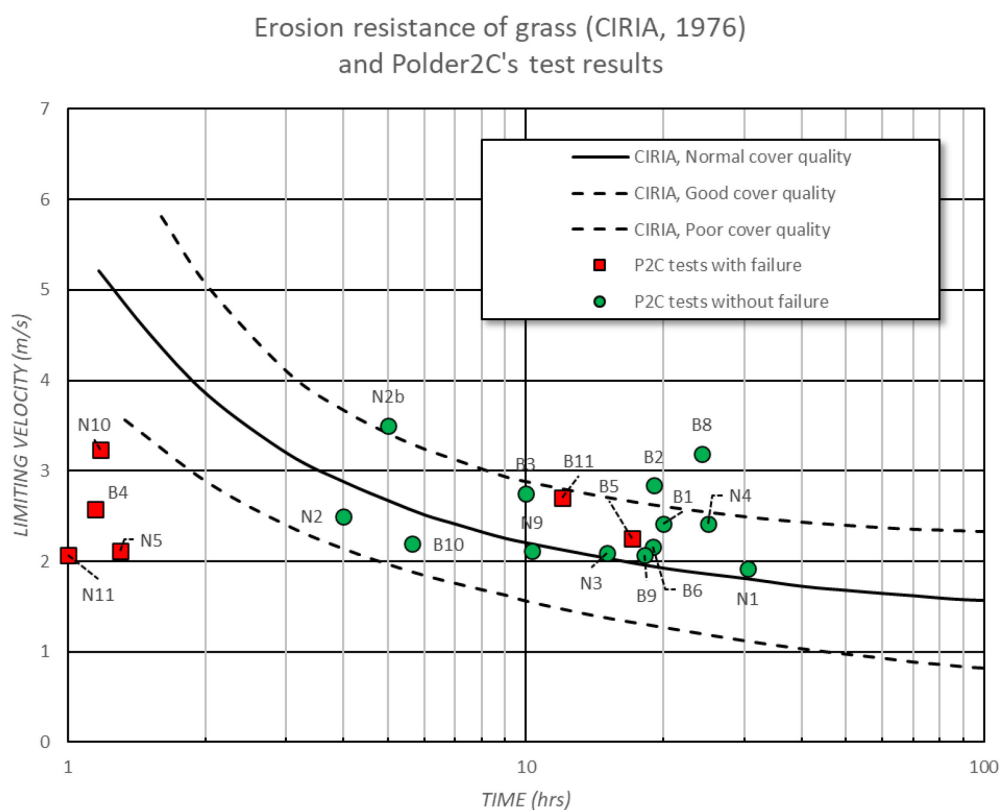
- The average velocity recorded at the upper slope sensor position, is mostly situated between 2 and 3 m/s. As shown in Vercruysse et al. (2023), and discussed in §3.1.4, there is uncertainty about the electromagnetic velocity measurements under aerated conditions. Because the measurements at the upper slope are often less or even not aerated, the quality of these data is most reliable. The same type of measurements lower on the slope are not reliable enough but is known to be higher than depicted here. PTV measurements have been performed on selected overflow tests and indicated accelerating flows from 2-3 m/s at the upper slope, up to 4-6 m/s at the lower slope. In this sense, the velocity of the data points is higher than shown hereunder. The consequence of this will be discussed below.

- There is a cluster of data points with short experiment duration (< 2 hours). These are experiments aiming specifically at testing slope anomalies although the reason of failure was not always as anticipated. It appeared that burrows and barren or soft soil areas were most vulnerable.

- There is a wide cluster of data points that did not lead to significant damage or further failure of the levee. These tests have durations of 4 to 30 hours.

- Two tests led to failure after 10 to 20 hours. The presence of burrows and/or other biological activity was related to the weakening of the levee cover (see §4.3).

Figure 21 – Velocity, duration, and outcome of Polder2C's overflow tests compared to CIRIA (1976) erosion resistance of grass cover of different qualities. Velocities should be considered as low estimates (see text).

The cluster of tests with positive outcome, even after 30 hours, indicate that most of the levees, when in a normally maintained condition, are strong and can withstand an overflow event. Because the indicated velocities (measured at the upper slope) are a lower limit for the velocities further down the levee slope, the cover quality exceeds the “normal (and even good) cover quality”, as indicated by the CIRIA curves, well. In other words, the tests indicate that the vegetated clay cover layer is even more resistant than what would be expected based on such curves. Thus, the tests that do not lead to failure indicate that most parts of the levee are in a normal to good condition because of the maintenance strategy applied.

identification of such anomalies during regular levee inspection, and it would be advisable to mitigate or repair such anomalies as soon as possible after discovery. However, if unmanaged, such anomalies clearly prove to lead to failure within the duration of an overflow event in case of a tidal environment, and well within the duration of upstream (fluvial) floods which may have durations of days. Several other short tests (N-OF5B, N-OF05C, N-OF06, N-OF07, N-OF08) are not shown in the graph because they relate to levee slopes without or poorly developed vegetation. The outcome of these experiments is that reinforced turf mats, geotextiles and other emergency repair solutions are insufficiently strong on the short term because regrowth of vegetation is lacking. Therefore, these do not relate to the erosion resistance of grass covers and are thus not included in the plot.

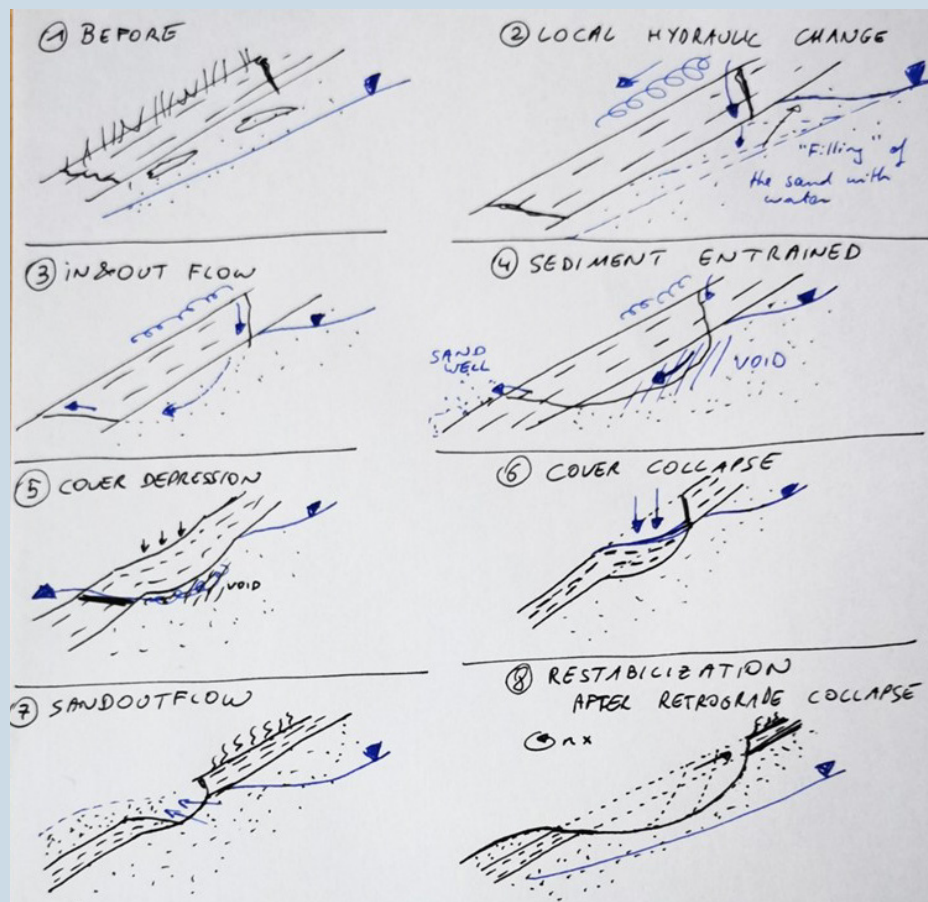
- d) **When also entrainment of sand from the levee core is present, the mass deficit will develop** below the cover layer which will remain intact thanks to its (tensile) strength of the grass cover layer on clay. If this mass deficit becomes large enough, an **initial depression** will develop (5), and will ultimately lead to **collapse of the cover layer**, the grass cover layer being tore apart and being collapsed into the mass deficit hole) (6). This latter collapse was observed during the field test.

- e) Once the collapse has taken place, the hydraulic head established in the levee core needs to equilibrate, leading to outflow entraining large portions of sand from upstream (7). This leads to retrograde erosion and subsequent collapse of the levee cover layer (8) until the cliff stabilizes under the influence of desaturation.

Figure 32 - Field sketch of the burrow induced failure process hypothesis.

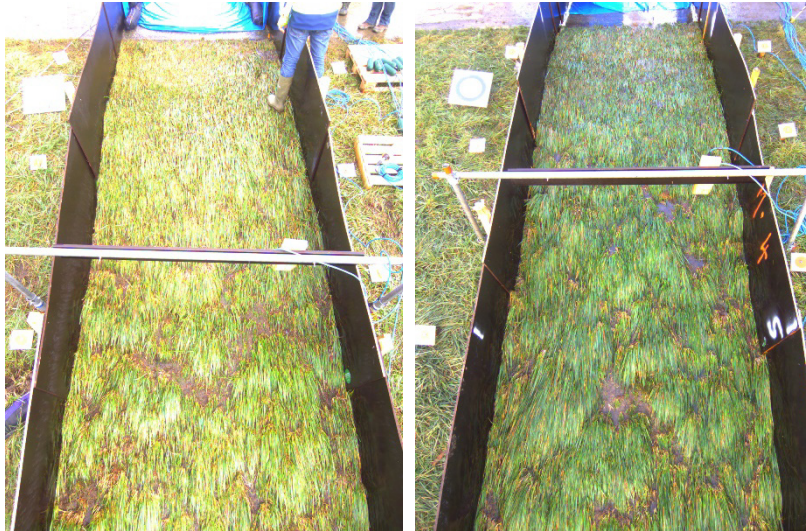
The **short(er) vegetation** (10 to 20 cm in length compared to typically 20 to 40 cm after 'regular' mowing<sup>2</sup>) in test B-OF02 did not result into faster erosion or damage of the levee slope, even though the shorter length could give less protection to the underlying soil. This does not seem to be the case. In terms of damage evolution, images of the cover layer (Figure 37, Figure 38) can be compared after a similar overflow time. For this purpose, the cover layer state after approximately 15 hours of overflow is considered:

Figure 37: Visual comparison of B-OF01 and B-OF02 (upper slope) after 15 hours of overflow.

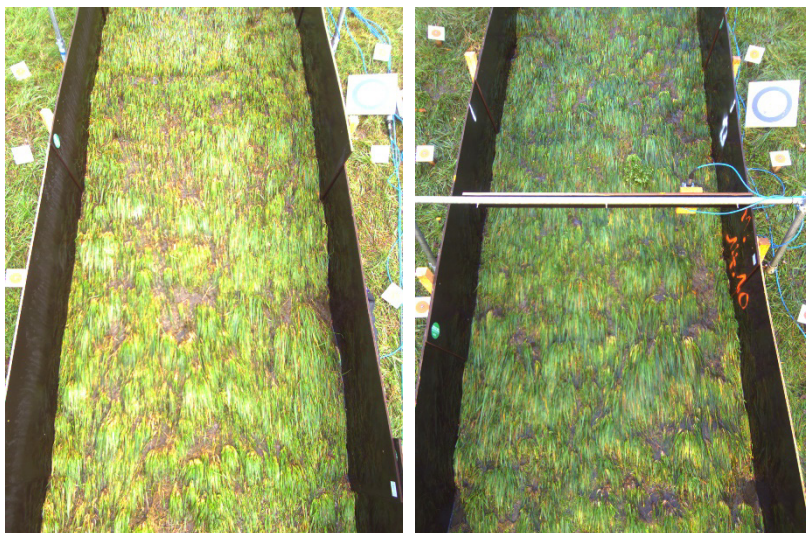
Figure 38: Visual comparison of B-OF01 and B-OF02 (lower slope) after 15 hours of overflow.

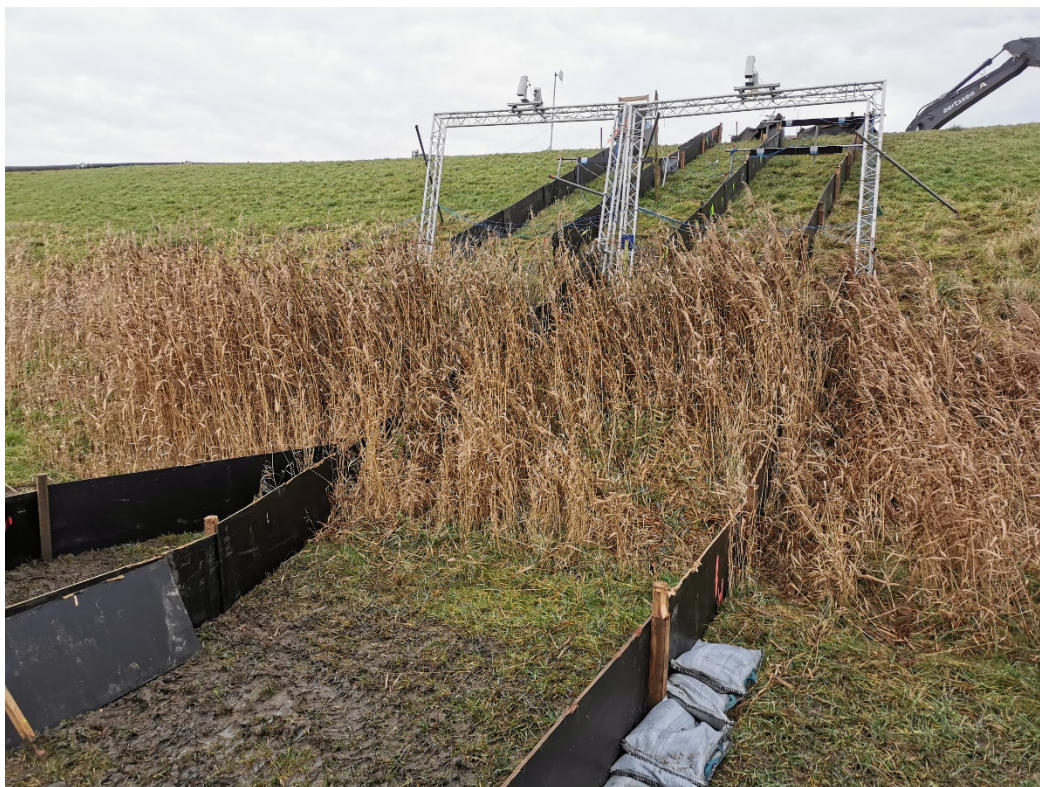
On the Dutch part of the levee, a reed patch was present in an area with soft soil due to a limited drainage (a gravel draining is present at the toe of the levee). The reed patch had developed because no mowing was executed during several years. It was expected that either the dense root system of the reed field would stabilize the levee slope, or that the soft soil would quickly erode and lead to failure (see N-OF10, N-OF11 in Figure 21).

Two tests were organized on the reed filed: test N-OF10 and test N-OF11, see Depreiter et al., 2023b. The outcome of these tests was clear: within minutes, soil started to erode. The root system did stabilize part of the area, but other parts eroded quickly and deeply. During the first test the sand core started to destabilize after 1 hour of testing. During the adjacent test the destabilisation started after 31 minutes of continuous overflow.

Figure 39 - Two parallel test sections in the reed overgrowth.

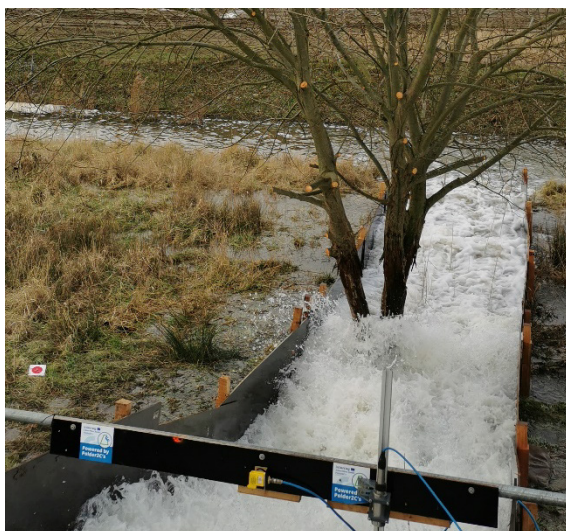
Two experiments were executed to assess the impact of a tree at the toe of the levee: test B-OF04 and test B-OF11. The test B-OF04 was a very short experiment due to early slope failure and no observations related to the tree could be made (for detailed discussion, see §4.3.2). The test B-OF11 lasted longer (13 hours). During both experiments, the soil around the root system of the tree was eroding and gradually exposing the roots of the tree running shallowly (centimetres) underground. This process does not lead to very strong erosion around the tree trunk itself but is more widespread. Therefore, the erosion does not destabilize the tree, nor it compromise the strength or stability of the levee.

Figure 41 - Overflow with tree at the levee toe (B-OF11).

Therefore, no negative direct impact of the tree on the levee stability is observed. Within the timeframe of a real overflow event, the tree will likely not lead to a problematic situation.

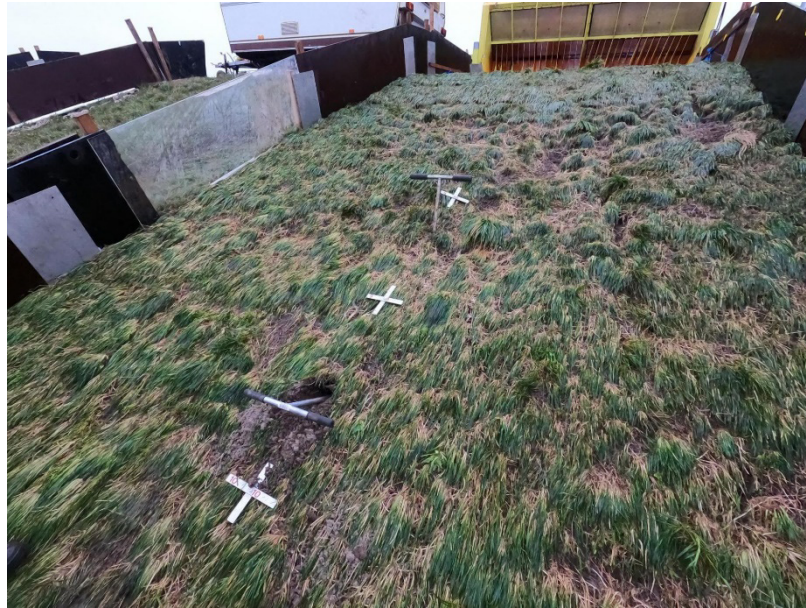
Therefore, 2 artificial burrows ( $\varnothing = 10$  cm) were drilled, in line with each other, one in the higher (boxes 8-9/9-10) and one in the lower (boxes 17-18/18-18) part of the slope, each consisting of an upward vertical pipe (angle of  $90^\circ$ ) connecting with a downward more or less horizontally (angle of  $-10^\circ$ ) pipe and touching upon the sandy core (Figure 46). Eventually, the cover (with artificial burrows) did not fail (Figure 45, d.).

Figure 46 – Drilled burrows with in- and outlet in the centre line of boxes 8-9 and 9-10.

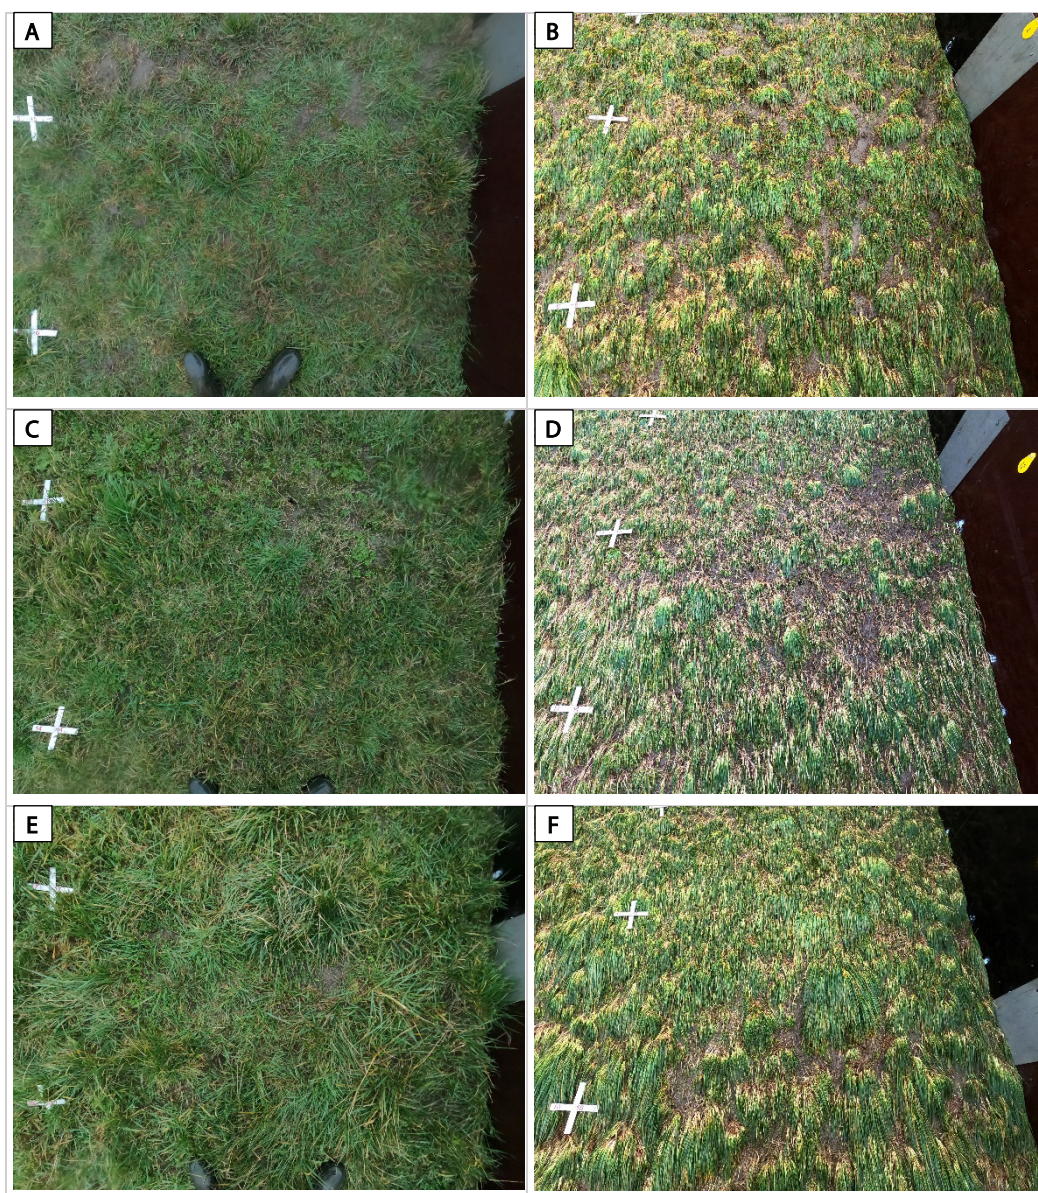
Another reference section was put to the test. When after 3 sets of waves no failure of the cover was imminent (Figure 47), 2 long(er) artificial burrows were created, adjacent in the higher part of the slope, again with a diameter 10 cm but by increasing the total length of the pipe (inlet of pipe at an angle of  $45^\circ$ , outlet of pipe at an angle of  $-12,5^\circ$ ) (Figure 48). Both pipes were connected within the sandy core. Next, after applying wave set '2m50lsm' for 30 minutes both pipes showed washout of sand. Continuing with wave set III ('1m190lsm'), transport of sand remained and after 15', suddenly, a pit was formed at the inlet of 1 pipe (failure of the cover) (Figure 49). Gradually this pit eroded further and found connection to the other pipe inlet. 15' later, a step of 3m by 4m with a cliff of 1 m height was formed (Figure 50). Notice that both outlet pipes are still in place.

Figure 47 – Detail of levee slope of N-OT04 - box 5-6: A) at the start and B) after waves set I, III & III; box 13-14: C) at the start and D) after waves set I, III & III; box 18-19: E) at the start and F) after waves set I, III & III

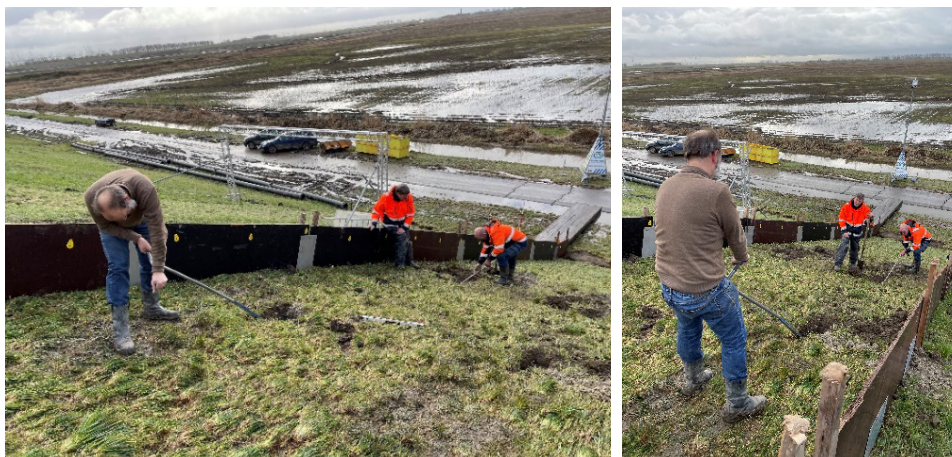
Figure 48 – Drilling of 2 adjacent burrows during test N-OT04 with inlet in box 7-8AB/CD and outlet in box 13-14AB/CD

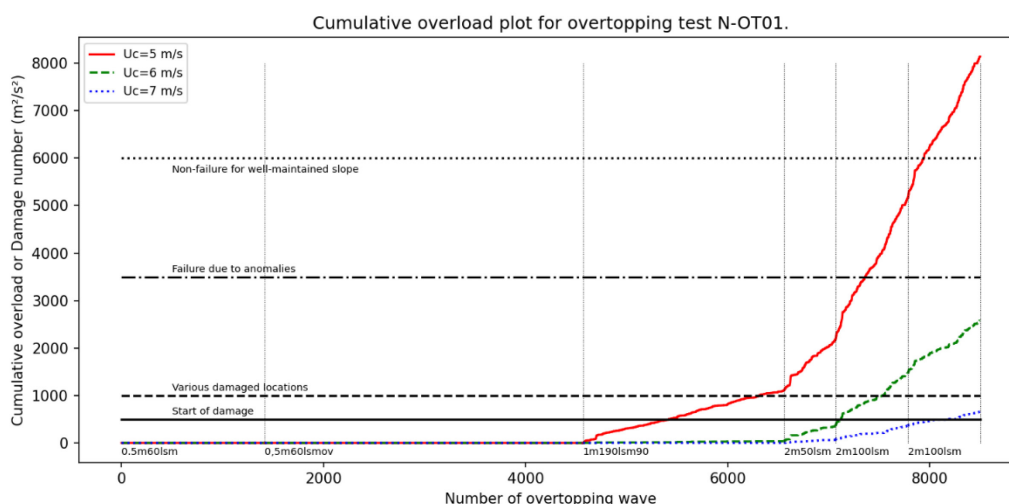
The predicted result for different critical velocities is indicated in Figure 51. The curve for  $u_c = 5$  m/s is applicable here. Figure 51 indicates that during the third condition, initial damage would be appearing and evolve into failure during the most intensive wave set at the end of the test.

Initial damage was already present at the end of condition I (0.5m60lsm) due to the presence of (a small number of) mole burrows. This is more severe than expected on the basis of the model (the red curve in Figure 51). A buried gravel drain situated at the toe became visible towards the end of condition II (0.5m60lsmov) and was further exposed during condition III (1m190lsm). This did not impact the levee slope itself. During condition III (1m190lsm), expulsion of sand through the mole burrows, adjacent to the test section, became apparent and led to a surface depression due to undermining of the cover layer during condition IV (2m50lsm). Condition V (2m100lsm) was prolonged (repeated) and after further sand expulsion, the levee slope collapsed towards at the end of the test. Subsequent wave impacts further eroded the damage. The outcome of the test thus seems in line with the expected slope behaviour.

Figure 51 - Cumulative overload function for N-OT01 indicating the damage numbers for three different critical velocities (5, 6 and 7 m/s). The 5 m/s curve (red) is applicable to this site. Each vertical line indicates a transition in wave conditions. The wave condition name (e.g. 0.5m60lsm) is indicated on the graph. The horizontal lines represent the damage qualification as indicated in Table 5.

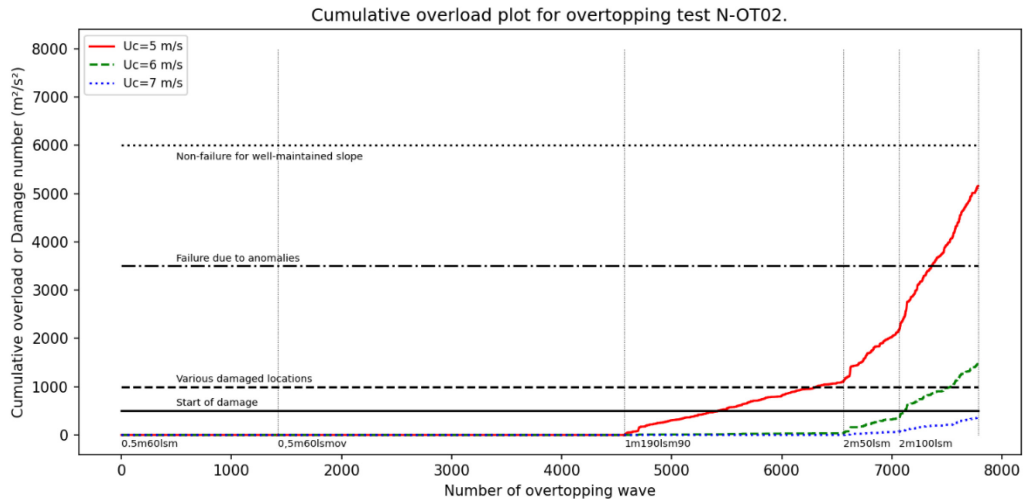
The test on N-OT02, containing the wet spot was conducted with wave conditions I, II, III, IV and V (Figure 52). The last wave condition (V, 2m100lsm) was only applied for 1 “storm hour”. As earlier described, this eroded faster than what would be predicted by the overload method (for cover layers in good shape), if we consider the soft or wet spot to be an anomaly.

Figure 52 – Cumulative overload function for N-OT02.

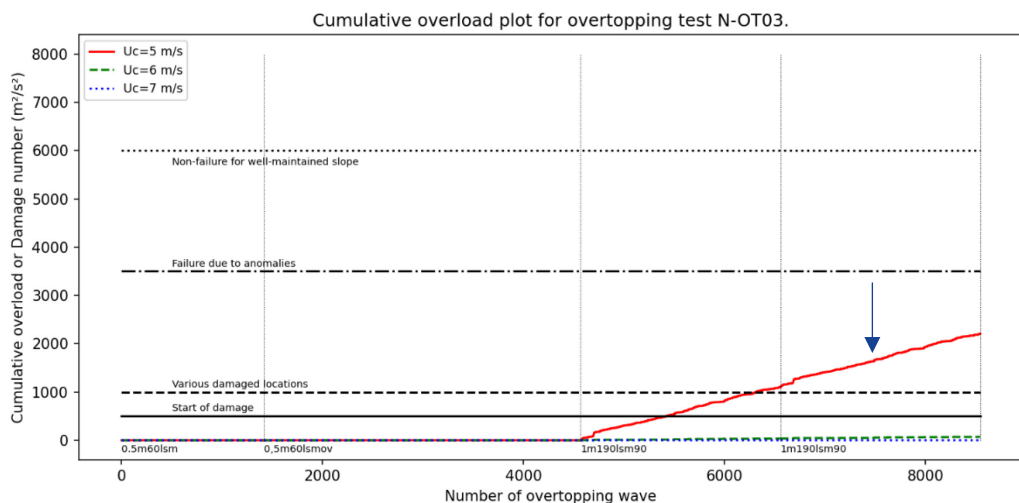
Test section N-OT03 contained, in comparison to N-OT01, a large amount of mole burrows. Here, test conditions I, II and III (2x) were applied (Figure 53). During condition II (0.5m60lsmov), erosion of the mole burrows was observed, and barren spots became apparent. The erosion increased during the first application of wave condition III (1m190lsm). In this episode, the gravel drain became visible at the toe. After 3 “storm hours” (i.e., halfway the second run of condition III), no severe damage had developed. Then, an artificial damage was applied: two additional artificial burrows, but even this did not lead to any failure in the subsequent hour of testing. According to the cumulative overload function, serious damage was expected after an overload of 3500 m<sup>2</sup>/s<sup>2</sup> but this level of loading was not reached during the test.

Figure 53 - Cumulative overload function for N-OT03. Arrow indicates introduction of artificial damage.

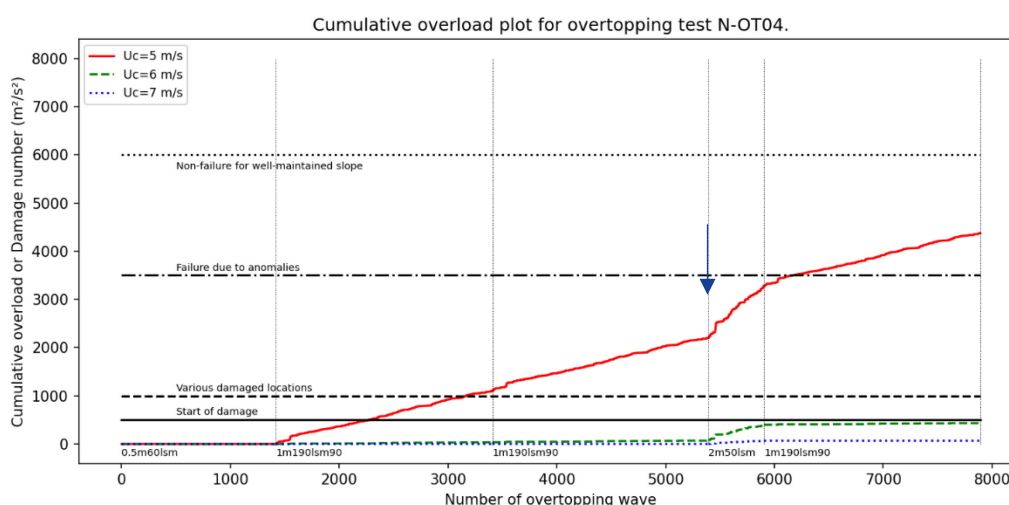
On the fourth section, the first part of the test consisted of wave condition I (0.5m60lsm) repeated by wave condition III (1m190lsm) (2x). Some barren patches had appeared during these runs, but no failure had occurred. Failure was not to be expected based on the overload function.

The introduction of a set of artificial burrows (indicated by an arrow on Figure 54) by manual drilling in a wide V-shape so that contact with the sand core was made, quickly led to expulsion of sand at the lower burrows when condition IV (2m50lsm) was applied. This condition was ended after half an hour of simulated storm and was continued with condition III (1m190lsm). Here also, sand expulsion led to undermining of the cover layer and ended with slope failure, but later than predicted by the wave overtopping damage function.

Figure 54 - Cumulative overload function for N-OT04, complete test. Arrow indicates introduction of artificial damage, after which sand expulsion starts. The damage function predicts failure shortly after the start of the last storm condition (overtopping wave 6000), but in reality the failure occurred only after the sand expulsion lasted much longer (nearly 2000 additional overtopping waves).
